Report of Marine Survey

Vessel: 2009 Mako 212

Purpose: Pre-purchase and Evaluation

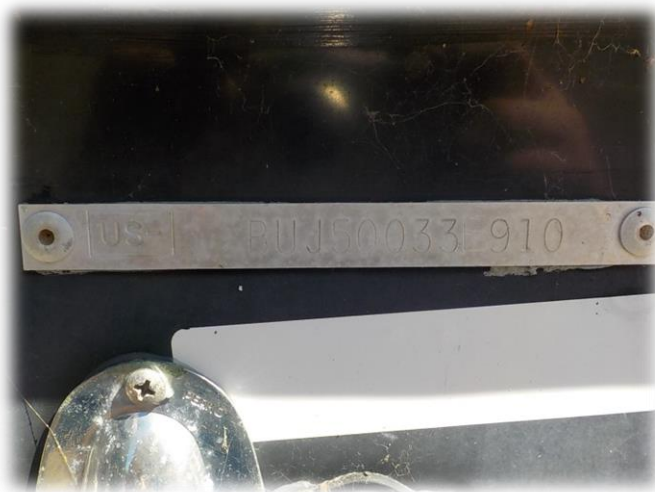
Hull ID number verification:

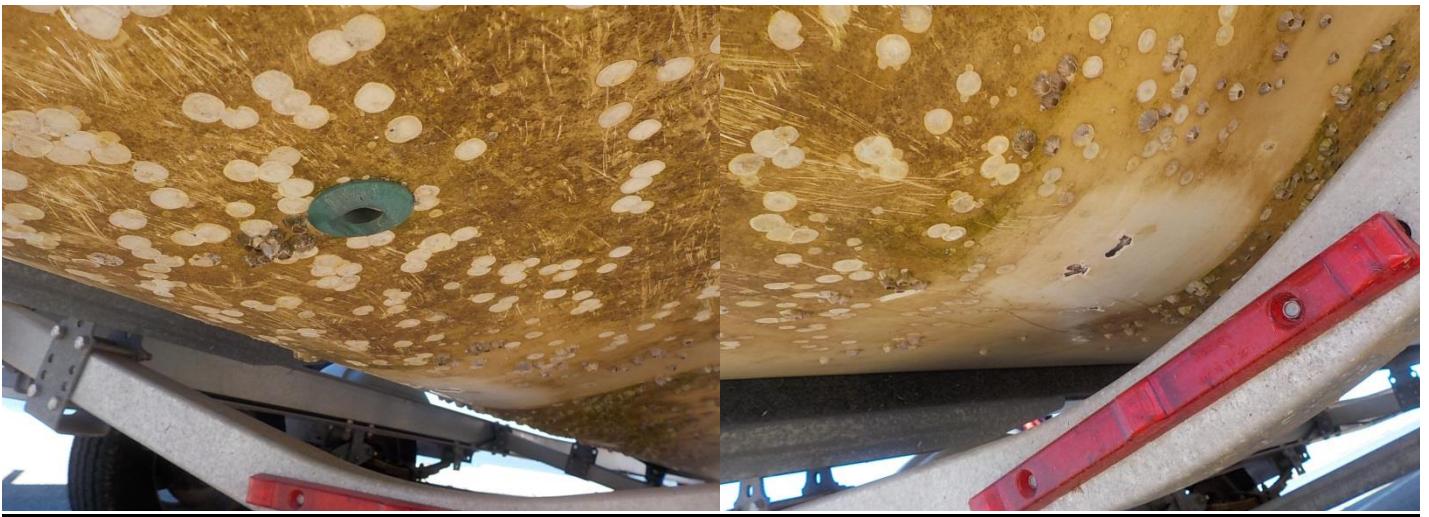
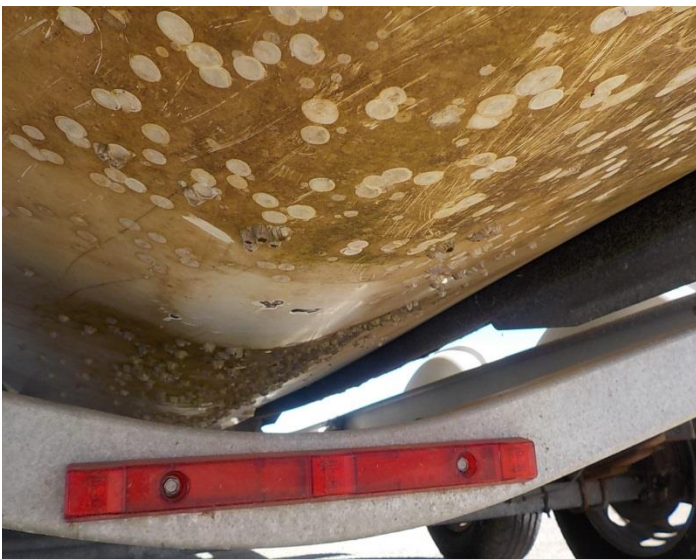
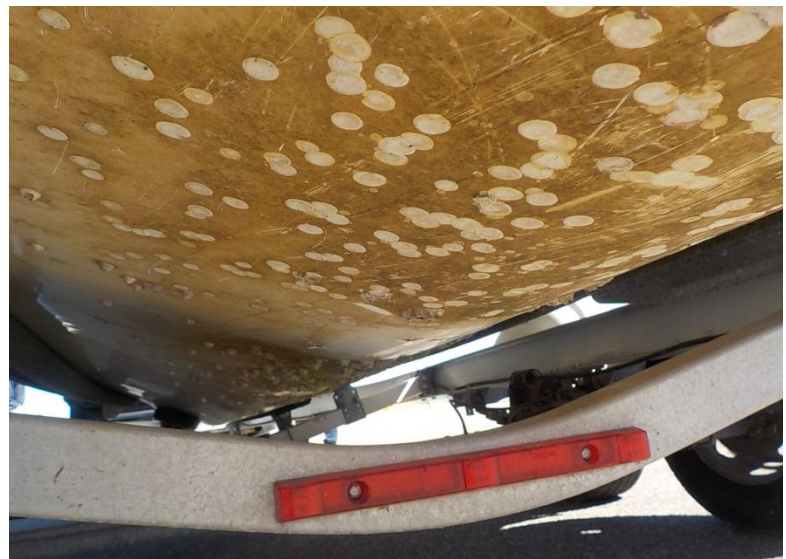
Fiberglass. NOTE: Damage sighted in the following areas: 1) Barnacle's sighted on the aft portion of the hull, leading surveyor to believe the vessel sat in a sling and was left partially in the water for a significant amount of time. Clean hull bottom and remove barnacle's. 2) Several longitudinal scuffs were observed on hull bottom running length of keel. Buff and polish as needed for cosmetic purposes. 3) Three 1"x1" gouges/voids were observed on the aft portion of the hull bottom. Repair to avoid water intrusion.
