# Schultze Property Inspect, LLC

## Confidential - Property Inspection Report - Confidential

7777 Client Drive, Kansas City, MO 64111

Inspection Date: 03/31/2017

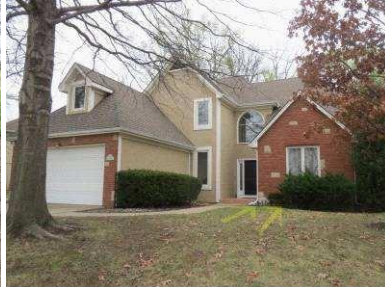
Water could be trapped here

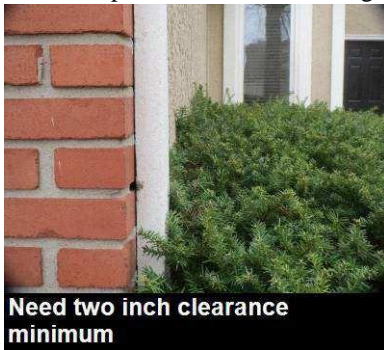
Attention Needed - The shrubs and/or bushes need to be trimmed or maintained. Bushes and shrubs need to be trimmed away from the structure at least 2 inches. This space is needed to prevent direct access to the structure for moisture and insects and to keep the bushes from damaging the siding.

Need two inch clearance minimum

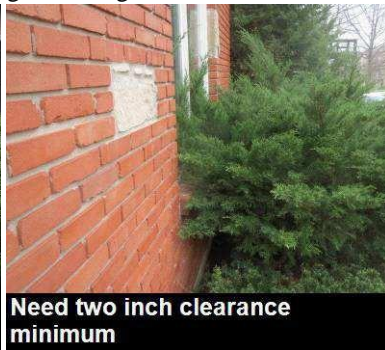
Need two inch clearance minimum

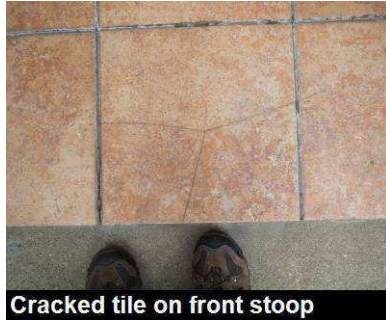
Attention Needed - The entryway stoop needs some minor repair in order to defer deterioration. At least one of the tile was cracked and grout was missing. Repair or replace as necessary.

**Cracked tile on front stoop**

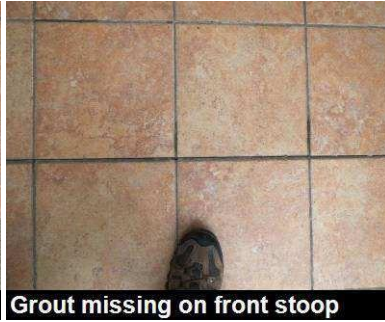
**Grout missing on front stoop**

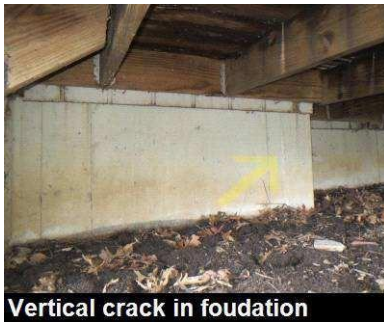
Yes - Cracking in the vertical foundation walls was noted from the exterior underneath the deck. Cracks less than 1/4 inch were noted in the foundation walls. This condition does not yet warrant further investigation provided the movement is not recent or does not show differential movement. If future movement is noted or the cracks grow, then further investigation by a professional structural engineer and/or a licensed qualified foundation contractor will be needed to determine the cause and course of action.

Vertical cracks were noted in at least one exterior wall underneath the deck.

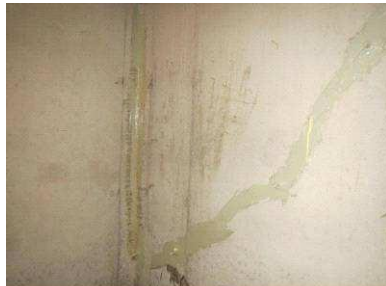
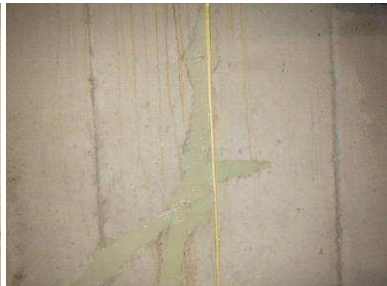
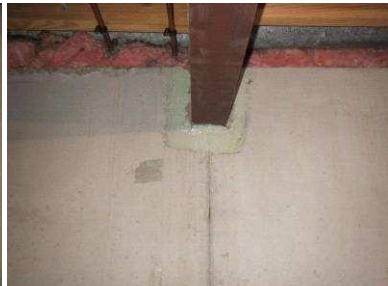
Satisfactory - The exposed portions of the interior foundation perimeter walls appear to be satisfactory. Epoxy injections and sealant have been done.

Basement wall repair work

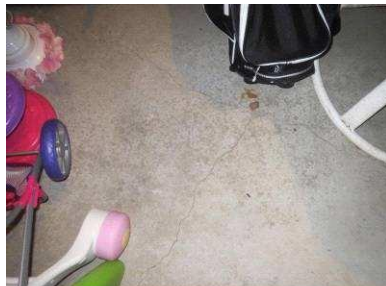
Yes - Cracks were noted in the slab floor. Unless otherwise noted, the cracks appeared to be nothing more than curing cracks.

Minor floor cracks in basement

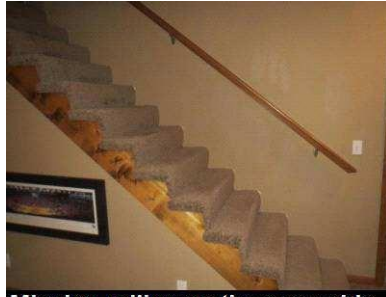
Attention Needed - Some portion of the staircase needs attention to perform satisfactorily. The right side of the stairway is not protected with a railing or handrail. Recommend installation of a railing. Also there is a board that is separating from the supporting structure of the stairs. Repair or replace as necessary.

**Missing railing on the open side of stairs**

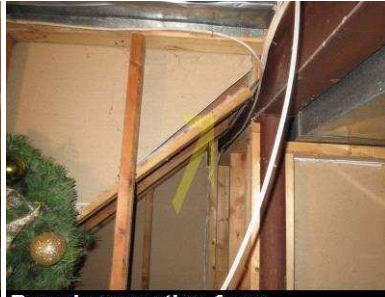
**Board separating from structure**

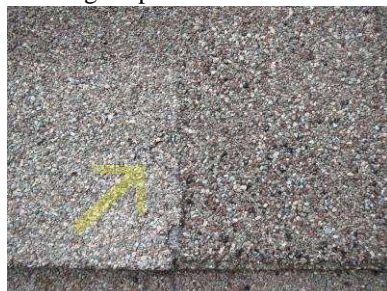
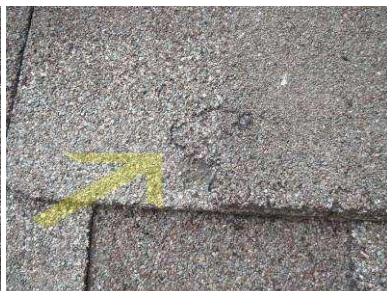
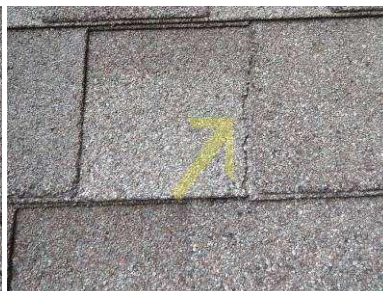
Good - The roof covering material is either new or near new, and it appears to be installed correctly. Only one section of the roof showed evidence of wear. It is the jut out section on the right (north) side of the house. Recommend repair or replace or at least get a professional roofer to examine.

Example of damage on roof

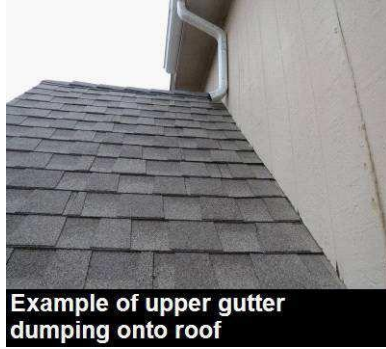
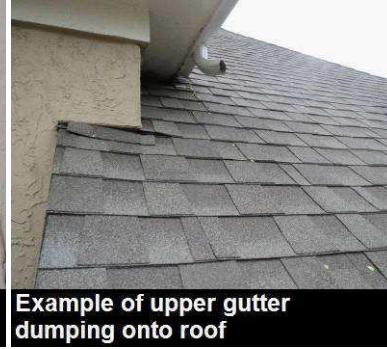
The gutter system on the roof edge appears to be functional and adequately sloped to carry the water to the downspouts. Several downspouts emptied onto the roof and drained to the lower gutter. Recommend installing extensions to prevent premature deterioration of shingles.

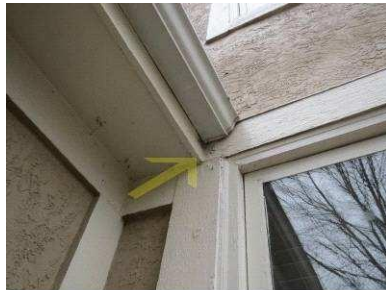
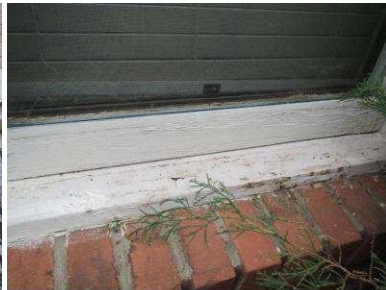
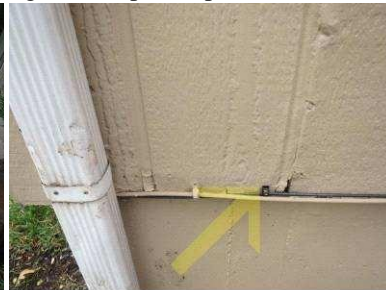
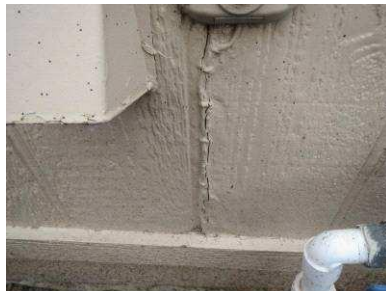
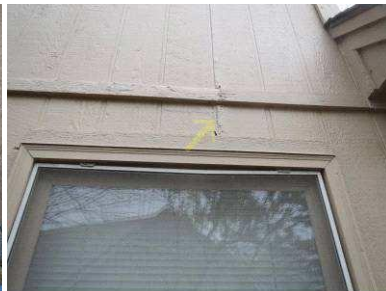
Attention Needed - The exterior siding material or finish is in a condition that requires minor repair to prevent further deterioration. There are areas on all sides of the structure where the wood siding needs repair, replacement or caulking.

Siding/trim deterioration

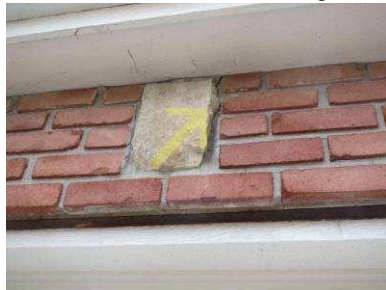
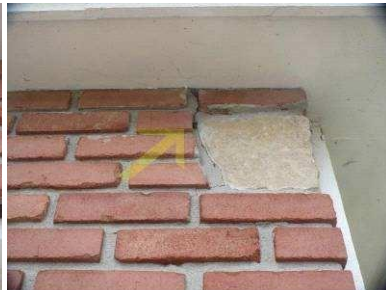
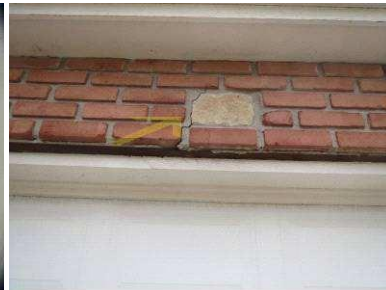
Attention Needed - The exterior siding material or finish is in a condition that requires minor repair to prevent further deterioration. The brick siding needs some attention as there are some cracks and cracked mortar.

Crack around stone

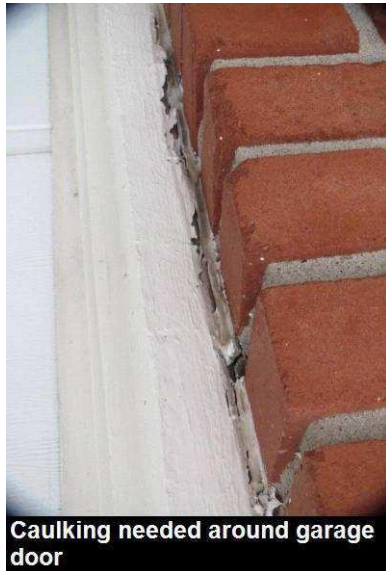
**Caulking needed around garage door**

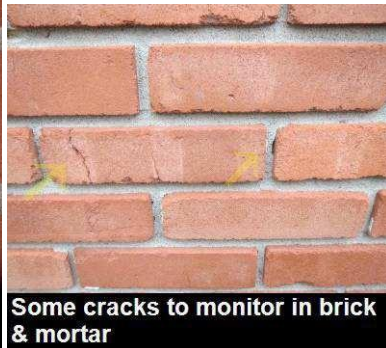
**Some cracks to monitor in brick & mortar**

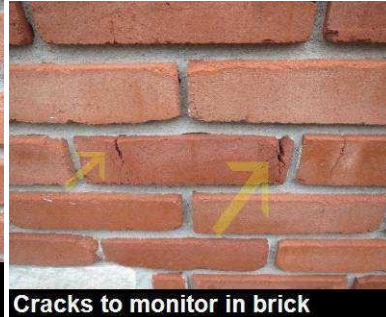
**Cracks to monitor in brick**

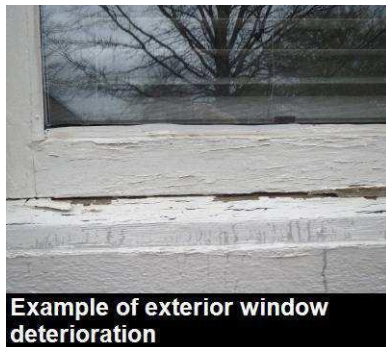
Attention Needed - There is at least one window that needs attention given to the glazing, framing, or caulking.

**Example of exterior window deterioration**

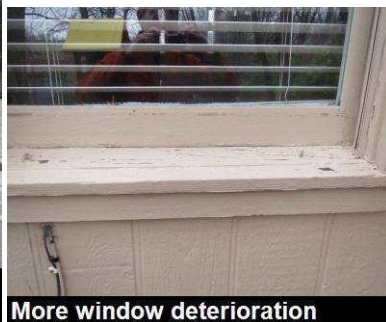
**More window deterioration**

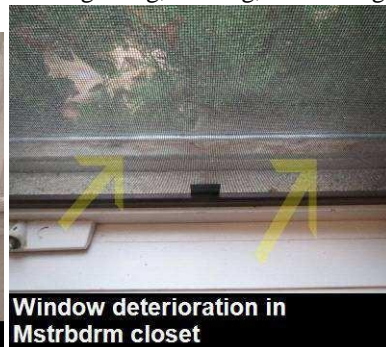
**Window deterioration in Mstrbrdm closet**

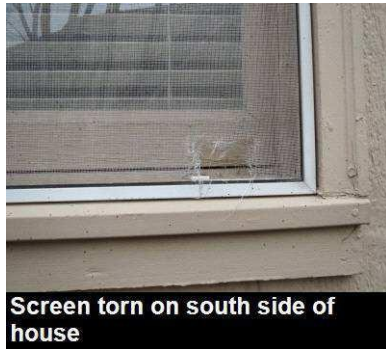
Satisfactory - There are storm windows installed, and they appear to be functional. Attention Needed - There is at least one missing or torn window screen that needs to be replaced.

Screen torn on south side of house

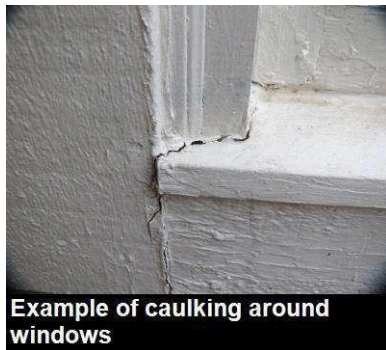
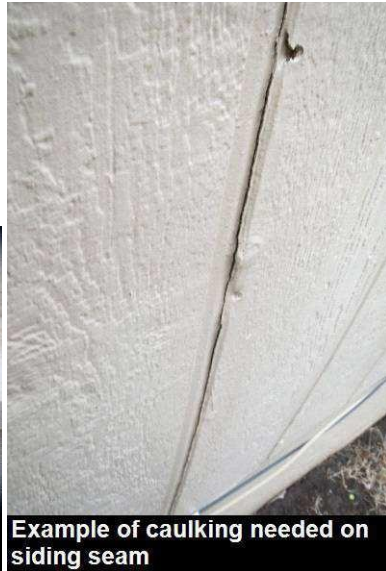
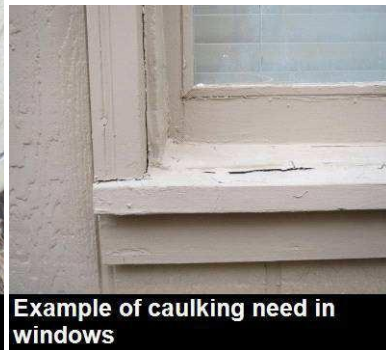
Action Necessary - Caulking around all wall penetrations and most siding joints is necessary. There are areas of the structure that either were never caulked or need immediate caulking. This will help prevent further deterioration.

Example of caulking around windows

Example of caulking needed on siding seam

Example of caulking need in windows

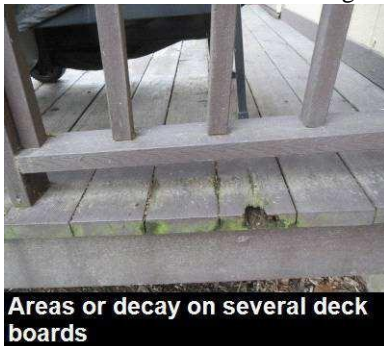
Attention Needed - The decking materials need some repair to function as intended.

Areas of decay on several deck boards

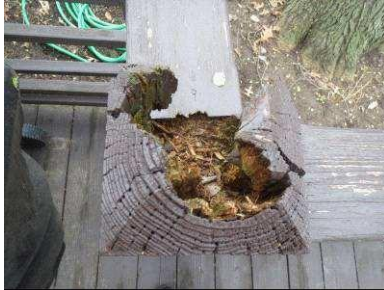
Action Necessary - The railings are in a condition that requires repair or replacement. Rotted railing posts and top rail need to be replaced. Railing balusters are too far apart. Recommend installing whole new railing system.

Rotting deck railing post

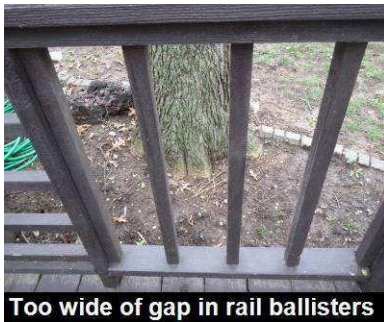
Too wide of gap in rail balusters

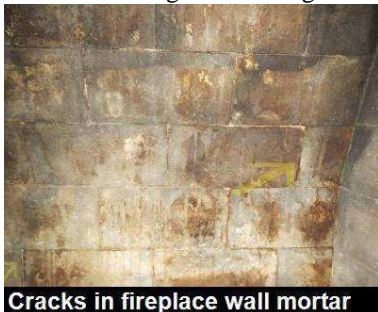
Action Necessary - A condition exists that makes the fireplace unusable in its current condition. It is recommended that the fireplace not be used in its current condition. Missing mortar, creating voids in the firebox walls, may present an unsafe condition during normal usage. Some replacement or repair is needed. Be sure to use refractory mortar in the firebox walls.

Cracks in fireplace wall mortar

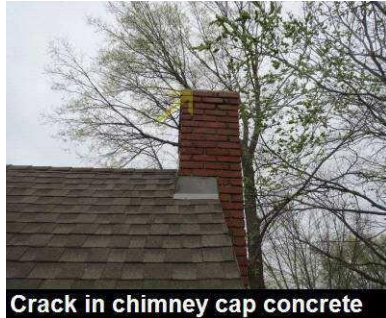
Yes - There is a chimney cap. Attention Needed - The chimney cap is made of mortar. Its function is to keep water from entering the masonry stack, causing deterioration. This cap needs some repair so that it can function as intended.

Crack in chimney cap concrete

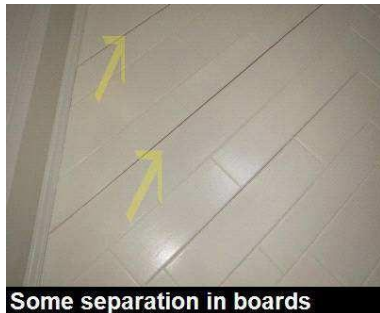
Yes - There is a mantle installed. The wood above the mantle has some separations. Repair or replace as necessary.

Some separation in boards

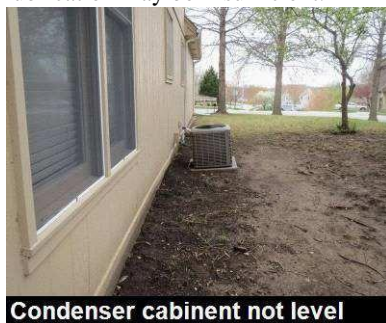
Attention Needed - The condenser pad should be solid and within 5-10 degrees of level. If the tilt is over this figure, internal lubrication may be insufficient.

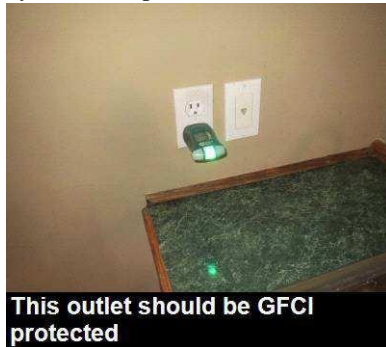
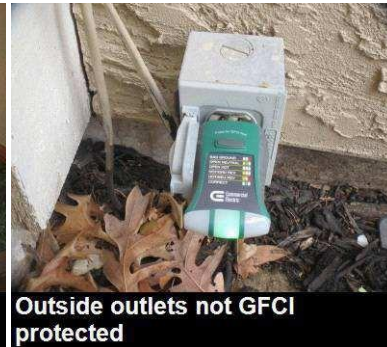
At some areas - This structure is partially protected by using Ground Fault Circuit Interrupt outlets at some of these locations: outlets within 6' of a water source, any outside outlets, in the garage, and any outlets in an unfinished basement. Any areas not protected should be considered for installation as they afford inexpensive protection from electrical shock. The outlet in the basement by the bar sink should be GFCI protected. The outside outlets are not protected by GFCI. Recommend installation by a licensed professional.

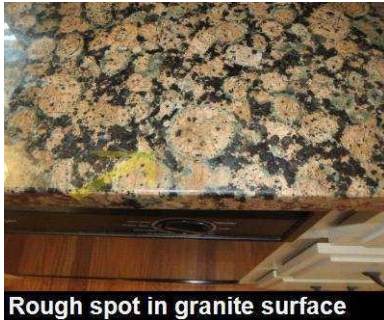
Attention Needed - The countertops in the kitchen need attention. The seam to the right of the sink needs resealing. There is a rough spot in that area as well.

Rough spot in granite surface

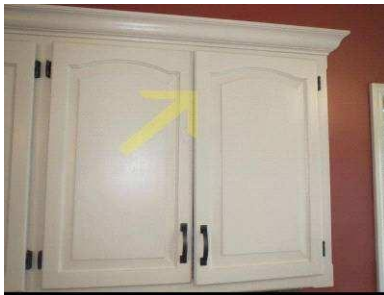
Attention Needed - At least one cabinet door or drawer is in need of some minor repair. The door needs adjustment in the upper righthand cabinet. There is an island cabinet installed in the kitchen. Note that there should be electrical outlets on each end of the island so that electrical cords are not run from the walls.

Door will not close

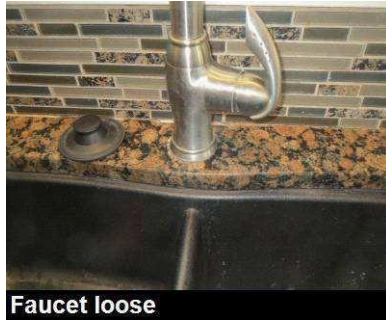
Attention needed: Faucet needs tightening. Supply lines are in good working order and show no signs of leaks.

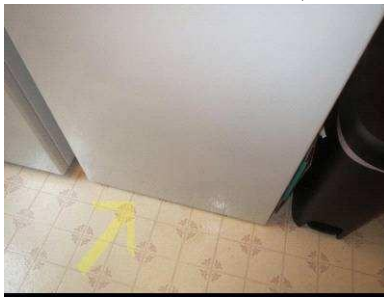
No - There is no washer pan installed under the washing machine. Any time the washing machine is installed on a floor level above another finished floor, a washer pan should be installed to prevent damage caused by an overflowing washer or a leak.

**Recommend washer pan**

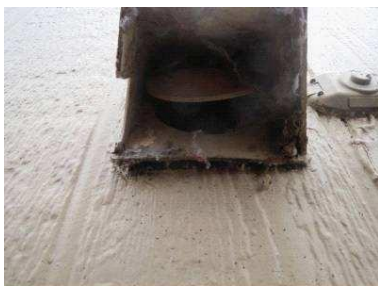
Attention Needed - The dryer ventilation as installed appears to need maintenance or repair. The flapper on the exterior vent does not close. Recommend repair or replace to prevent outside entry of air or vermin. .

**Flapper not closing; dirty**

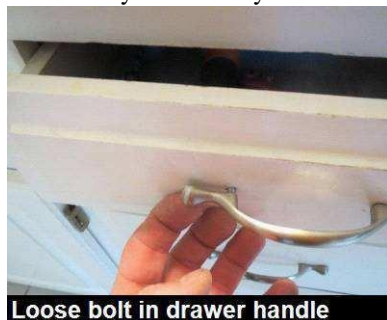
Satisfactory - The vanity cabinet and top in this bathroom are satisfactory. However there is one bolt loose on a handle.

Loose bolt in drawer handle

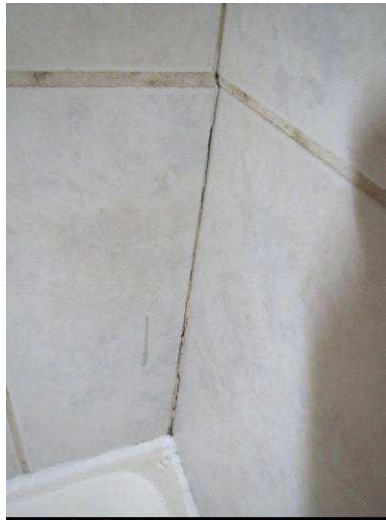
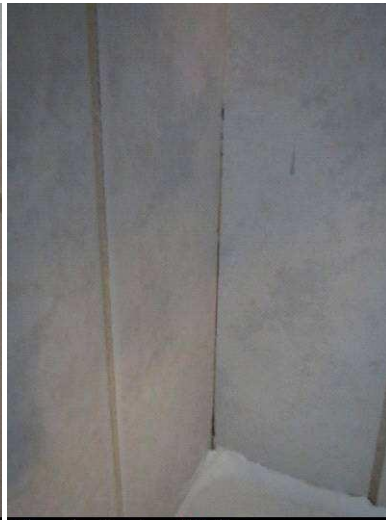
Attention Needed - The walls show some deterioration. Some attention is needed to prevent further deterioration.. There is some missing grout between some of the tiles. There is no evidence of water damage yet. Do not delay making these repairs to prevent future damage.

Grout missing

Grout missing Mbth

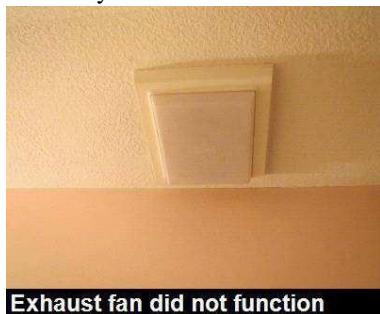
Action Necessary - There is an exhaust fan installed, but it would not activate using normal controls. Repair or replacement is necessary.

Exhaust fan did not function

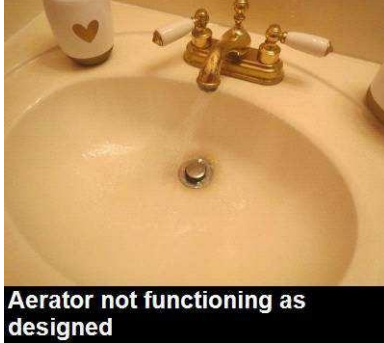
The faucet's aerator did not function well as it sprayed water.

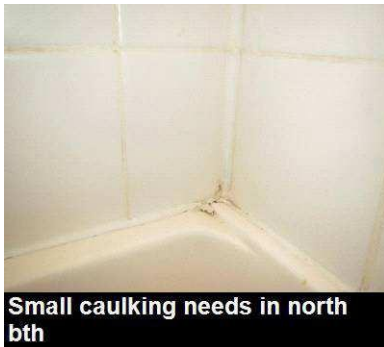
Attention Needed - The walls show some deterioration. Some attention is needed to prevent further deterioration. Caulking recommended.

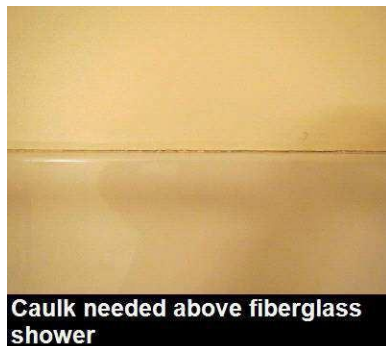
Attention Needed - The caulking in the water contact areas appears to need attention. Damage may result if not corrected. The wall - tub or shower seam needs to be caulked to prevent moisture from entering the wallboard.

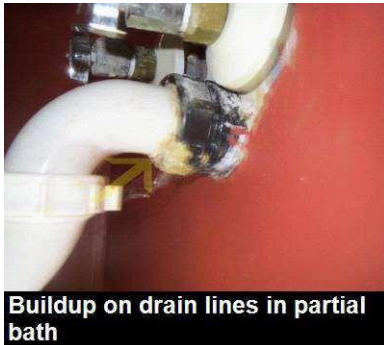
There is some corrosion on the drain lines but no evidence of leak on the floor. Monitor and repair as necessary.

**Buildup on drain lines in partial bath**

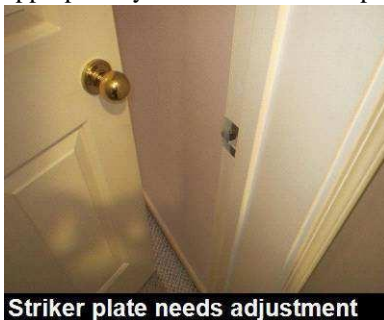
Attention Needed - The entry door or hardware for this bedroom needs some adjustment or repair for it to function appropriately. The latch or strike plate needs to be adjusted so that the door will latch correctly.

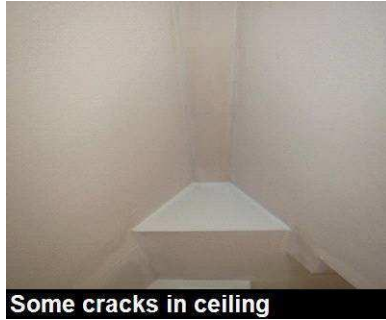
Attention Needed - There is a condition in the ceiling that needs attention, There is some minor cracking noted. Be sure to take note of any future movement. Most minor cracking is due to shrinkage of the construction materials.

Some cracks in ceiling

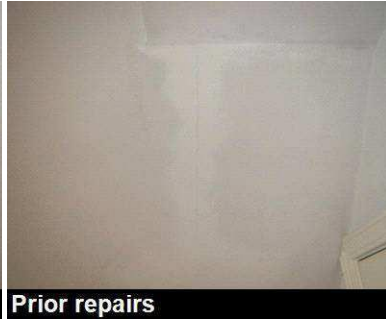
Prior repairs

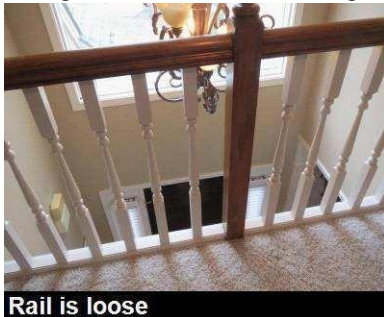
Satisfactory - The upper level hallway walls and floor are in satisfactory condition. Attention Needed - The upper hallway railing need attention. The railing is a little loose, and should be secured for safety.

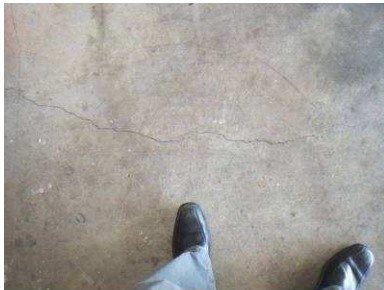
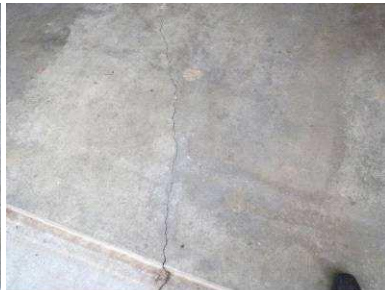
Satisfactory - The garage floor is in satisfactory condition. To prevent further deterioration of the slab floor, it is recommended that the cracks be sealed.

Minor cracks in garage floor
