Homeward Bound Home Inspection
1-800-228-8865

Sample Reprot,
123 Your New St
Your New Town, MI 48???

Inspection Summary

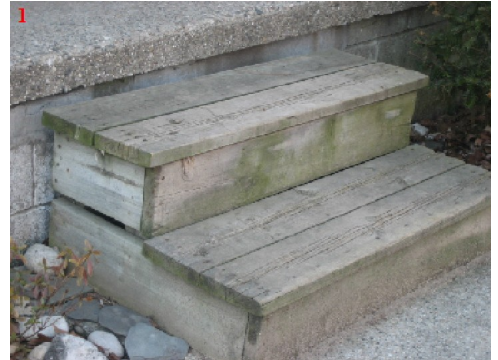
Steps

The wood steps a the front porch are inconstant. They should be replaced or corrected for safety.

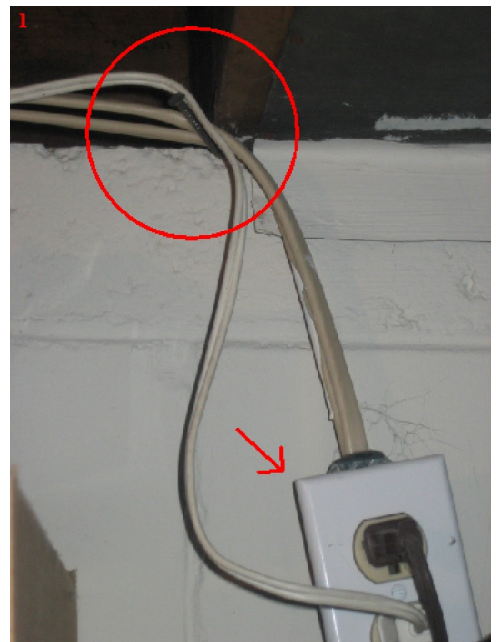
Type of House Wire

Some homeowner added wiring noted. All exposed romex should be in conduit. All junction boxes should be secured.

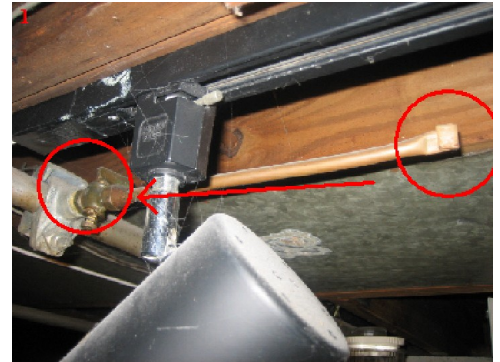
Gas Line.

There is a crimped off gas line in the basement. The copper tube should be removed to the valve and the valve properly capped for safety.

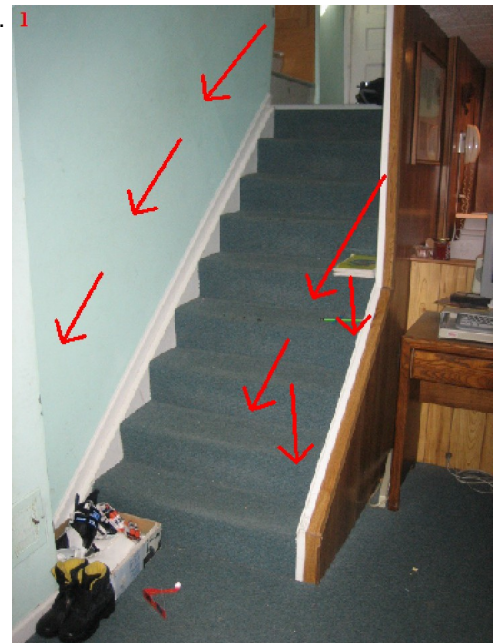
Basement Stairs

No hand rail noted. Add a hand rail and a guard rail to the opened side for safety.

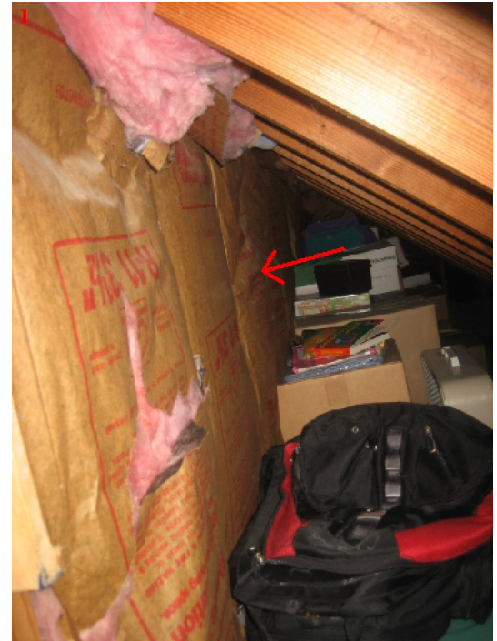
Insulation Type

The knee wall insulation is installed backwards. The paper is to face the warm side for fire safety. It should be corrected.

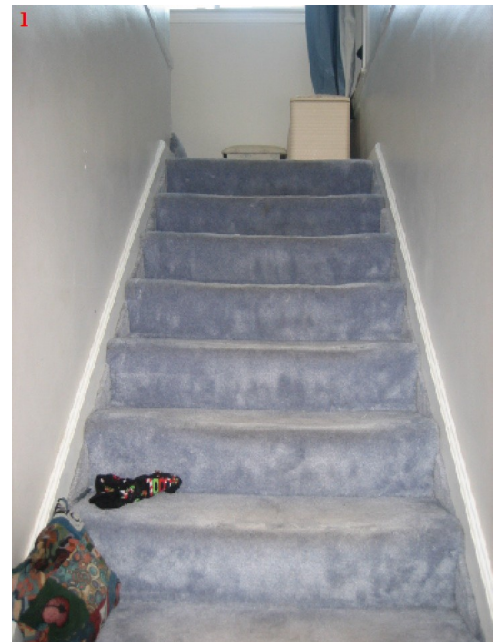
Stairways

Add a hand rail to the upstairs stairway for safety.

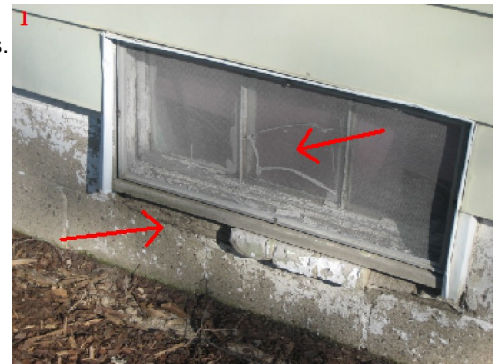
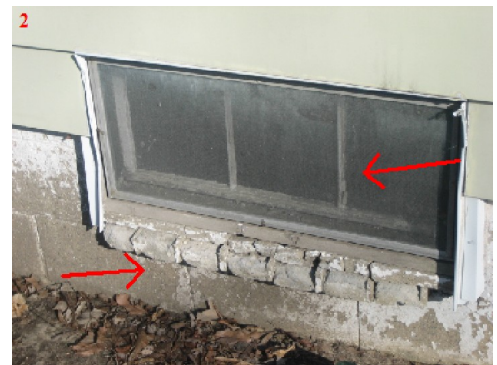
Basement Windows

There are several cracked basement windows and deteriorated sills. Replacement is needed. Consider glass block. Anticipate expensive repair costs.

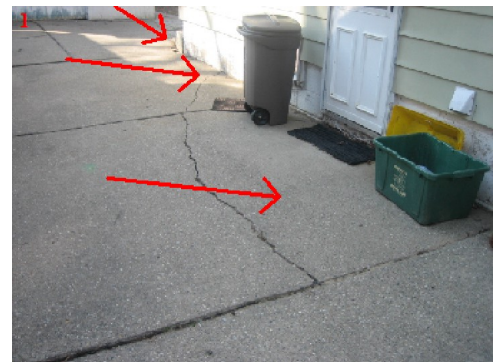
Driveway

The driveway has cracked and settled towards the house. Some slab replacement is needed. Anticipate expensive repair costs.

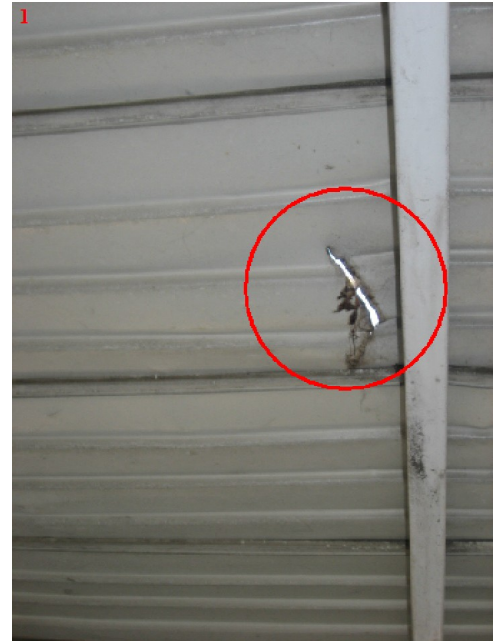
Roof Covering (Area 2)

The metal awning over the front porch is torn. Repair, or replacement is needed. Anticipate expensive costs to replace it.

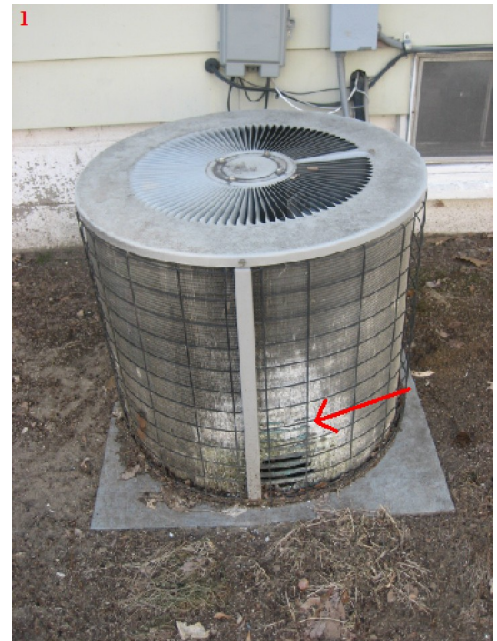
System Coils and Fins (1)

There is significant damage to the fins on the a/c unit. This will affect the efficiency of the unit. Replacement should be considered.

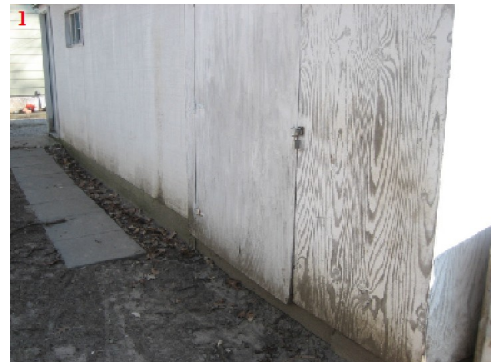
Garage Exterior Walls

Proper prep and paint is needed (expensive to hire).

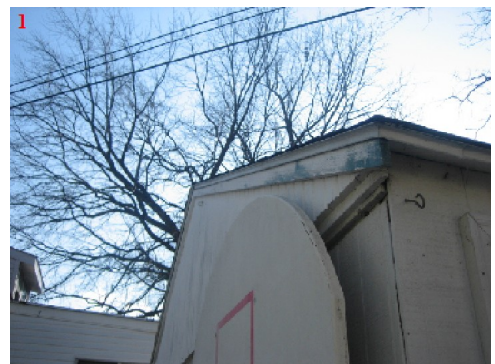
Garage Fascia\Soffit\Trim

Proper prep and paint is needed (expensive to hire).

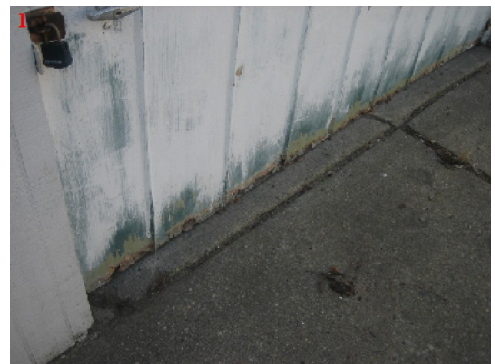
Overhead Doors

Extensive rust noted at base. Replacement should be consider .

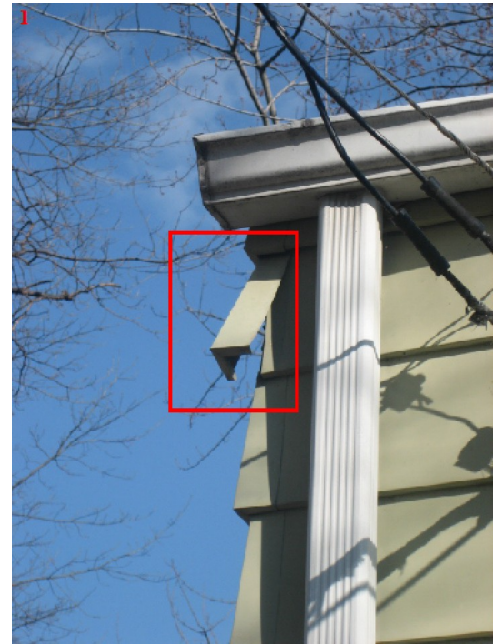
Siding

The presence of wood rot behind the aluminum/vinyl can not be determined by this inspection. There is a loose corner piece at the northwest corner. Minor repair is needed.

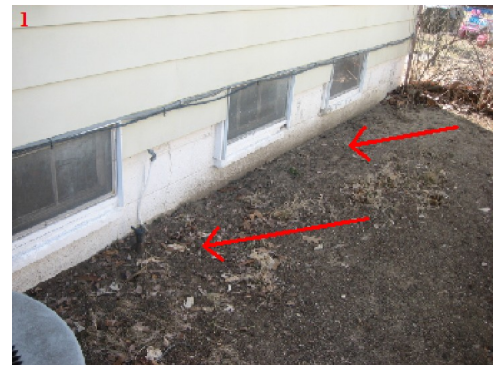
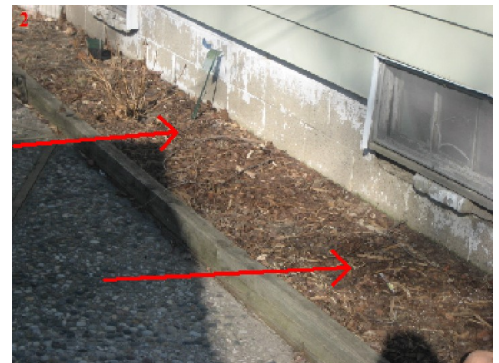
Grading

Soil should be sloped away from house to improve drainage. Minor regrading is needed at the north and west. The drive also drains towards the house (see below).

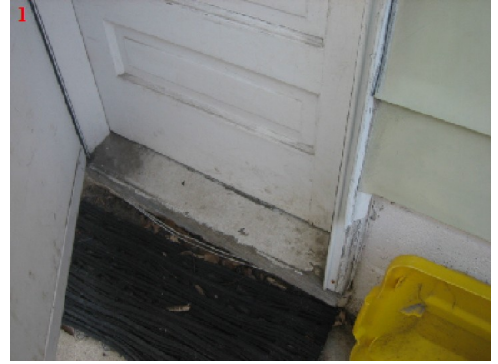
Entry Doors

Reconditioning is needed at the sill and frame of both the side and front doors.

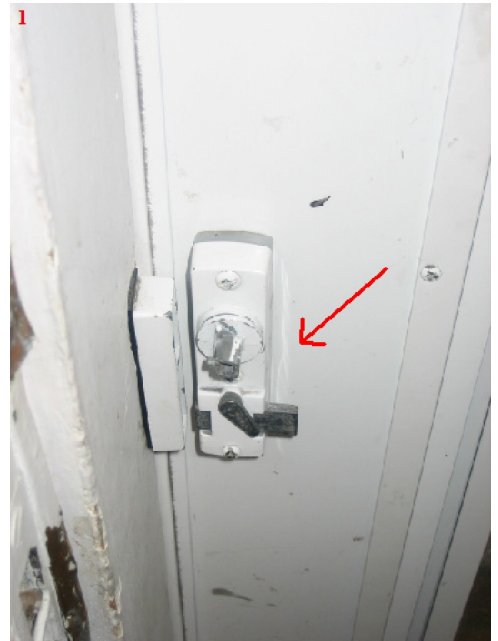
Storm Doors

The storm door inside handle needs to be replaced.

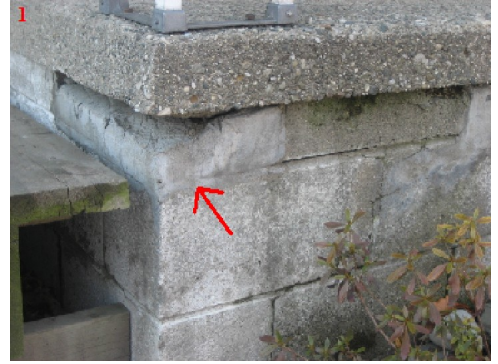
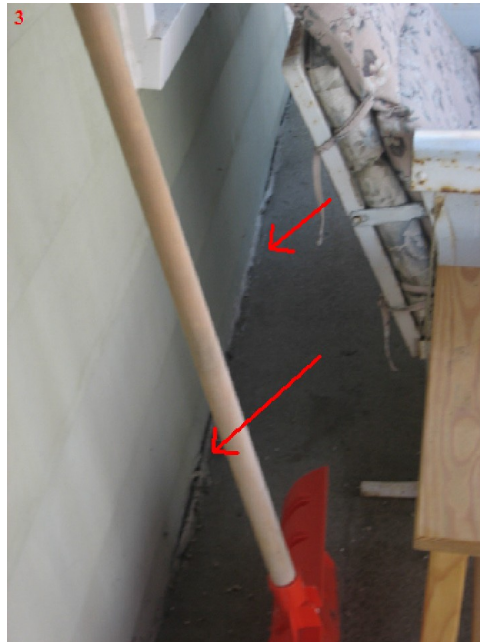
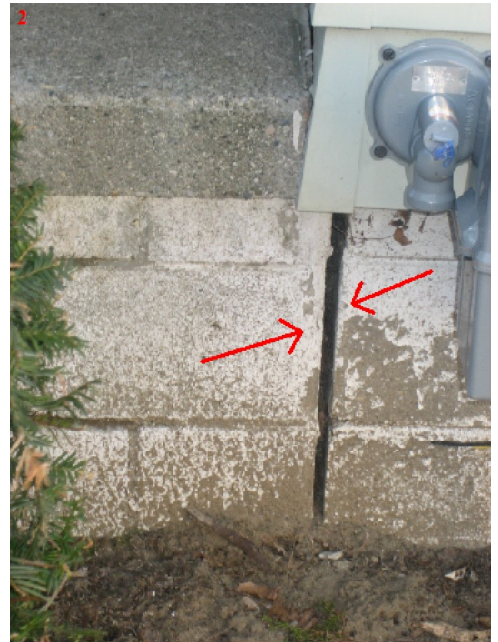
Porches

Some block deterioration noted and some settlement away from the house is visible. Repair the block deterioration and seal the joint between the porch and house. Monitor for further movement. Eventual replacement may be needed but is unlikely in the near future.

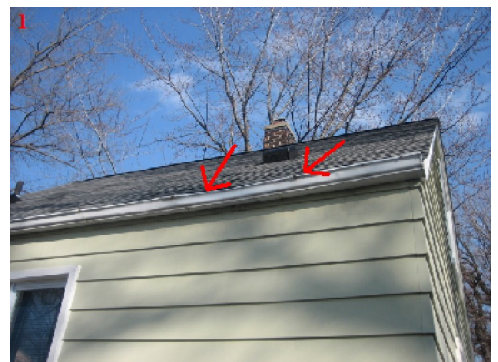
Gutter

The back gutter is dented and loose. It functions properly but eventual replacement will be needed.

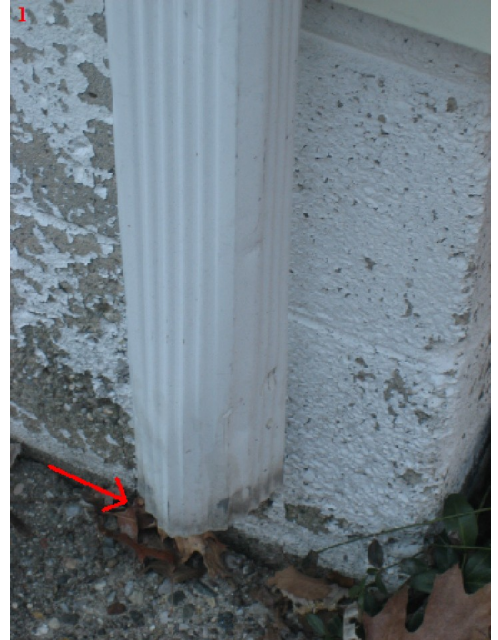
Downspout

The bottom boot is missing at two west downspouts.

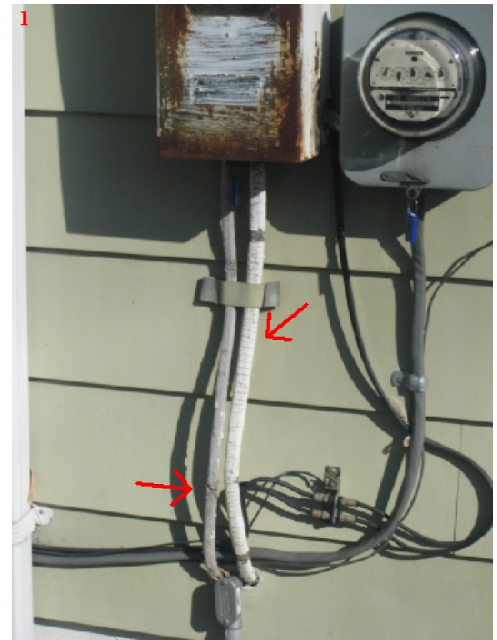
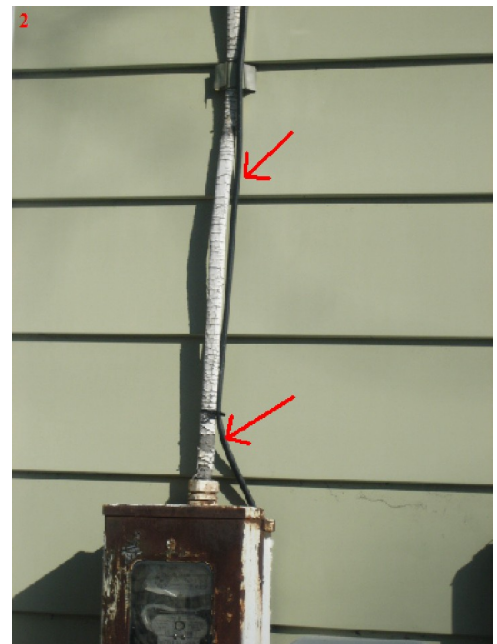
Entry Line

The entry line is frayed and deteriorated. Replacement is needed. Contact a licensed electrician for a repair quote.

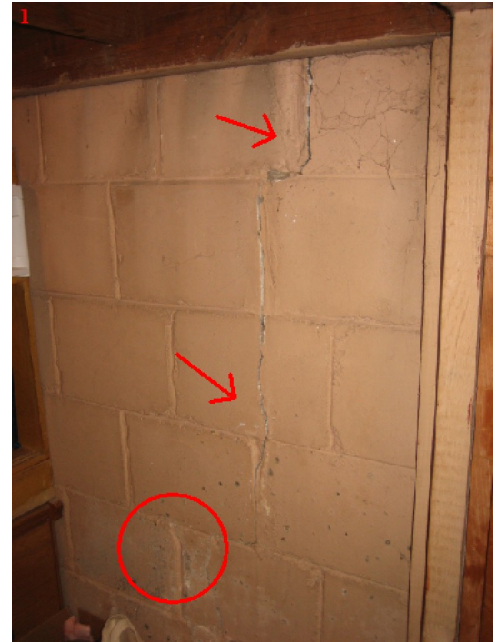
Basement Foundation Walls

Some cracks and past water penetration noted.

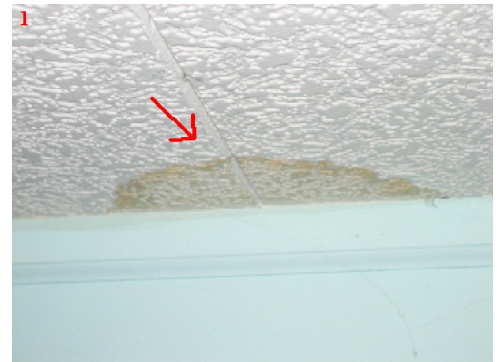
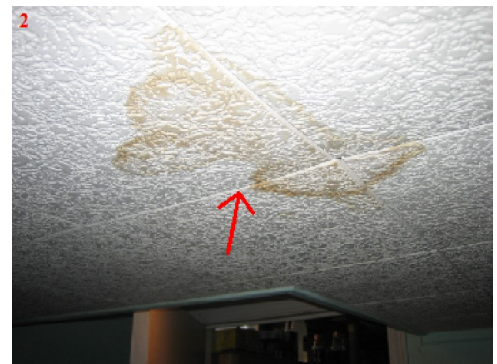
Basement Finished Ceiling

Moisture stains were noted under the bathroom and at the west wall indicating past plumbing leaks. Both areas were tested and found dry at the time of inspection.

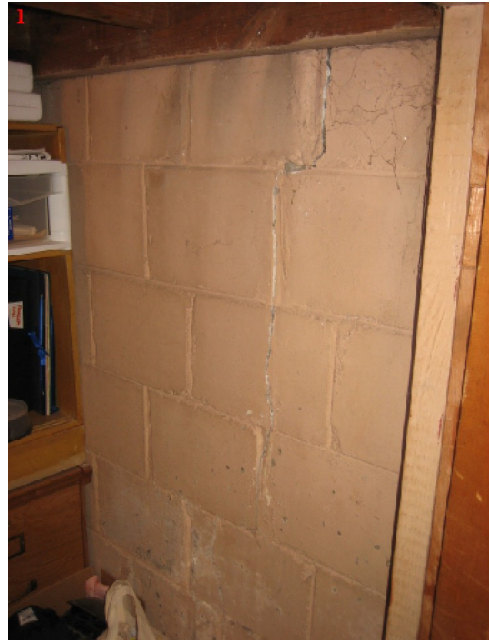
Basement Wall Finished/Obstructed

Inspection limited by finished areas and stored items. Approximately 70% of the walls are obstructed. Some minor settling cracks were noted. No repair needed at this time.

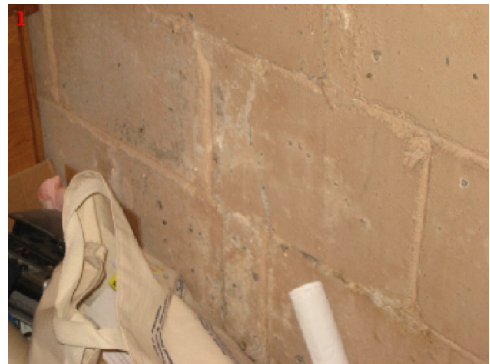
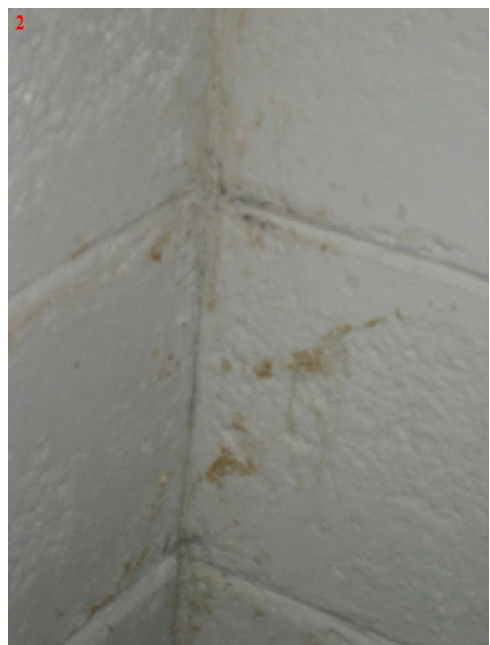
Water Penetration

Some visible staining and efflorescence present, indicating past water penetration. Ask the current owner for any history of past leaking and what was done to prevent it. Regrading and proper gutter maintenance, can help minimize the potential for water penetration. All basements can leak during extreme weather. Monitor for water penetration and repair as needed.

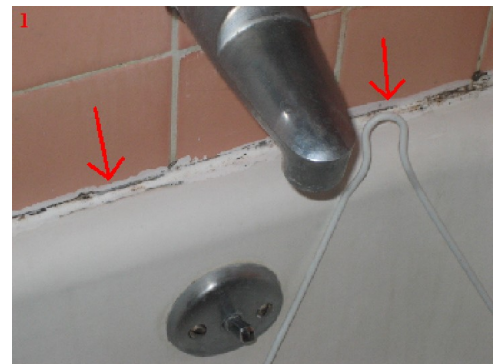
Bathtub (1)

The bathtub caulk needs to be improved.

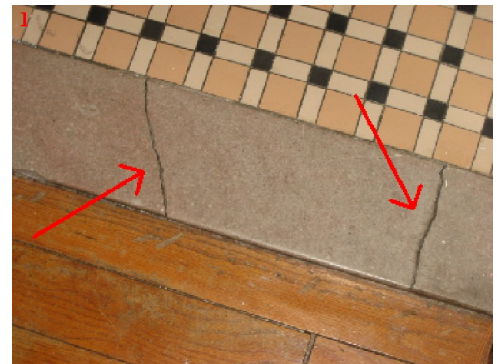
Bathroom Floor (1)

The threshold tile is cracked and loose. It should be replaced.
