# WNYE

2nd/2010 WITH NEW YORK FIREFIGHTERS

# Queens Transformer Fire Prompts Use of New Technologies

# F-500 and its Use at Queens Box 33-6334

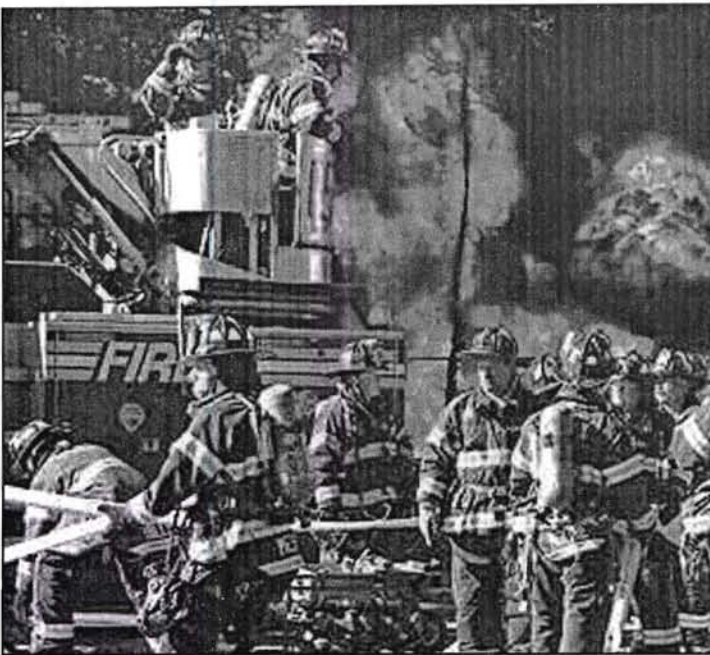
Transformer fire at Queens Box 33-6334, Northern Boulevard/45-08 244th Street, July 24, 2009.
