SEAL COAT SUPPLY, Inc.

PAVEMENT PRESERVATION

PAVEMENT DETERIORATION PROCESS

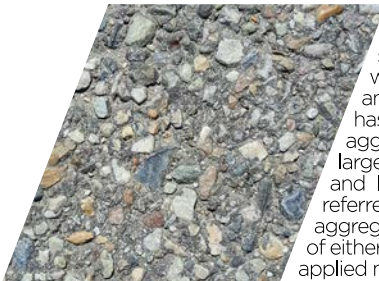
When the pavement changes from black to brown, then to gray, the untreated pavement surface has been damaged by oxidation. This will cause the asphalt to become dry, porous and brittle. The top layer of the asphalt binder has been deteriorated allowing the fine aggregate particles to erode, exposing the larger aggregate and leading to small cracks and loose gravel on the pavement. This is referred to as Inter-aggregate loss, raveling or aggregate segregation. A surface treatment of either Tuff Coat or Tuff Coat P+ needs to be applied now to prevent further deterioration.

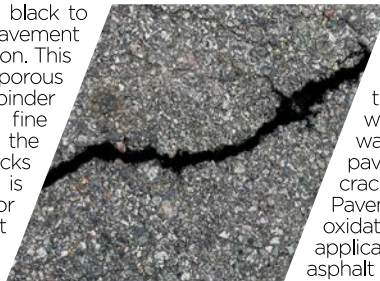
When cracks appear in the pavement, sealing them is very important. Cracks left untreated leave pavement and its subbase vulnerable to water. As water permeates the pavement through these cracks, it washes out and weakens the subbase. In colder regions, the water in the cracks and underneath the pavement freezes and expands leaving larger cracks, potholes and fatigue cracking. Pavement surfaces with cracks and signs of oxidation should have all cracks filled and an application of Tuff Coat to preserve the native asphalt binder from further deterioration.

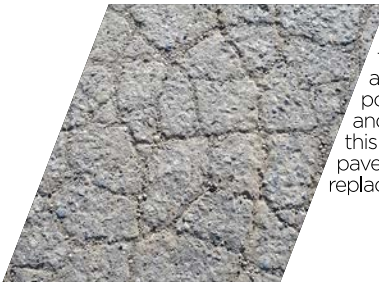
Fatigue cracking which is also known as "alligator cracking" is an indicator of structural failure caused by the loss of base, subbase and or subgrade support which is caused by poor drainage, water seeping through cracks, and freeze thaw cycles. The only way to fix this problem is to remove the fatigue cracked pavement, dig out and replace the base, then replace the pavement.

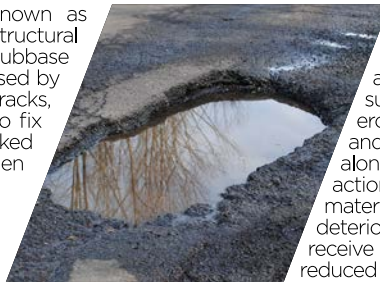
A pothole is a type of failure in pavement caused by the presence of water in the subbase and subgrade structures and traffic driving over the affected area. The introduction of water to the subbase and subgrade first weakens, then erodes the base layers. Traffic will then fatigue and break the poorly supported asphalt surface, along with freeze thaw cycles. Continued traffic action ejects the broken asphalt chunks and base material causing a hole in the pavement. The deteriorating effects that the asphalt pavements receive from the environment can greatly be reduced by proper care and maintenance.

Asphalt pavement Asphalt concrete, commonly called asphalt, blacktop or pavement, consists of a mineral aggregate blend bound together with asphalt.

Aggregate base Aggregate base, also called base course, is composed of crushed gravel usually varying from 0.75 in down to dust particle size. Base course makes it easier to get the proper grade and level.

Aggregate subbase Subbase is composed of crushed stone, crushed slag or concrete. The quality of subbase is very important for the life of the pavement surface. The Subbase is the main load-bearing layer, this layer will bear the heaviest load from the pavement above.

Subgrade "natural soil" Subgrade is the native material underneath a constructed road or parking lot.

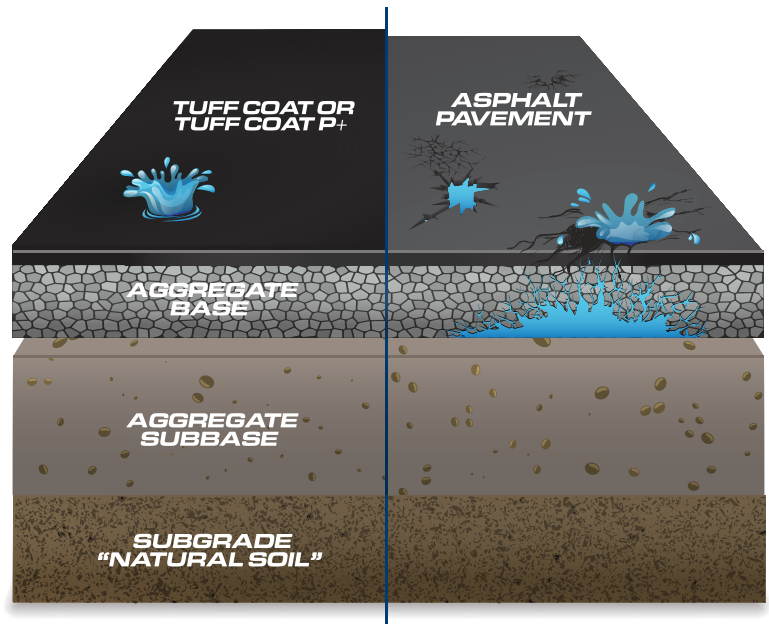
SEALED VS. UNSEALED

Asphalt pavement left untreated will start deteriorating rapidly. As the asphalt binder is exposed to oxidation, UV rays, rain, snow, frost and traffic the asphalt pavement becomes dry, porous and brittle. Cracks develop allowing water to penetrate the pavement leading to base and subbase erosion, then pavement failure.

Limiting the damaging effects to the asphalt pavement binder from UV rays, oxidation and moisture intrusion by treating with Tuff Coat or Tuff Coat P+ before damage sets in, leads to an optimum and cost-effective asphalt preservation program. Tuff Coat will greatly extend the life of pavement while enhancing the appearance.
