MARRIOTT MARQUIS RENOVATION

By Virginia Mosquera, Ph.D., P.E.

Supporting world's largest LED billboard installation at the crossroads of the world required quick coordination and immediate solutions to conflicts.

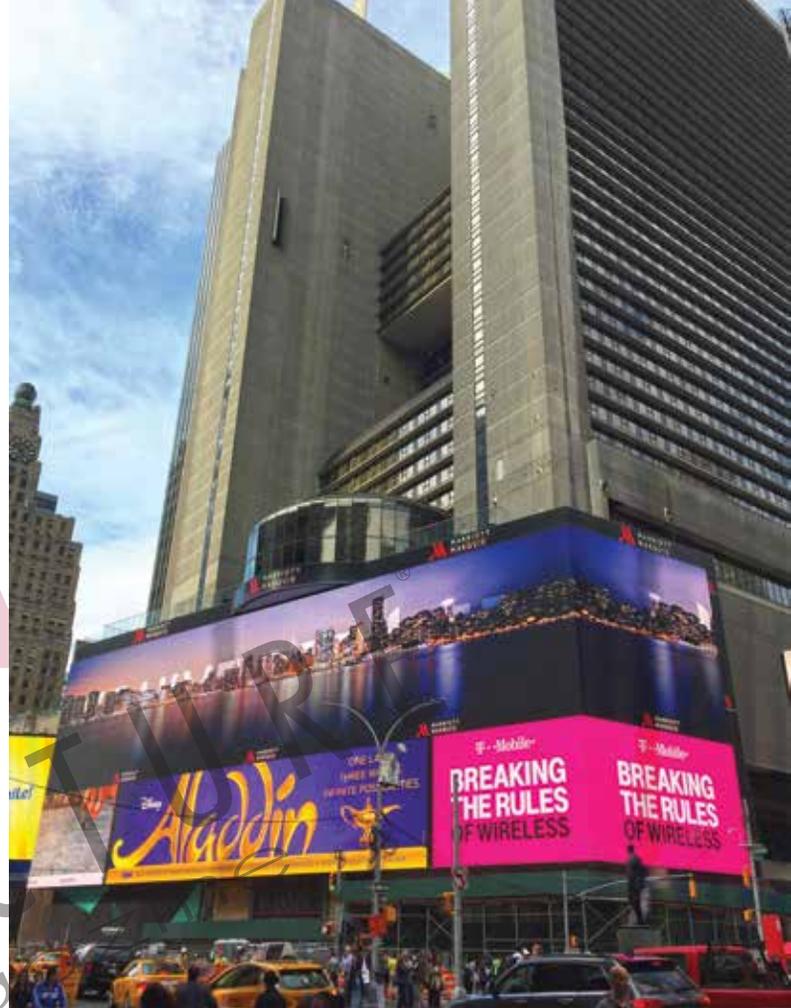
Figure 1. Marriott Marquis building featuring the world's largest high definition LED sign.

The iconic Marriott Marquis hotel, located at the center of Times Square, was recently renovated to display the world's largest high-definition LED billboard (Figure 1). At five stories tall, this gigantic screen spans the entire width of the building (a full city block, from West 45th Street to West 46th Street on Broadway), wrapping partway around its sides. The renovation also included converting the two underground parking levels and first two above grade-levels to prime double-height retail spaces, the remodeling of back-of-theater rooms, and the creation of new rooftop space offering covered views of the New Year's Eve ball dropping.

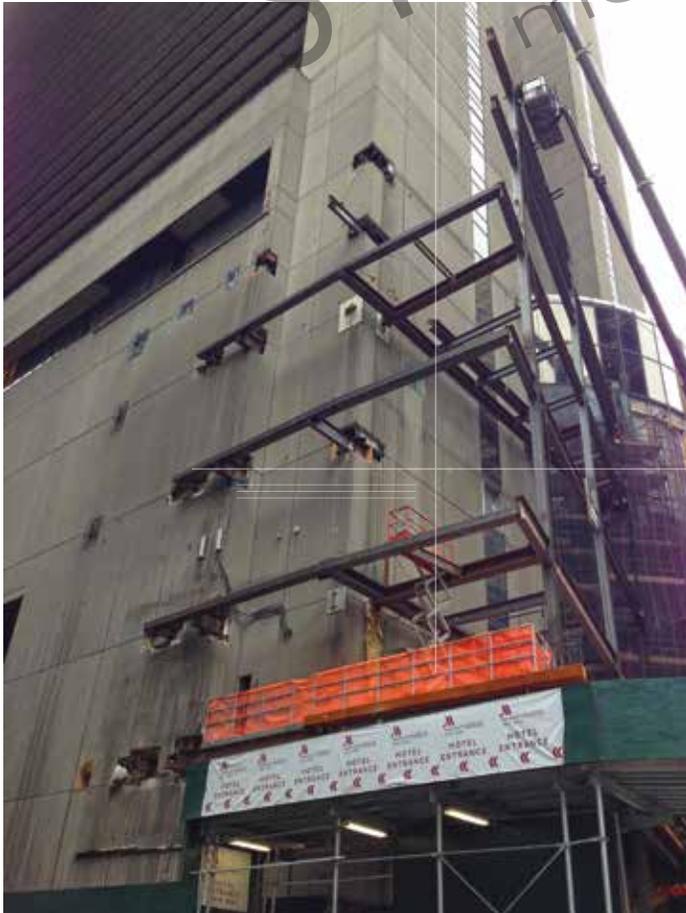
Figure 2. Broadway framing.

The LED screen is five stories tall and is located between levels 3 and 8. The supporting framing for the sign along Broadway was divided into three sections (Figure 2). On the north and south sections, the existing façade was set-back from the property line; at these two areas, the hotel requested open-terraces overlooking Times Square to be constructed on the 8th floor. On the south side, moment frames were constructed along the property line that provided support to both the LED sign and the south terrace. On the north side, a combination of new framing along the property line and framing cantilevering out of existing columns was used. For economy, existing connections and precast openings were also used on the north and south sides of the Broadway façade. In the middle section, above level 6, the existing façade protruded and had to be demolished to install and support the LED sign. The framing in the middle portion of the Broadway façade consisted of hangers suspended from the floors above, and did not have the capacity to support the new load; therefore, the existing structure in this area could not be used. To accommodate the absence of connection points on this portion of the façade and satisfy the stringent limitations on the deflections of members supporting the LED screen, a vierendeel truss was used (Figure 3). The truss spans 57 feet horizontally and has vertical supports only at the existing columns at level 3. It is connected horizontally at only a few discrete points within its 75-foot height to reduce displacement produced by wind loads. The vierendeel truss was selected

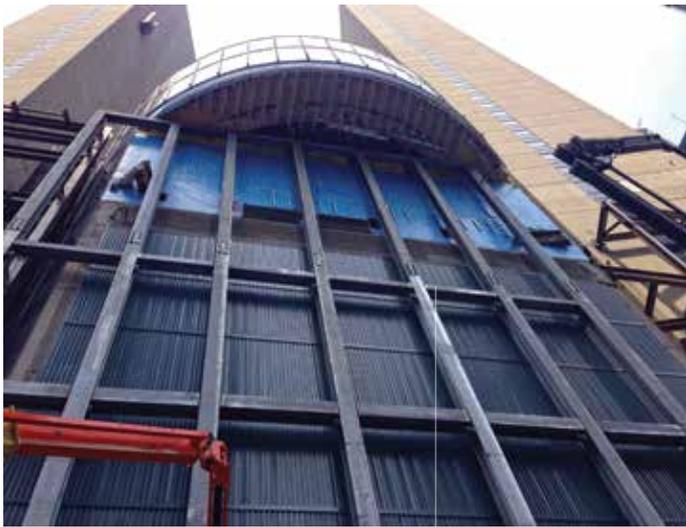
Figure 3. Vierendeel truss.

as the most efficient solution to span the distances between the supports, creating a structure that was robust for both the vertical load and the wind load.

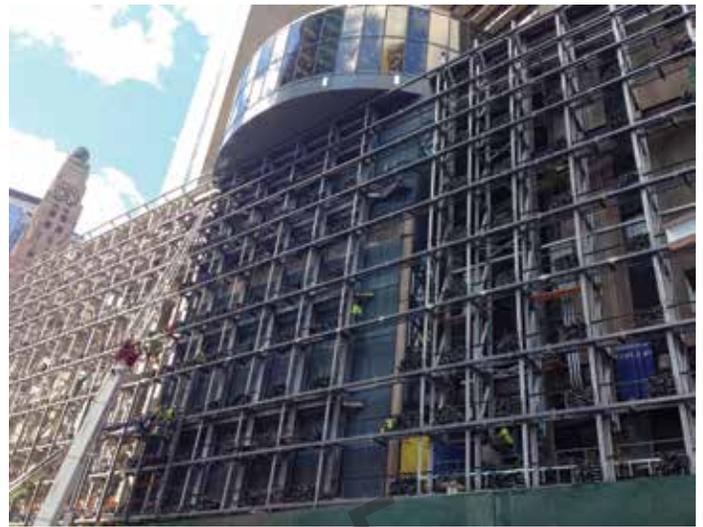
Figure 4. Installation of LED sign.

The LED screen consists of approximately 6- by 8-foot interlocking panels that connect to a secondary or back-up structure connected to the supporting structure described previously. The supporting structure had to be designed for the deflection limits required to accommodate the LED screen; however, it was also very important in the design to control the relative deflections at different support points within the width and height of the screen to avoid having issues during and after the installation of the screen panels. For this reason, sandbags with the same weight as the LED screens were stacked on the back-up structure of the LED sign, allowing for adjustments to be made before the installation of the LED screen and resulting in a successful procedure (Figure 4).

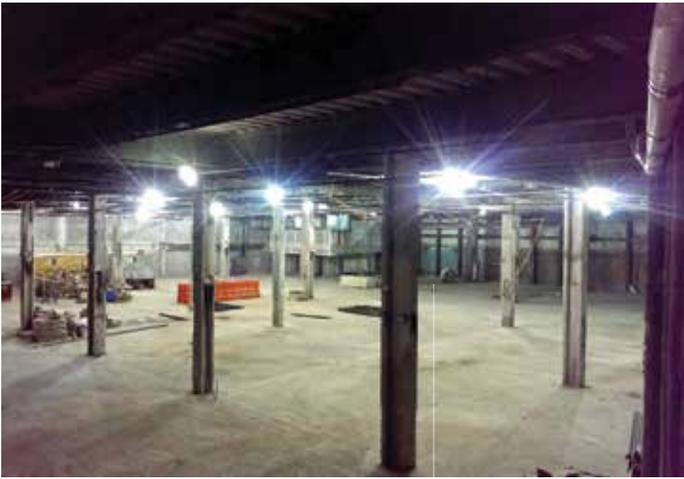
Figure 5. New double story space with reinforced columns.

An important aspect of this work was to devise a sequencing scheme for the reinforcement of the columns and foundation wall that allowed for the demolition of the floor level and also ensured the safety of the structure at all stages. Different types of reinforcing options were evaluated. The main two factors that determined the column reinforcing used were that plating would cause minimum space intrusion and guarantee the stability of structure at all construction stages. The existing columns had the strong-axis capacity to span the two levels, however the weak-axis capacity was insufficient; therefore, the demolition and reinforcing scheme chosen consisted of initially demolishing only the deck and beams bracing the column on its strong axis, then providing

the flange plate reinforcing. Once the reinforcement was installed, the increased column section would have sufficient axial capacity in the weak axis to allow for proceeding to demolish the beams that were bracing the columns on the weak axis.

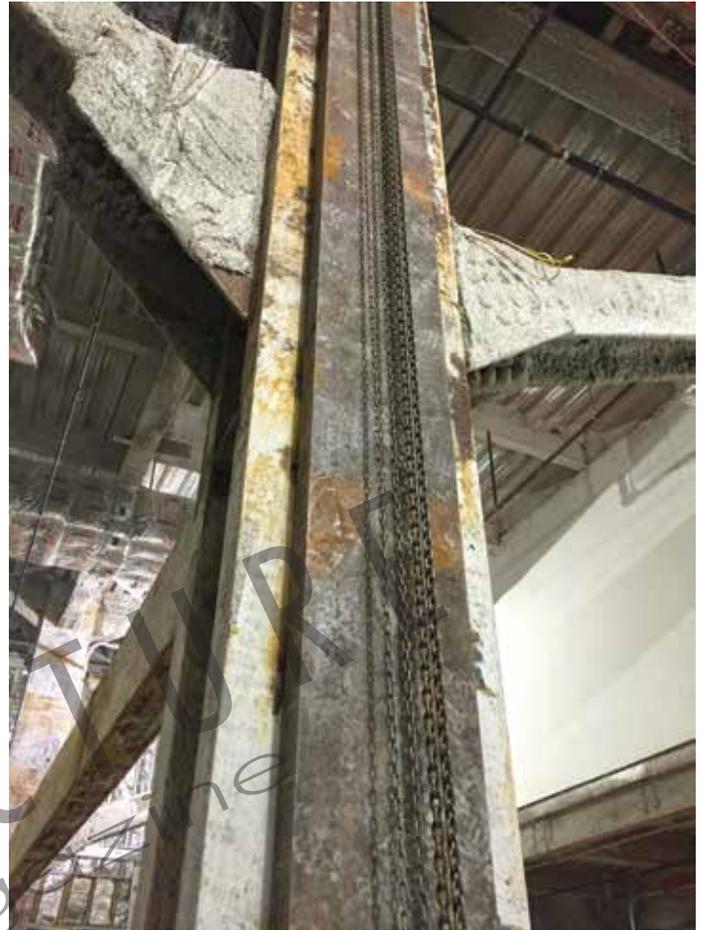
Figure 6. Column reinforcing.

That reinforcing scheme was typical at the two basement levels. Some of the columns on the first two levels above grade also had to be reinforced to allow for double height spaces. These columns were very critical to the structure as they were part of both a vierendeel truss lateral system for the building in one direction and a bracing system used for gravity in the other direction. The moment connected beam of the Vierendeel needed to be removed to allow for an open space. Since these columns were critical to the building, plating sequencing needed special care. Plates on each side of the beam were temporarily installed on the column to provide the required axial capacity. After the beam removal, a plate centered on the column flange was installed that would not protrude as much from the column as the temporary side plates (Figure 6).
