Report of Marine Survey

Vessel: 2009 Mako 212

Purpose: Pre-purchase and Evaluation

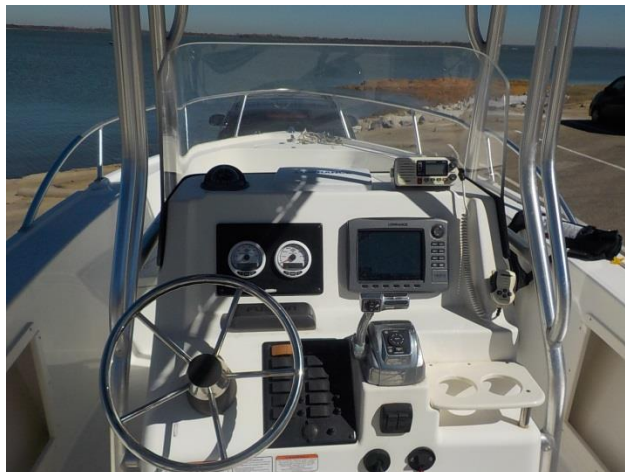
Surveyor recommends a side-scan transducer so you can take full advantage of your fish-finder. The following is a link to the transducer and computer-box you would need to purchase and install.

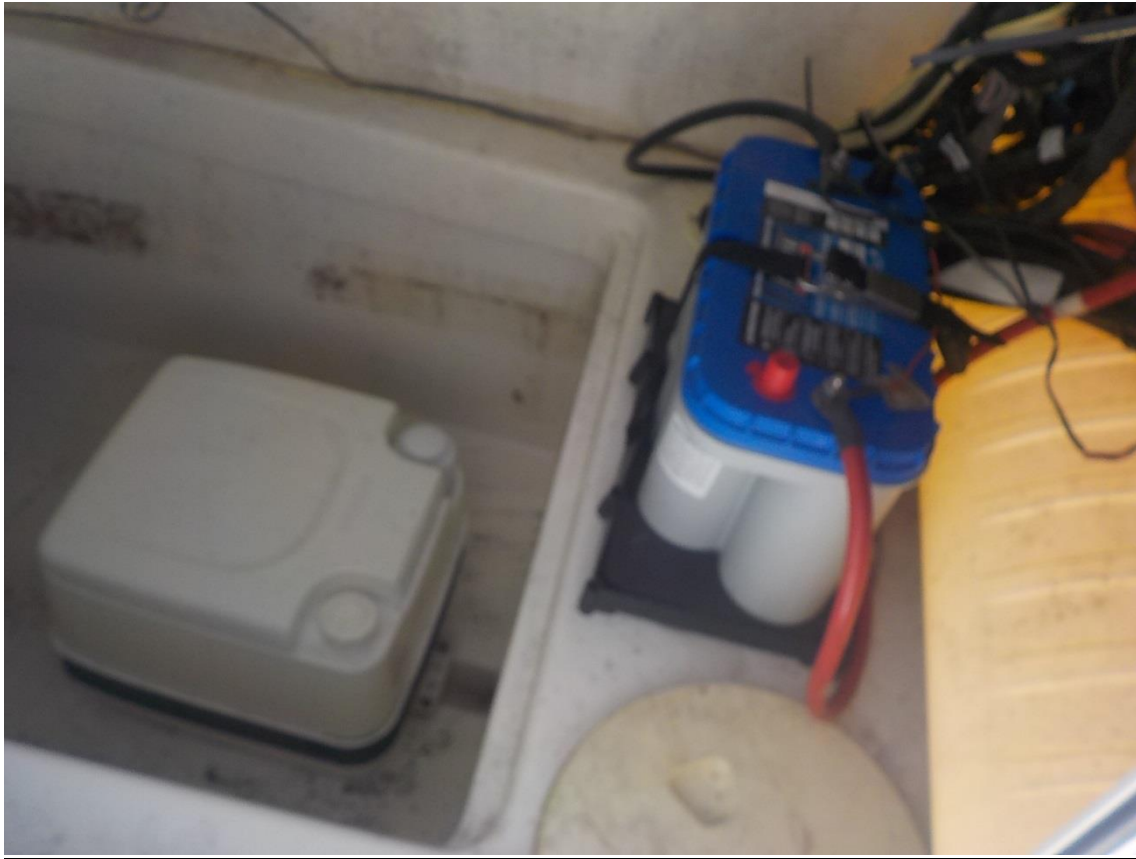
Porta-Potty system. Not tested for functionality but unit appears clean and operational.
