# Schultze Property Inspect, LLC

## Confidential - Property Inspection Report - Confidential

7777 Client Drive, Kansas City, MO 64111

Inspection Date: 03/31/2017

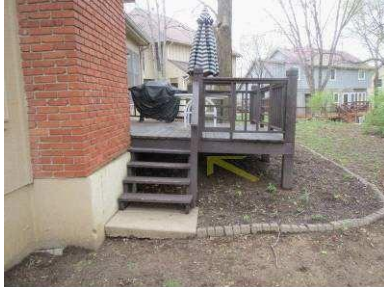
Attention Needed - The lot needs some minor adjustment in areas to prevent water from standing in the yard.

Water slopes toward house

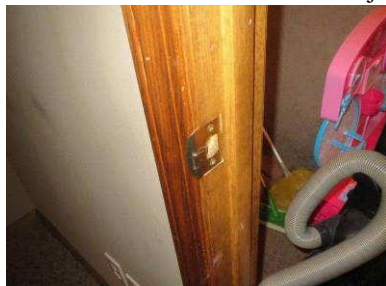
There are basement level windows. The windows as installed are not egress accessible. As a result of the lack of egress, the areas should not be considered as living space nor used as a sleeping area for safety reasons. The door entry into the southeast closet does not latch. Adjust as necessary.

Door does not latch-SE corner bsmt closet

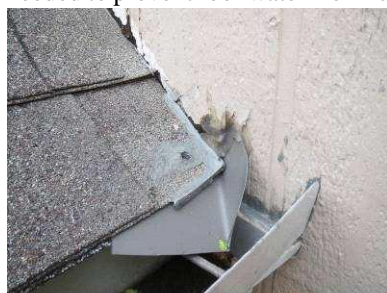
Action Necessary - There is at least one kick-out flashing that is either not installed or is incorrectly installed. Kickouts are needed to prevent roof water from running down behind the exterior wall covering material.

Attempted flashing kickout installation

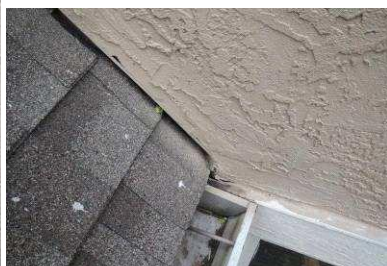
Needs flashing kickout installed

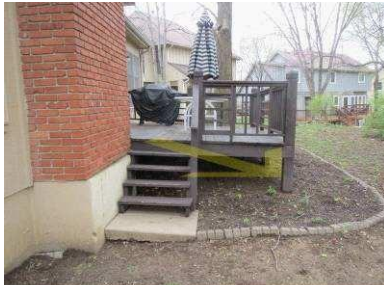
Attention Needed - There is some area of the framing that is in need of attention. Note: Today's deck construction, support, and attachment standards typically call for proper footings, 6x6 posts, and 1/2 inch bolts securing deck to the beam and the house. There did not appear to be bolts through the plate into the house. The deck also slanted more than accepted amount away from the house.

More than normal slant of deck

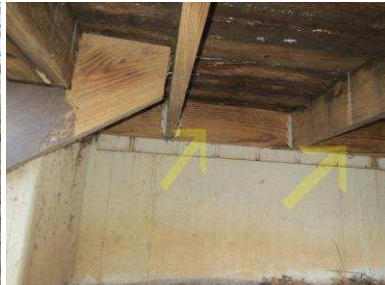
No bolts in evidence

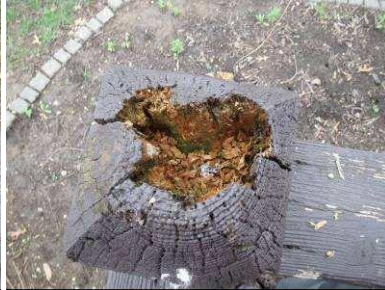
Rotting deck railing post

**Action Necessary** - The railings are in a condition that requires repair or replacement. Rotted railing posts and top rail need to be replaced. Railing balusters are too far apart. Recommend installing whole new railing system.

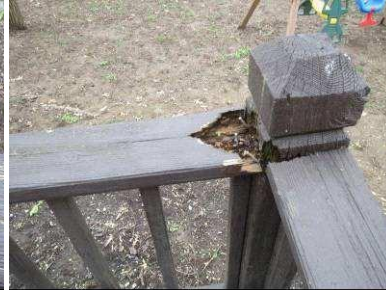
Rotting top railing

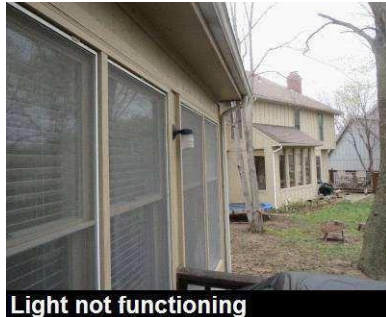
Attention Needed - Some portion of the exterior security lighting is not functioning as intended. The light on the back deck was not functioning at time of inspection.

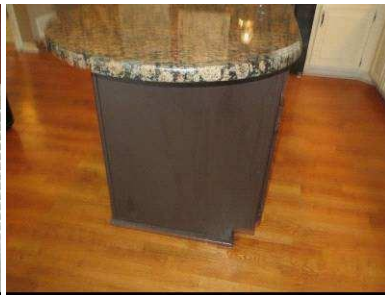
Should be an electrical outlet

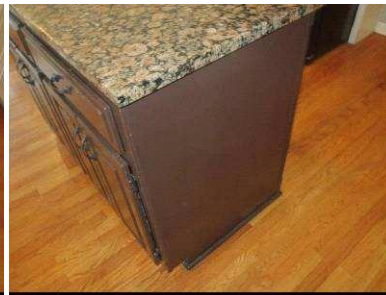
Should be an electrical outlet
