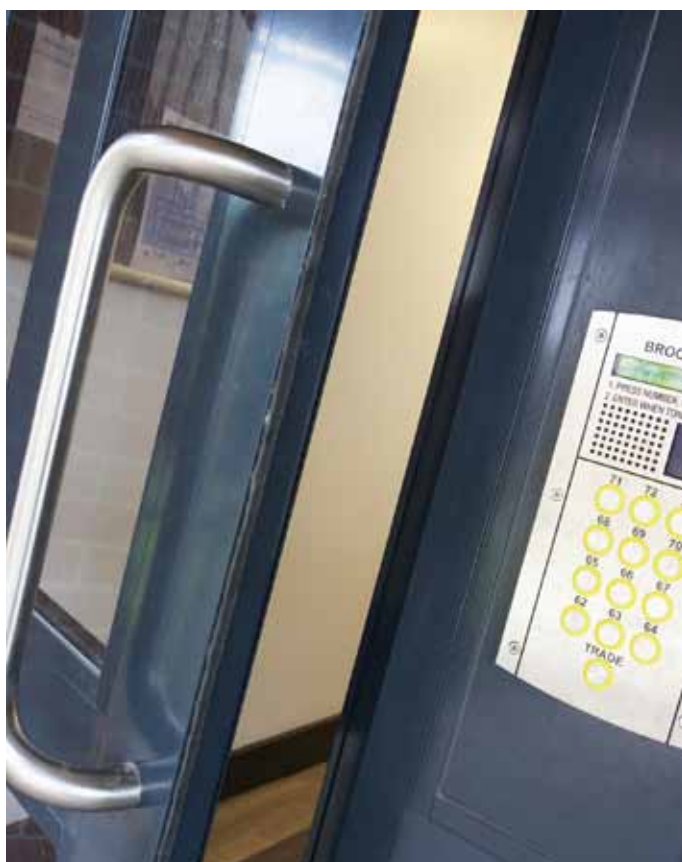
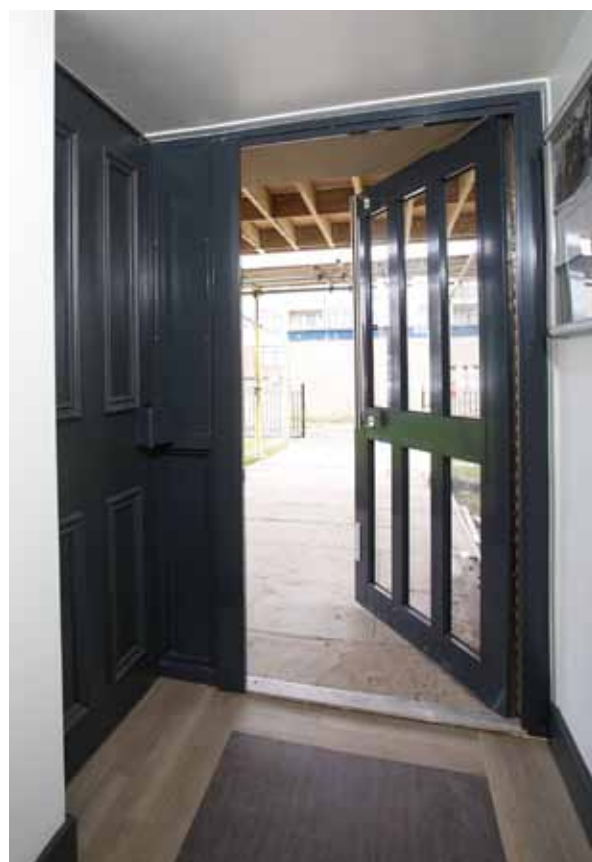
Object:	Halton House Trust, Cheshire, UK 2014
System:	Hammerglass Single Clear, 12 mm and 8 mm
Performance:	ATB Systems
	<p>Communal entrance doors and side screens to low rise apartment blocks were replaced by new aluminium high security doors and side screens.</p> <p>Hammerglass clear 12 mm was installed to the glazing in the side screens and 8 mm in the doors with multiple pieces of tall, thin glass sections.</p>

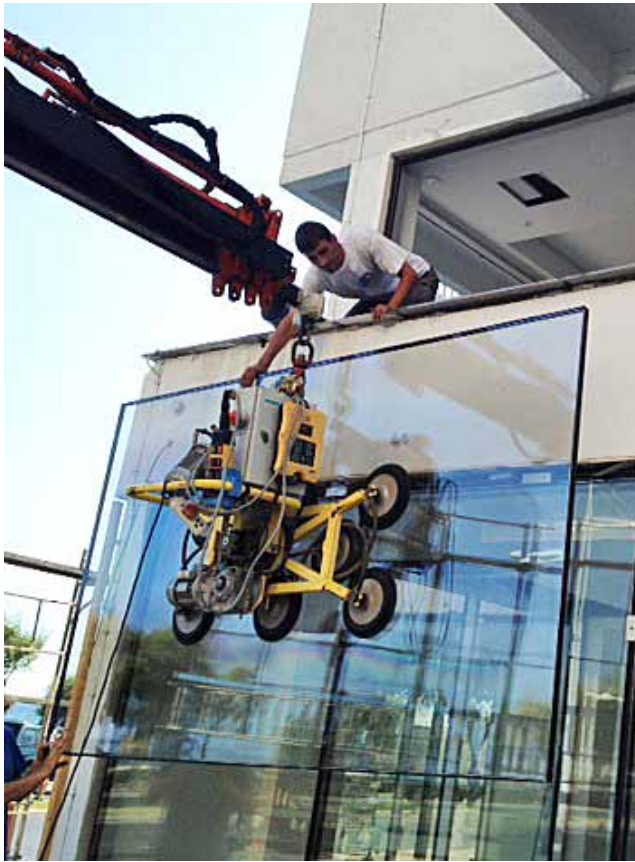
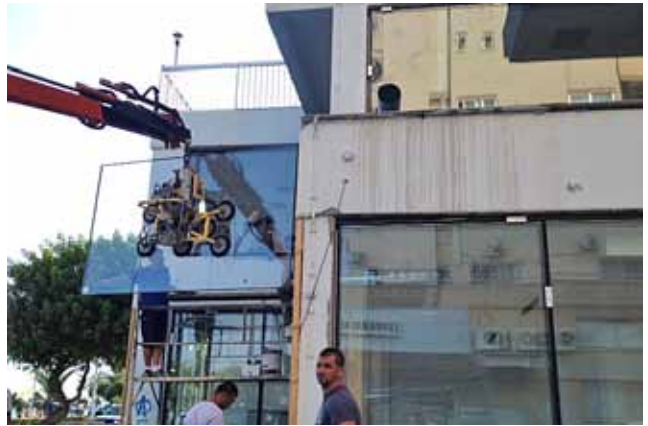
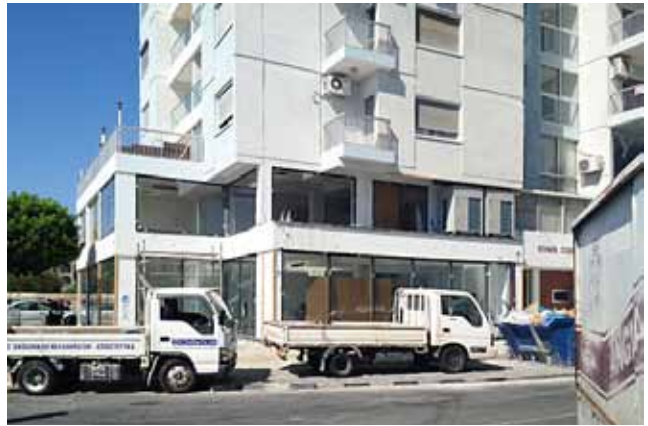
Object:	IPTP Networks, Limassol, Cyprus 2014
System:	Hammerglass Insulate, double pane
Performance:	Fredonia Trading Ltd

<p>Insulate glazing units consisting of Hammerglass 10 mm in combination with sound proofing laminate glass were installed on the ground floor of an office building in a busy seaside area.</p> <p>The first floor was equipped with Insulate glazing units consisting of Hammerglass 12 mm and Toughened Low E.</p> <p>The installation of the panes, some of which had considerable dimensions (up to 2900x1800 mm) was performed successfully.</p>

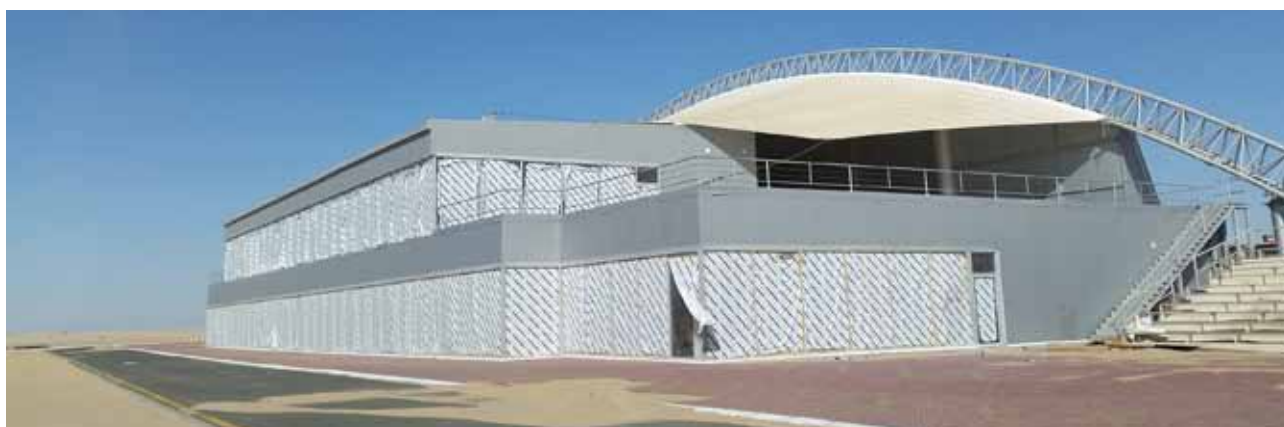
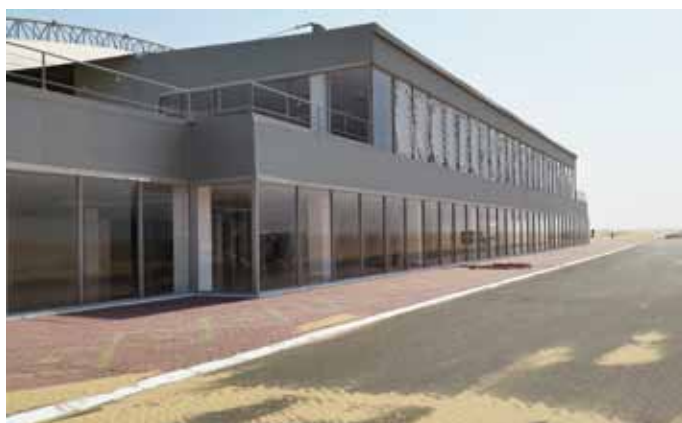
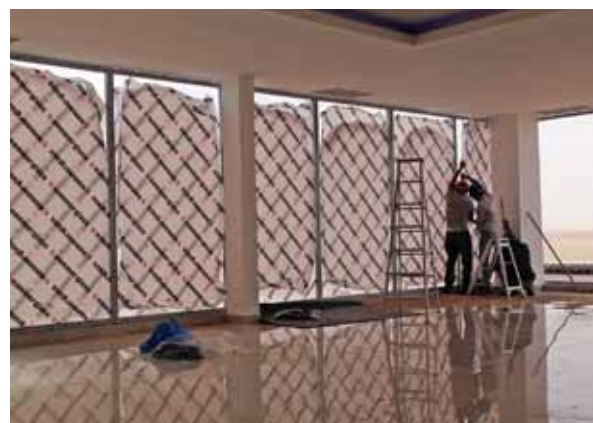
Object:	Kuwait Ministry of Defense Pavilion, 2014
System:	Hammerglass Single 12 mm
Performance:	SABECO Kuwait
	<p>Securing of exposed ground floor and first floor windows of the Kuwait Military Pavilion, situated at the desert Firing Range, a project supervised by the US Army.</p> <p>About 460 m² of Hammerglass Single 12 mm was installed. Sections of 1.7 m each were mounted in profiles to withstand occasional vibration and heavy wind loads of 140 km/h.</p>

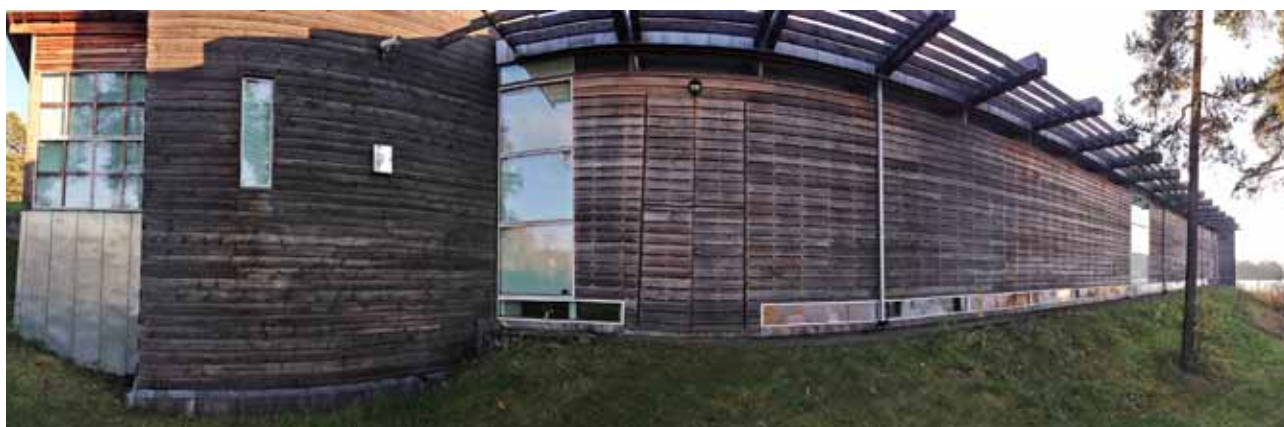
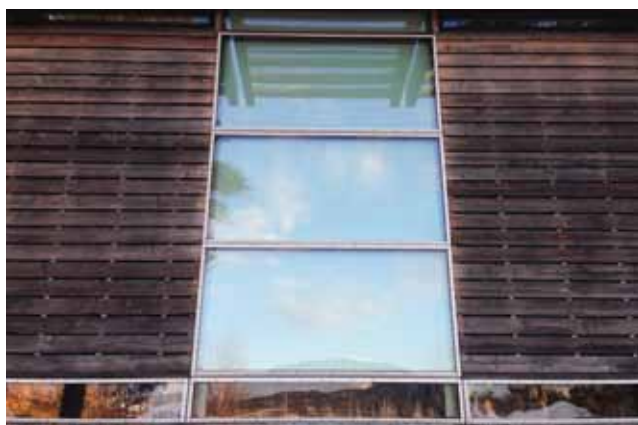
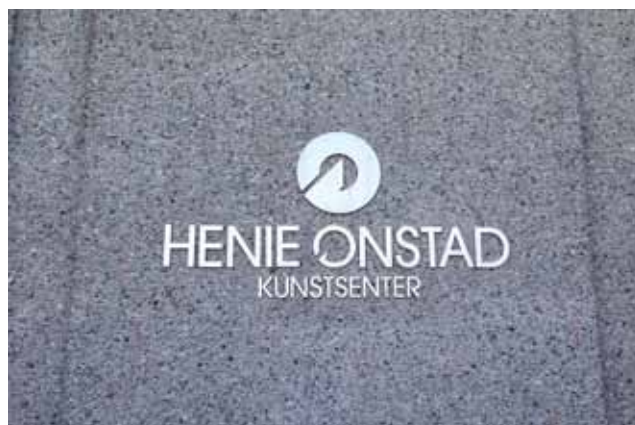
Object:	Henie Onstad Art Center, Oslo, Norway 2014
System:	Hammerglass Add-On System S, 8 mm
Performance:	Mil Sec Norway
	<p>Securing of exposed ground floor windows of the Art Center “Henie Onstad” in Oslo.</p> <p>Hammerglass Add-On System S, with 8 mm Hammerglass Clear, mounted in RAL-coloured systems.</p>

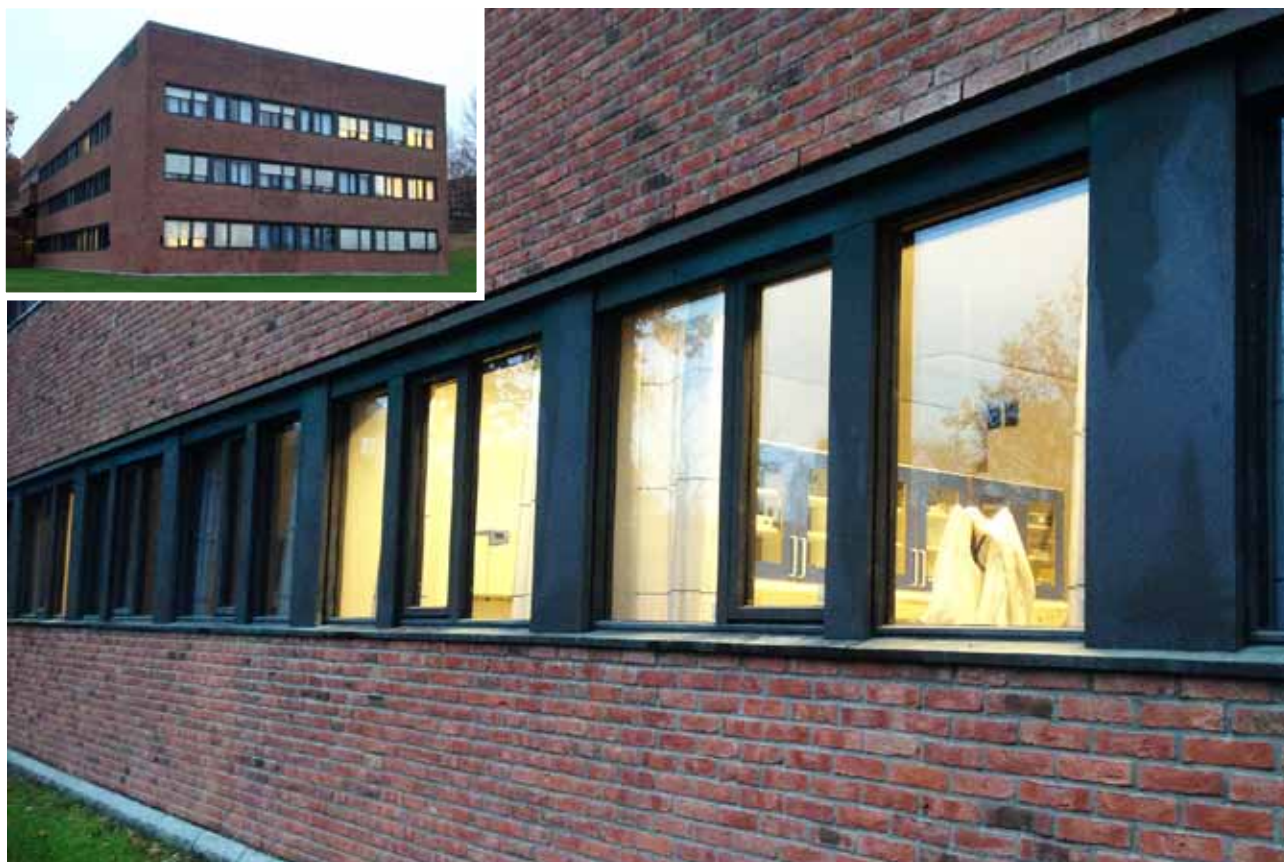
Object:	Chemistry Institution, Oslo University, Norway 2014
System:	Hammerglass Insulate, double pane
Performance:	Mil Sec Norway
	<p>Insulate glazing units consisting of Hammerglass 6 mm in combination with Sunergy Clear, a clear toughened pyrolytic glass, combining solar control, thermal insulation and low light reflection thanks to its clear colour.</p> <p>This installation was the perfect choice to obtain the combination of both security and thermal control.</p>

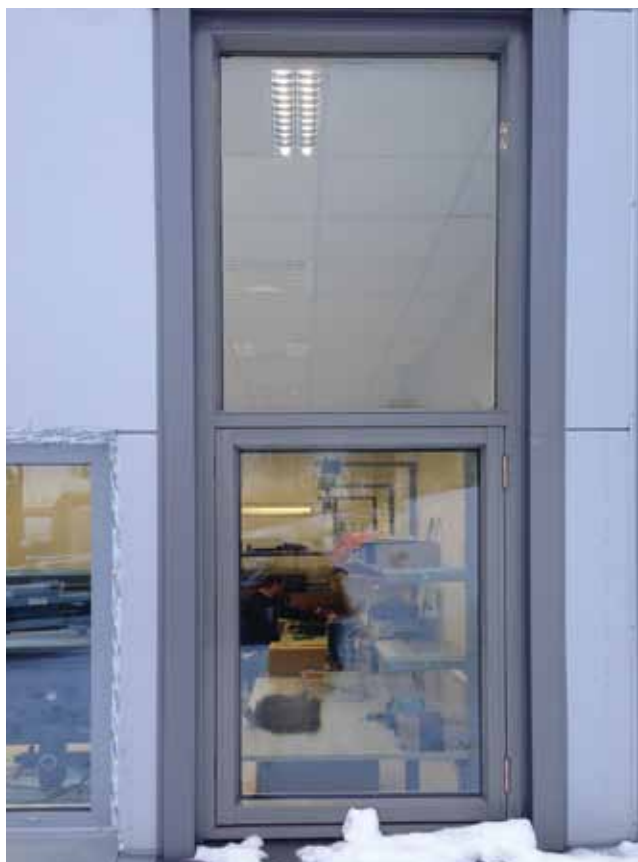
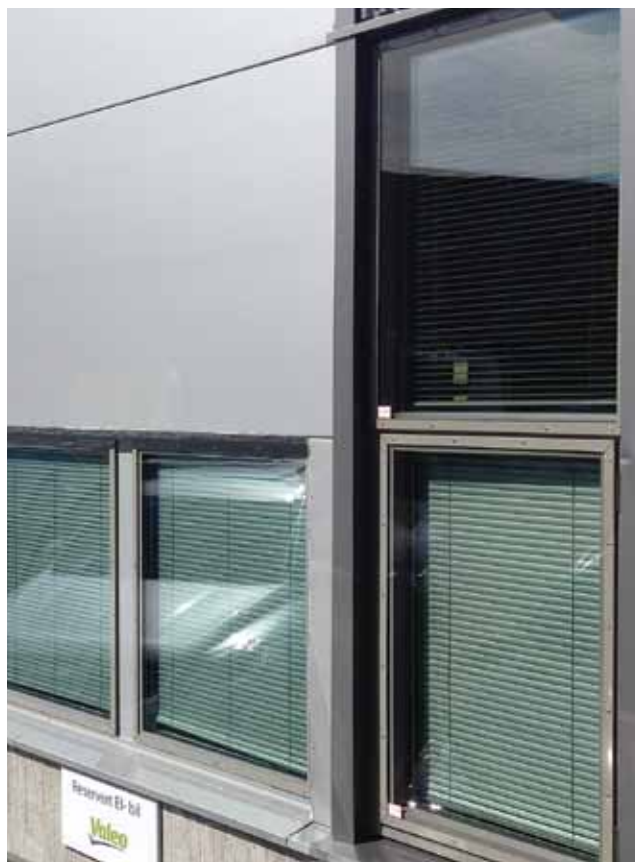
Object:	Valeo Powertrain Energy Conversions AS, Norway 2014
System:	Hammerglass Add-On System U, 8 mm
Performance:	Mil Sec Norway
	<p>Securing of exposed ground floor windows of laboratories.</p> <p>Hammerglass 8 mm mounted in RAL-coloured Hammerglass Add-On System U.</p>

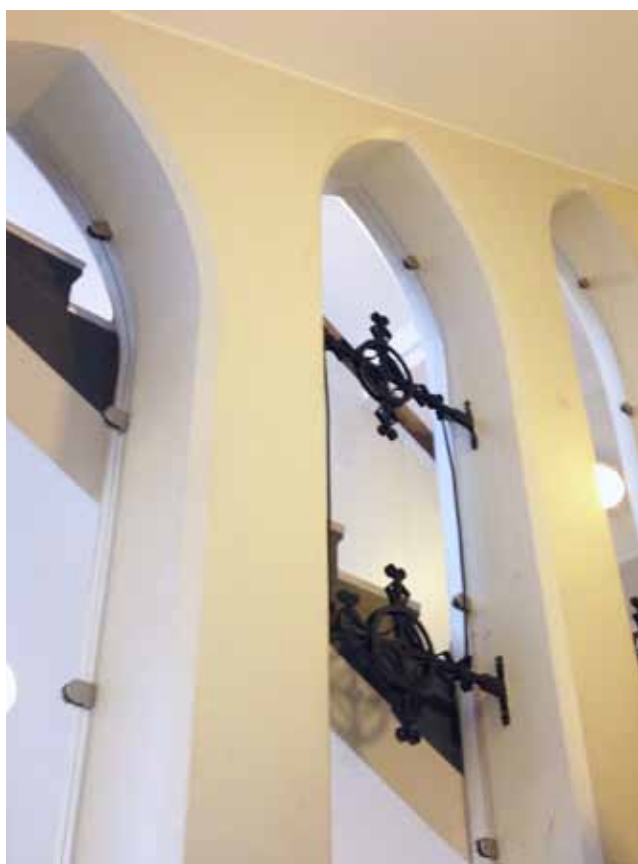
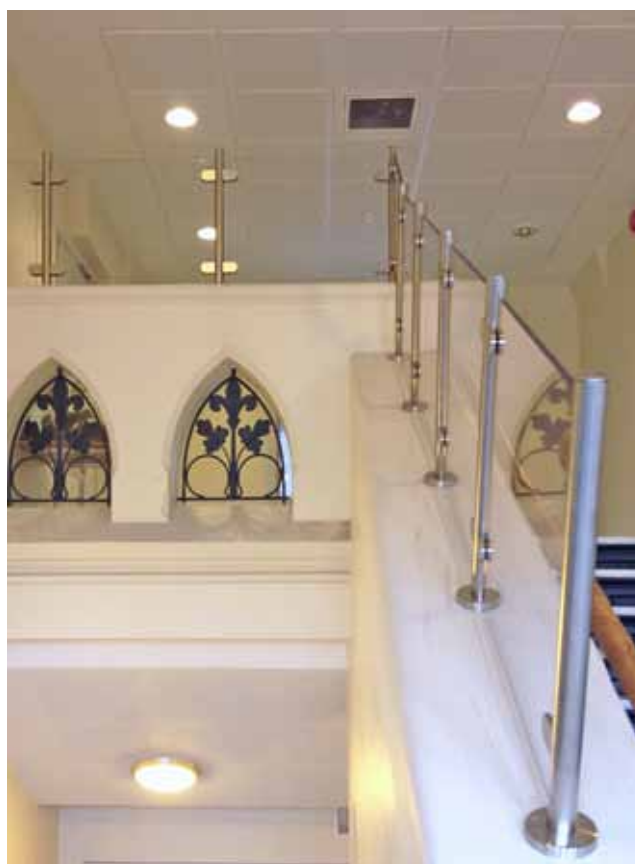
Object:	Vålerenga School, Oslo, Norway 2014
System:	Hammerglass Single 12 mm
Performance:	Mil Sec Norway
	<p>Hammerglass Single 12 mm was installed to increase security in the stairwell of a Vålerenga school in Oslo.</p> <p>The panels were cut into shape with arched top sides to cover dangerous openings beside the staircase, and mounted with glass clamps.</p>

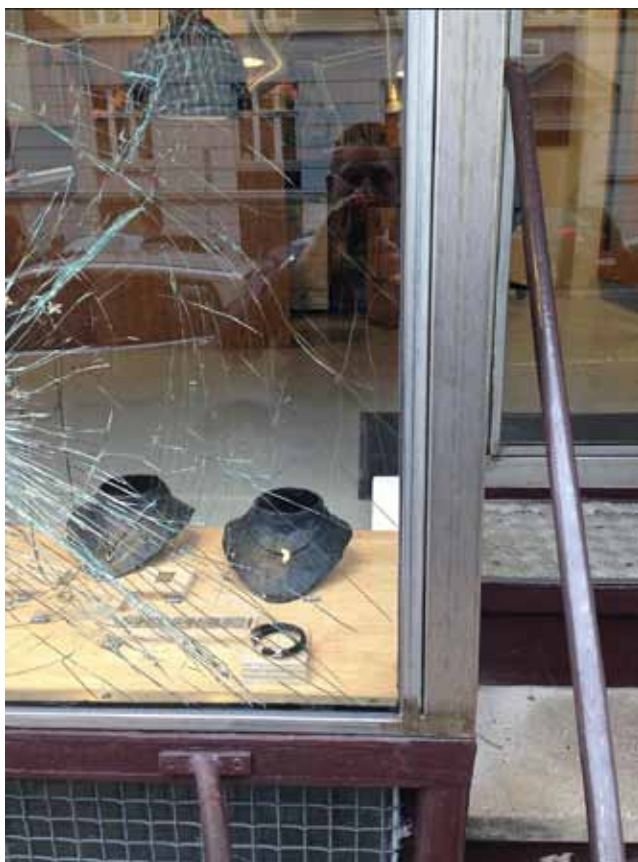
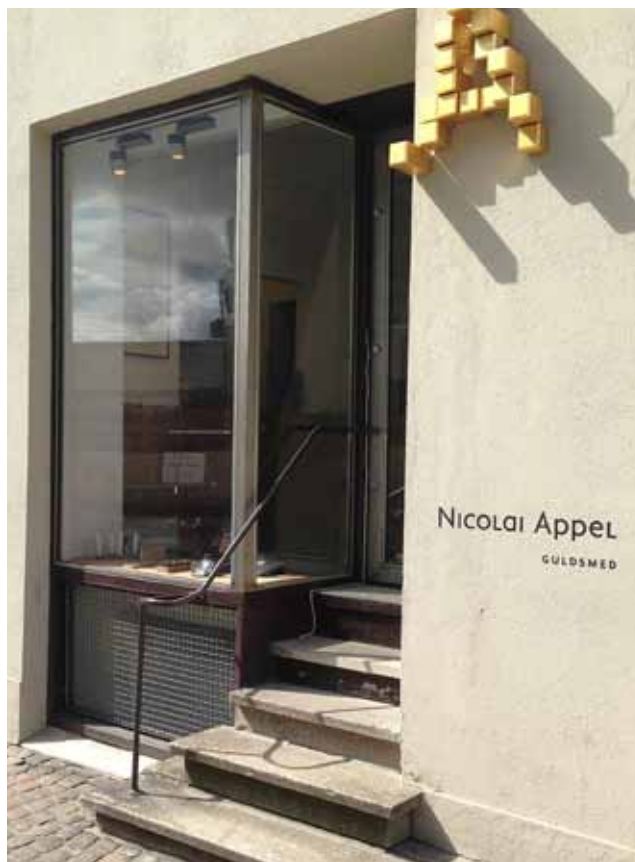
Object:	Jeweller Nicolai Appel, Denmark 2013
System:	Hammerglass Single 12 mm
Performance:	Hammerglass Single 12 mm
	<p>Hammerglass Single 12 mm was installed in the shop window and door of Jewellery Store Nicolai Appel, to avoid future glass breakage.</p> <p>Security Class EN 356, P8B.</p>

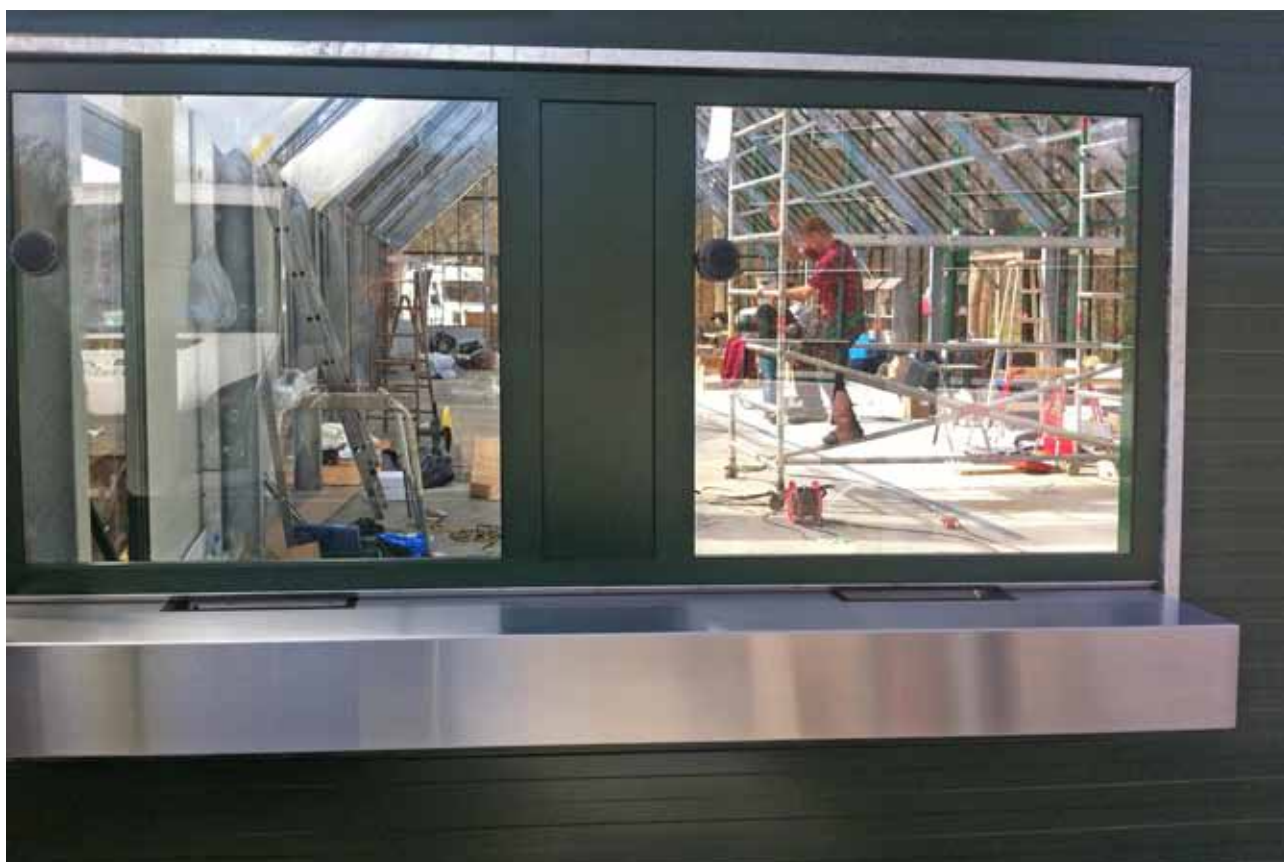
Object:	Egeskov Castle, Denmark 2013
System:	Hammerglass Single 10 mm
Performance:	Howeni Eurosafe Denmark A/S
	<p>Hammerglass Single 10 mm was installed to secure service desks at Egeskov Castle, Denmark.</p> <p>Security Class EN 356, P8B.</p>

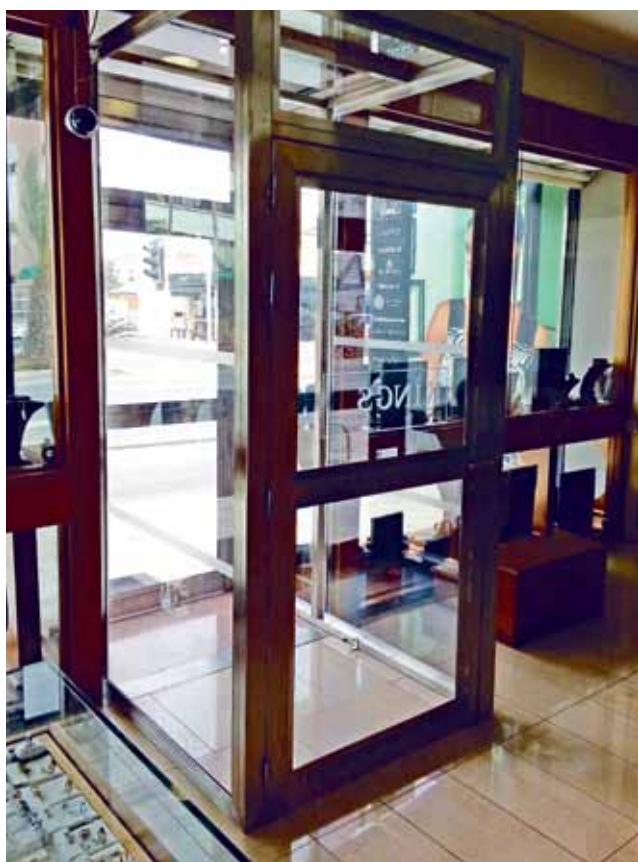
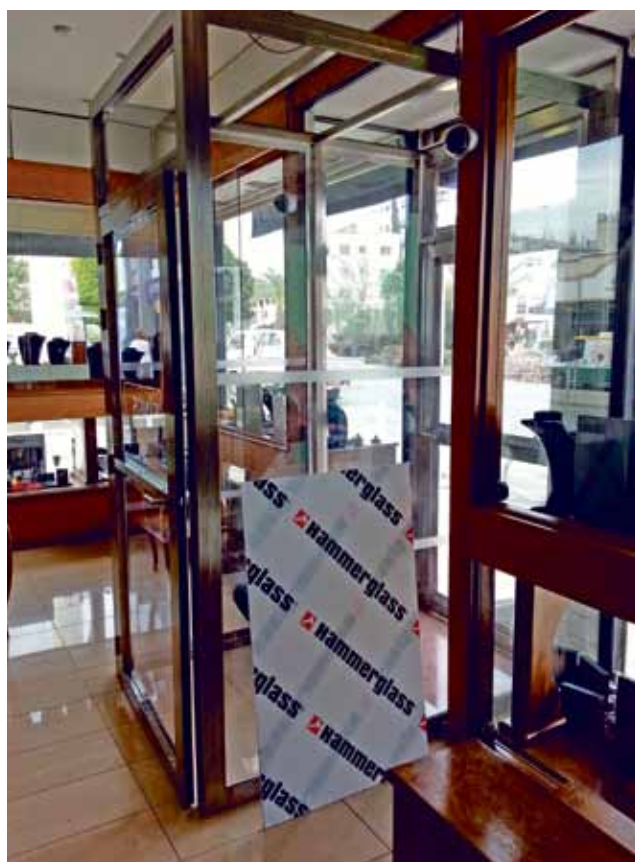
Object:	Kings Jewellers, Lemesos, Cyprus 2013
System:	Hammerglass Single 10 mm
Performance:	Lemoniatis Window Films, Limassol
	<p>A security enclosure/booth with double doors in stainless steel, all equipped with 10 mm Hammerglass.</p>

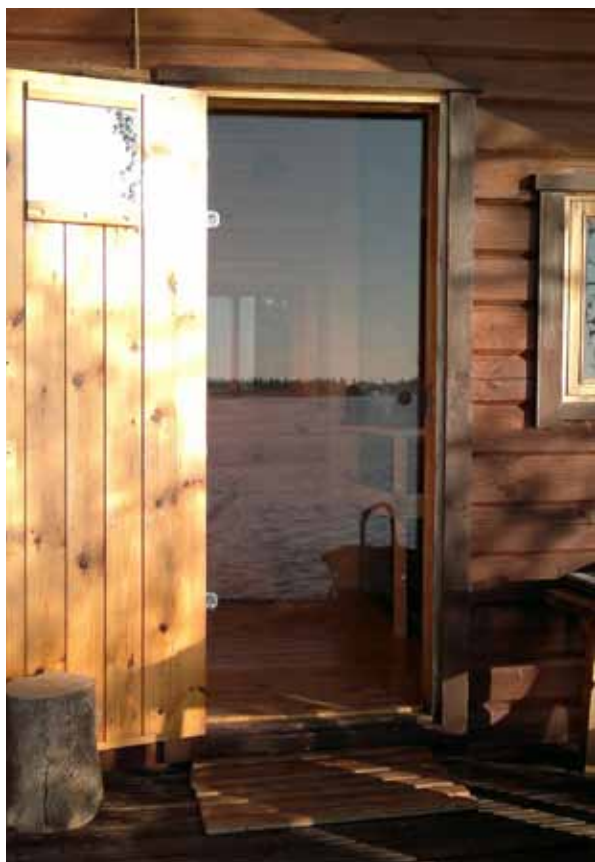
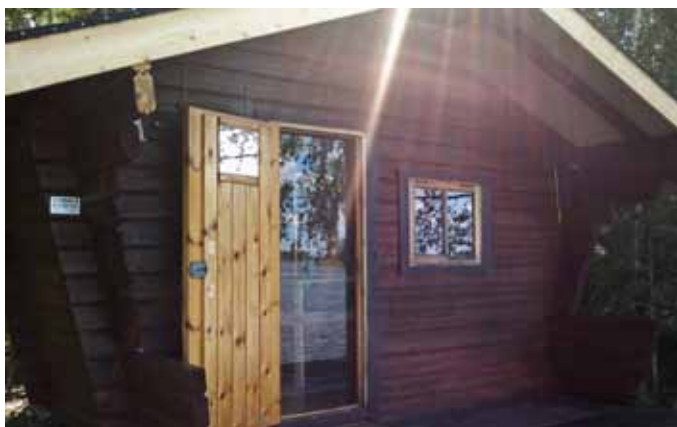
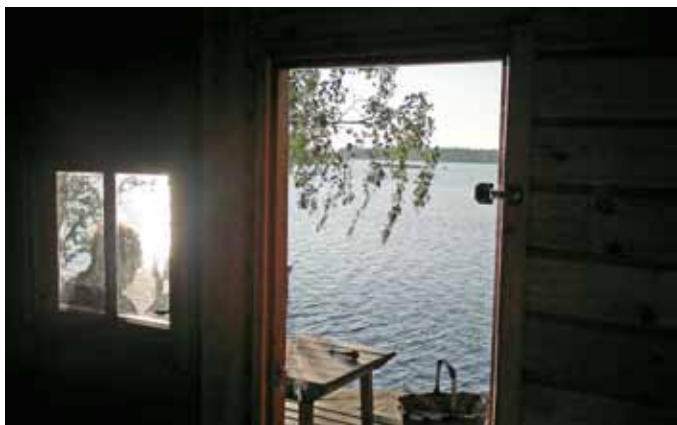
Object:	Sauna, Finland 2013
System:	Hammerglass Single 15 mm
Performance:	Hammerglass Finland
	<p>When expanding the sauna, the client asked for a secure, unbreakable lightweight door with light weight construction.</p> <p>As clarity and durability were critical factors to the customer, Hammerglass was the obvious choice.</p>

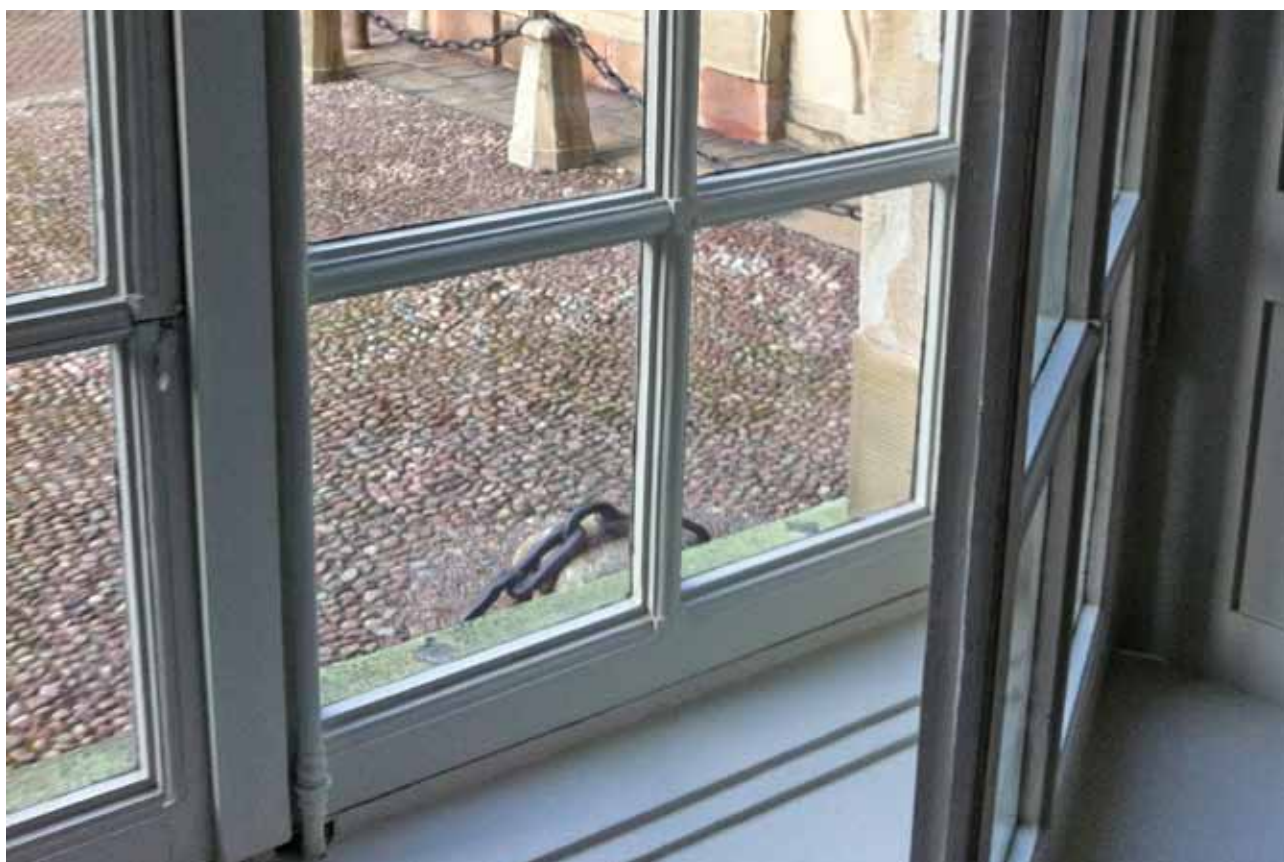
Object:	The Royal Castle, Stockholm, Sweden 2012
System:	Hammerglass Single
Performance:	Hammerglass AB
	<p>Hammerglass Single mounted as the middle pane of the window, between linked sashes. Listed property with high security requirements.</p> <p>Glass solution with low weight. The installation does not alter the outer appearance of the existing architecture.</p>

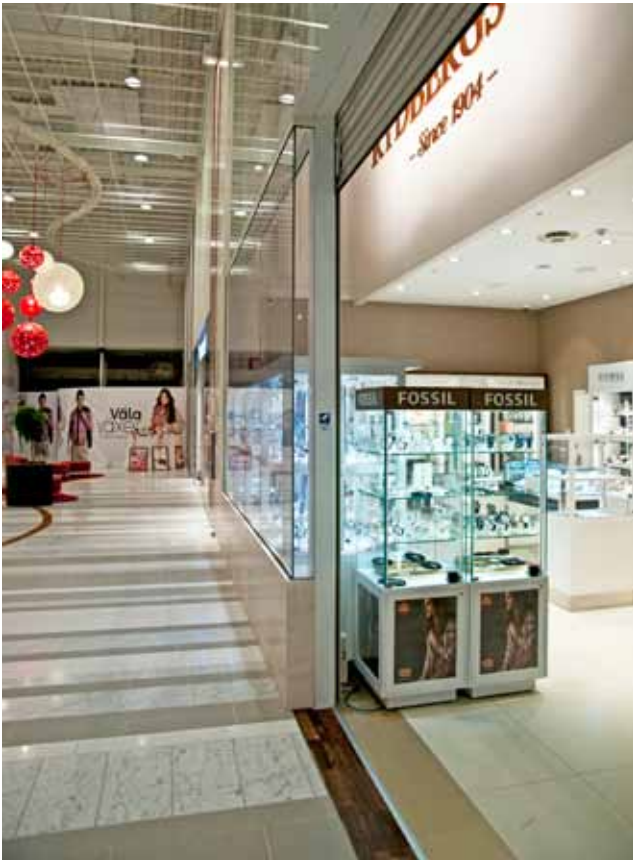
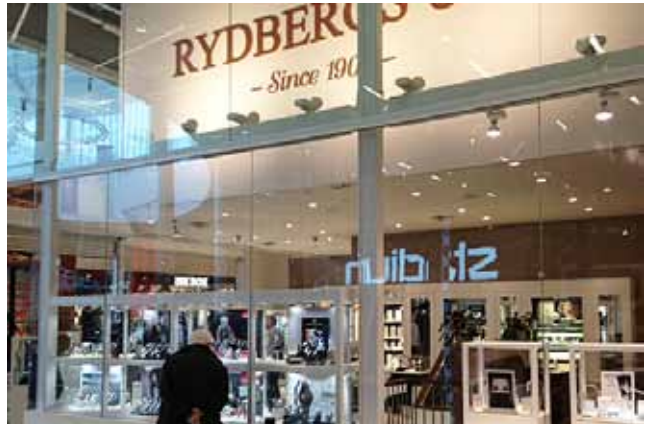
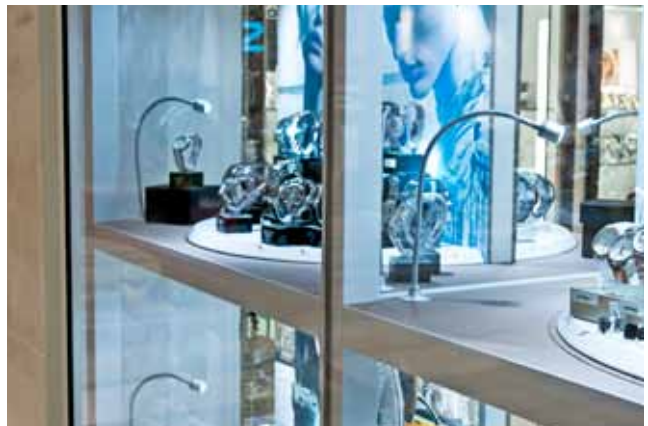
Object:	Rydbergs Jewellery and Watches, Väla, Sweden 2012
System:	Hammerglass 12 mm, tongue and grooved system
Performance:	Hammerglass AB
	<p>Hammerglass Single 12 mm was installed at a Jewelers/Watch Store in the “Väla” shopping mall of Helsingborg.</p> <p>Hammerglass mounted in profiles at the top and bottom of the windows. Vertical tongue and groove system. Even the glass cabinets inside have been equipped with Hammerglass, mounted in the store’s existing frames.</p> <p>Security class Hammerglass Single 12 mm: EN 356, P8B</p>

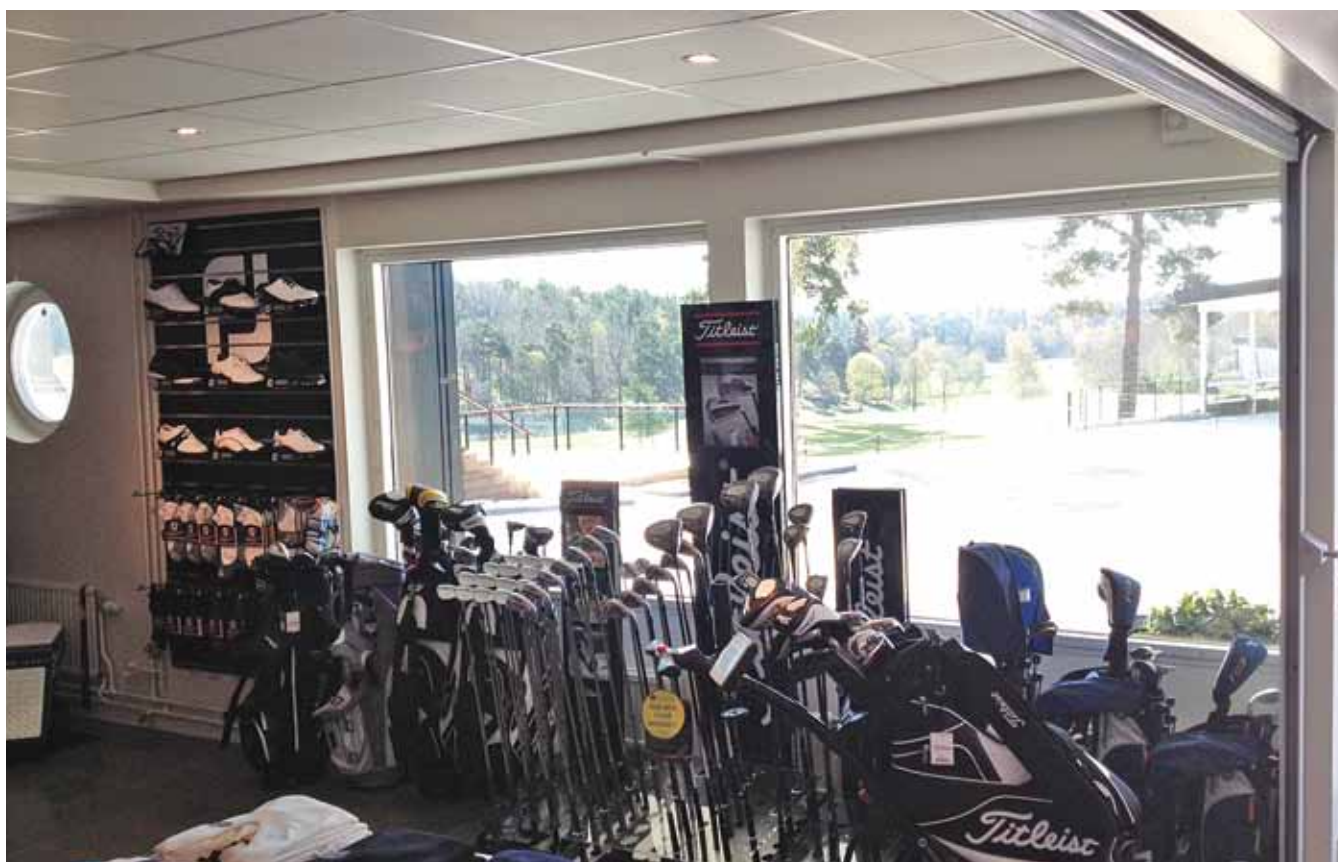
Object:	Lidingö Golf Club, Stockholm, Sweden 2012
System:	Hammerglass Add-On System U, 6 mm
Performance:	Lidingö Låsservice
	<p>When securing the Lidingö golf shop, an internal shutter was installed to enable closing the shop during other activities. However, on the windows an open view option was preferred. Hammerglass Add-On System U was mounted on the inside of the shop windows.</p> <p>"Today we did the final review of all parts of Lidingö Golf Club's security solutions. We all agree that everything looks neat and well performed. Your solution is an excellent complement to the security systems." (Lidingö Låsservice)</p>

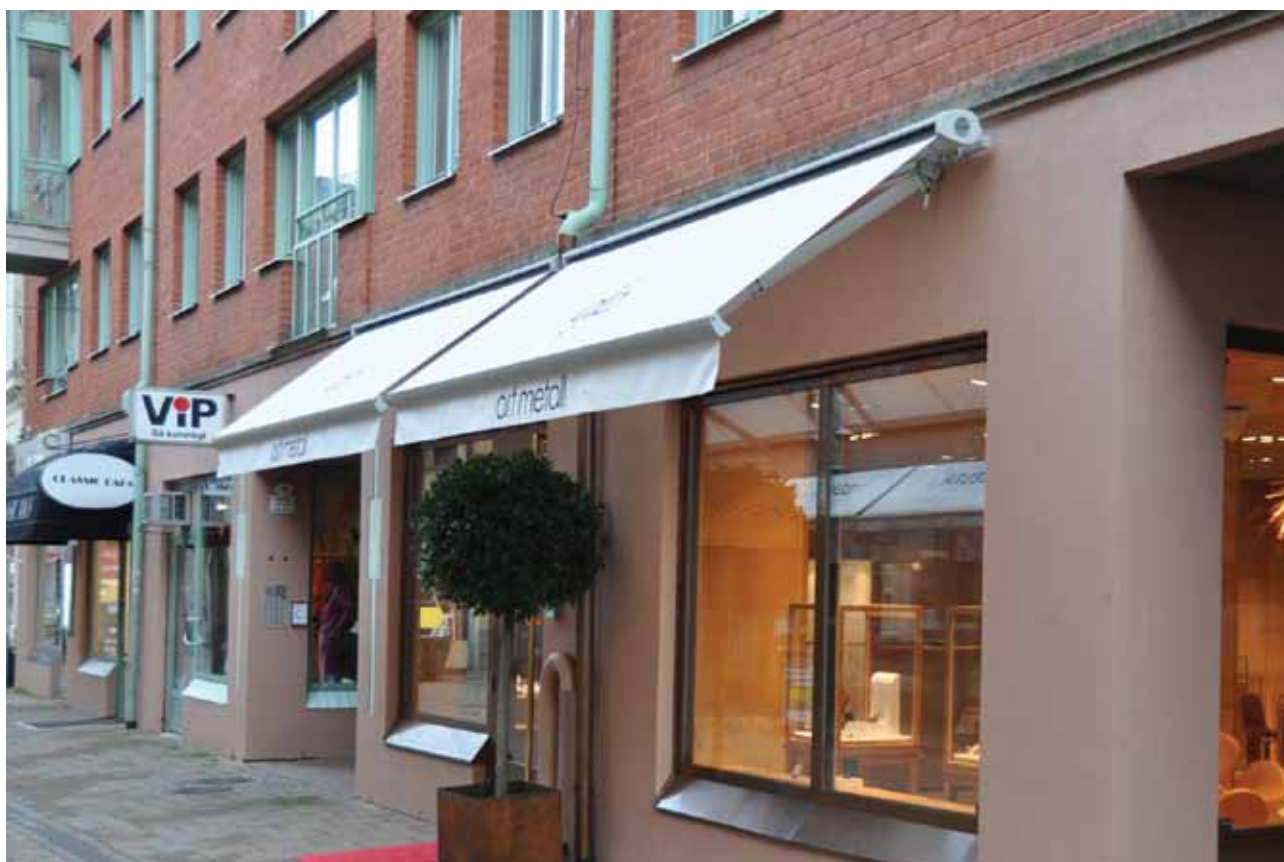
Object:	Art Metall, Helsingborg, Sweden 2010
System:	Hammerglass Add-On System F
Performance:	Gallerexperten
	<p>All windows are protected with Hammerglass. Art Metall chose Hammerglass Add-On System F behind shop windows to get glass break detectors initiating the alarm directly on a burglary attempt.</p> <p>The project is described in detail in its own folder.</p>

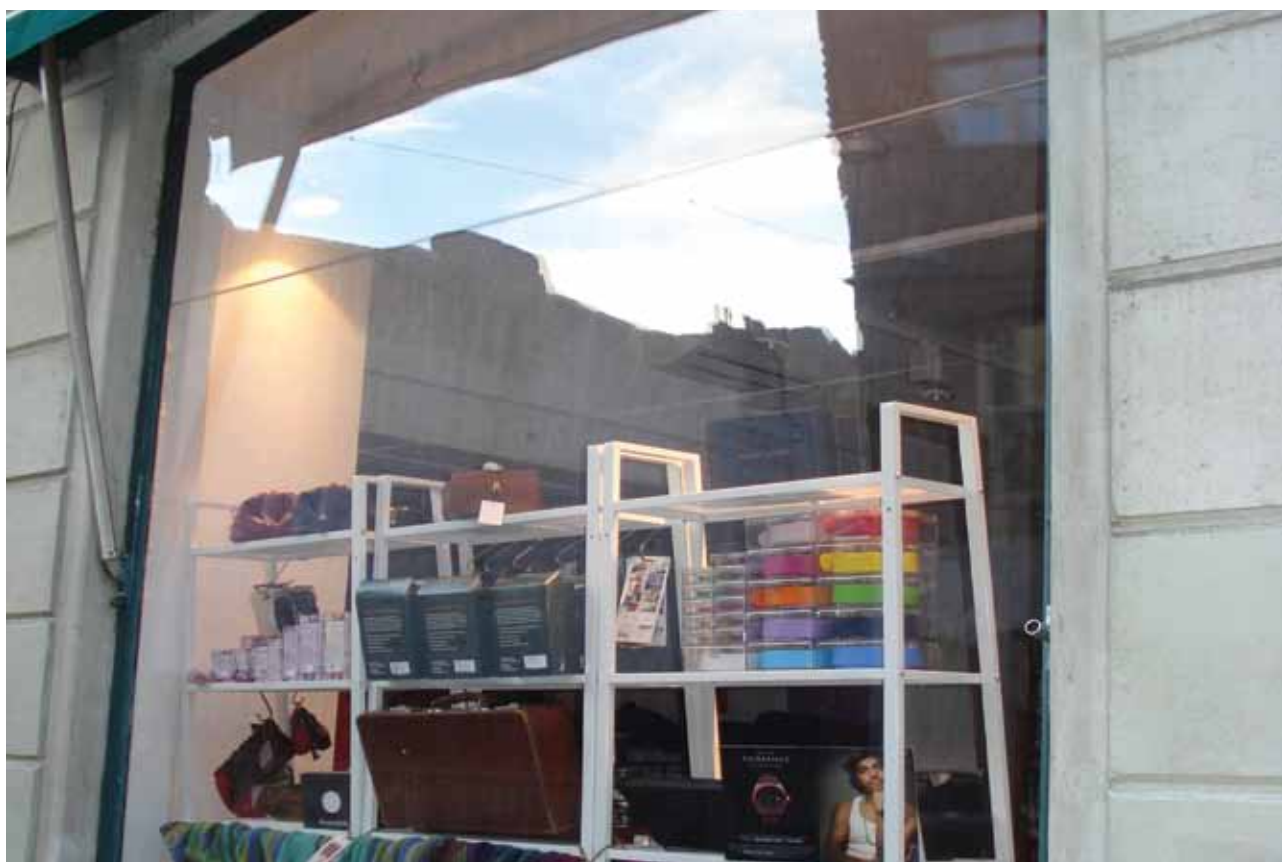
Object:	Scandinavian Sportsman, Lund, Sweden 2010
System:	Hammerglass Single 12 mm, tong and grooved system
Performance:	Gallerexperten
	<p>Animal rights activists have repeatedly exposed the shop for vandalism. Hammerglass Single was mounted in the existing arches of three windows with curved upper sections.</p> <p>Following the Hammerglass panels size limit (2x3 m), the panels were spliced with a tongue and groove system at two metres height.</p>

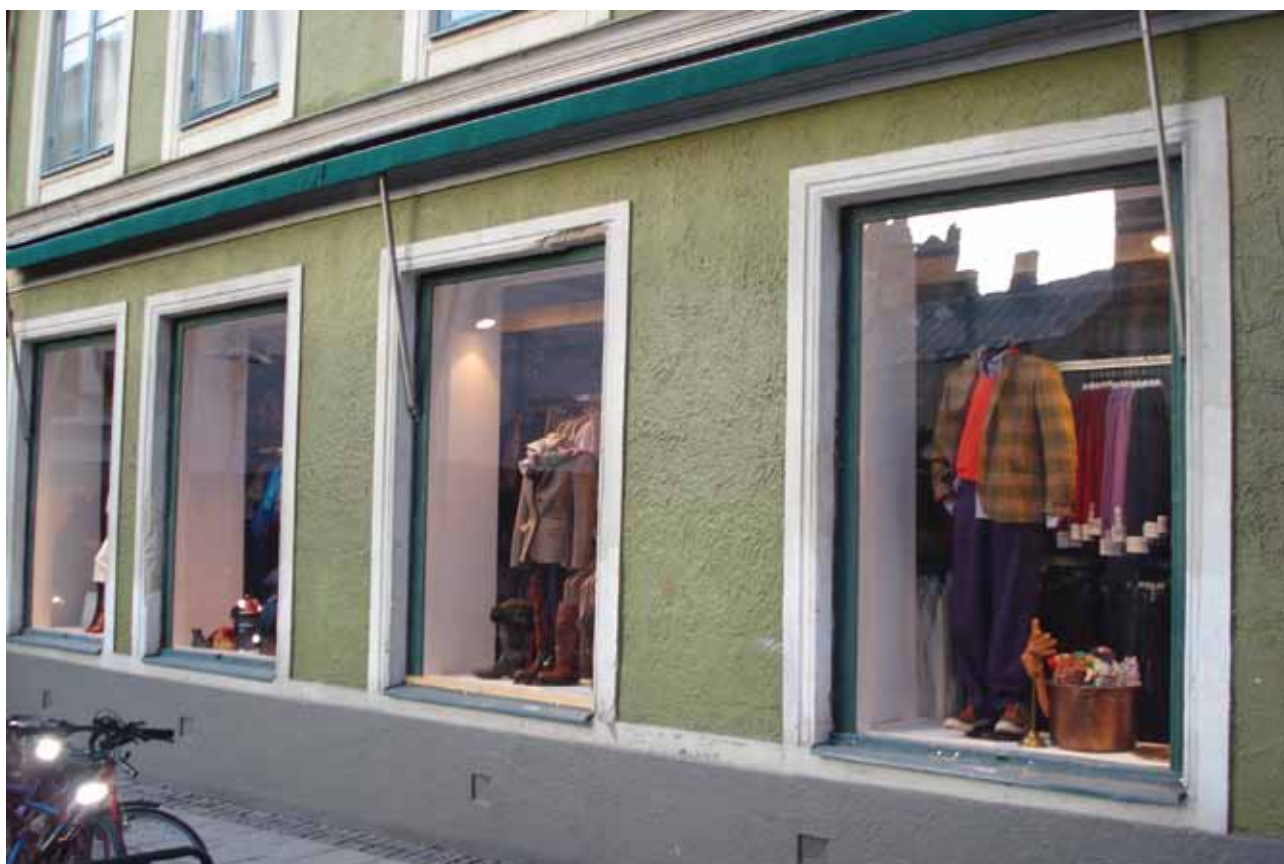
Object:	Scandinavian Sportsman, Lund, Sweden 2010
System:	Hammerglass Single 12 mm
Performance:	Gallerexperten
	<p>Hammerglass Single was installed in existing frames in 8 windows. The panels were glued into the frames and the glazing beads were fixed with screws.</p>

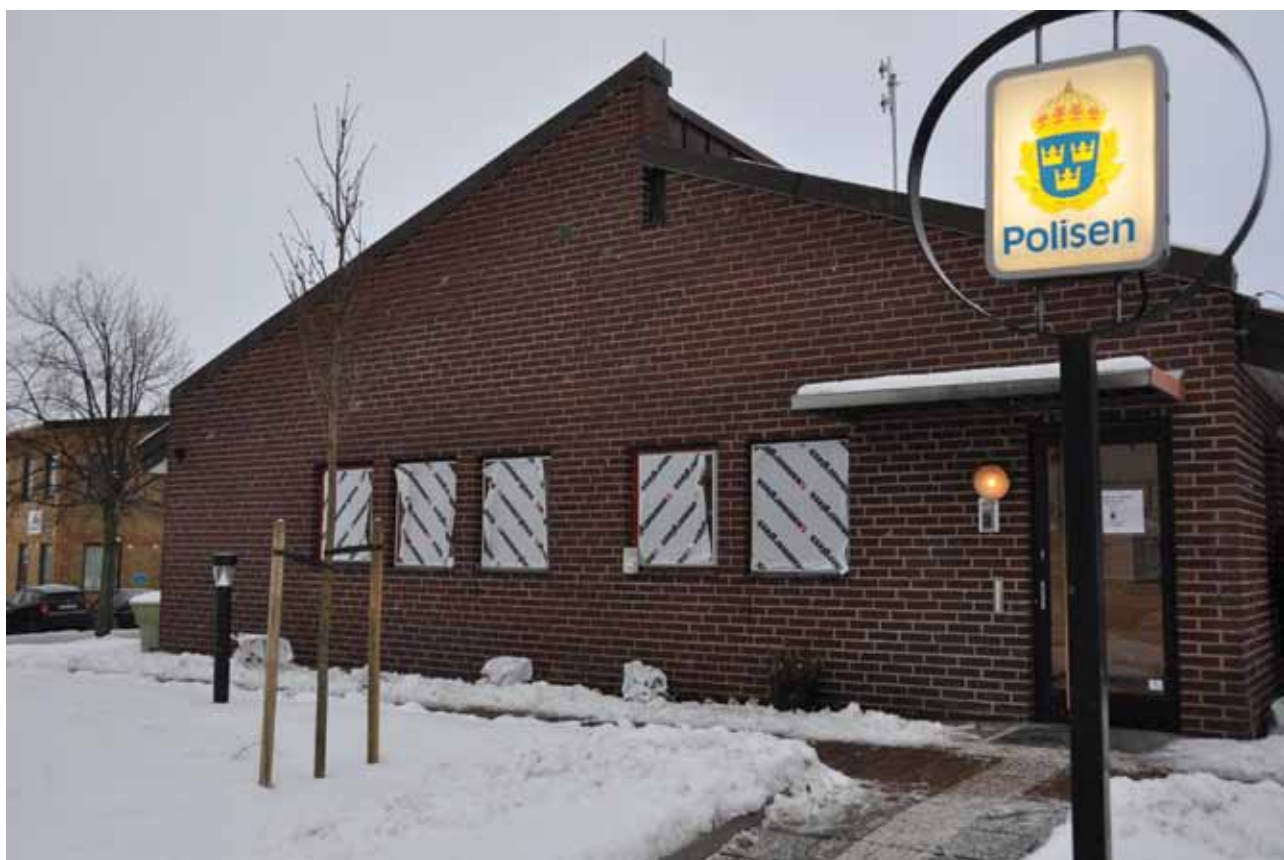
Object:	Police station, Båstad, Sweden 2010
System:	hammerglass Add-On System S
Performance:	Metallfasader
	<p>Hammerglass Add-On System S 6 mm, in all the windows of the police station in Båstad as protection against vandalism.</p> <p>Security class EN-356, P7B.</p>

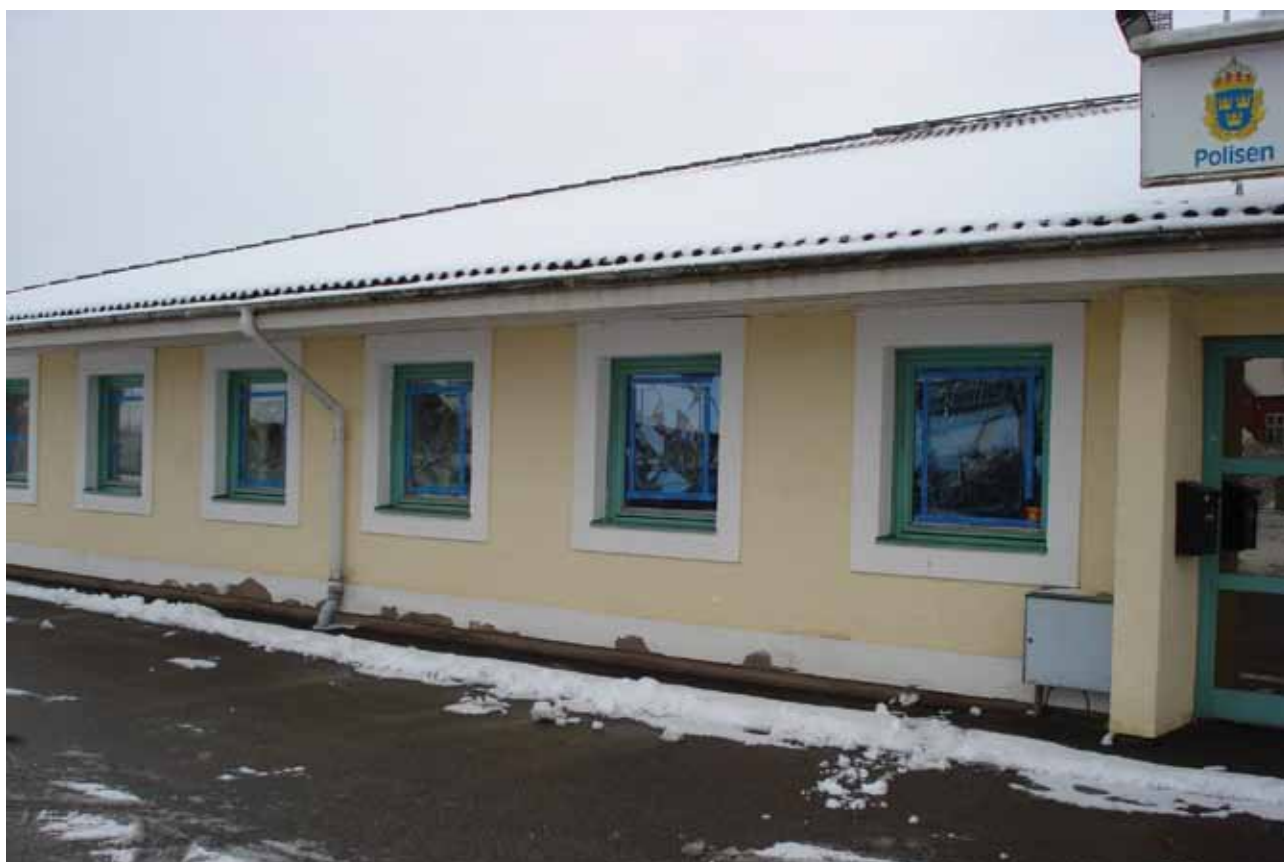
Object:	Police station, Dalby, Sweden 2010
System:	Hammerglass Insulate double pane
Performance:	Teriör AB
	<p>The police station was subject of an attack in which most of the windows were crushed.</p> <p>To avoid further glass breakage ALL THE windows in the ground floor and entrance sections were replaced with unbreakable Hammerglass Insulate.</p>
