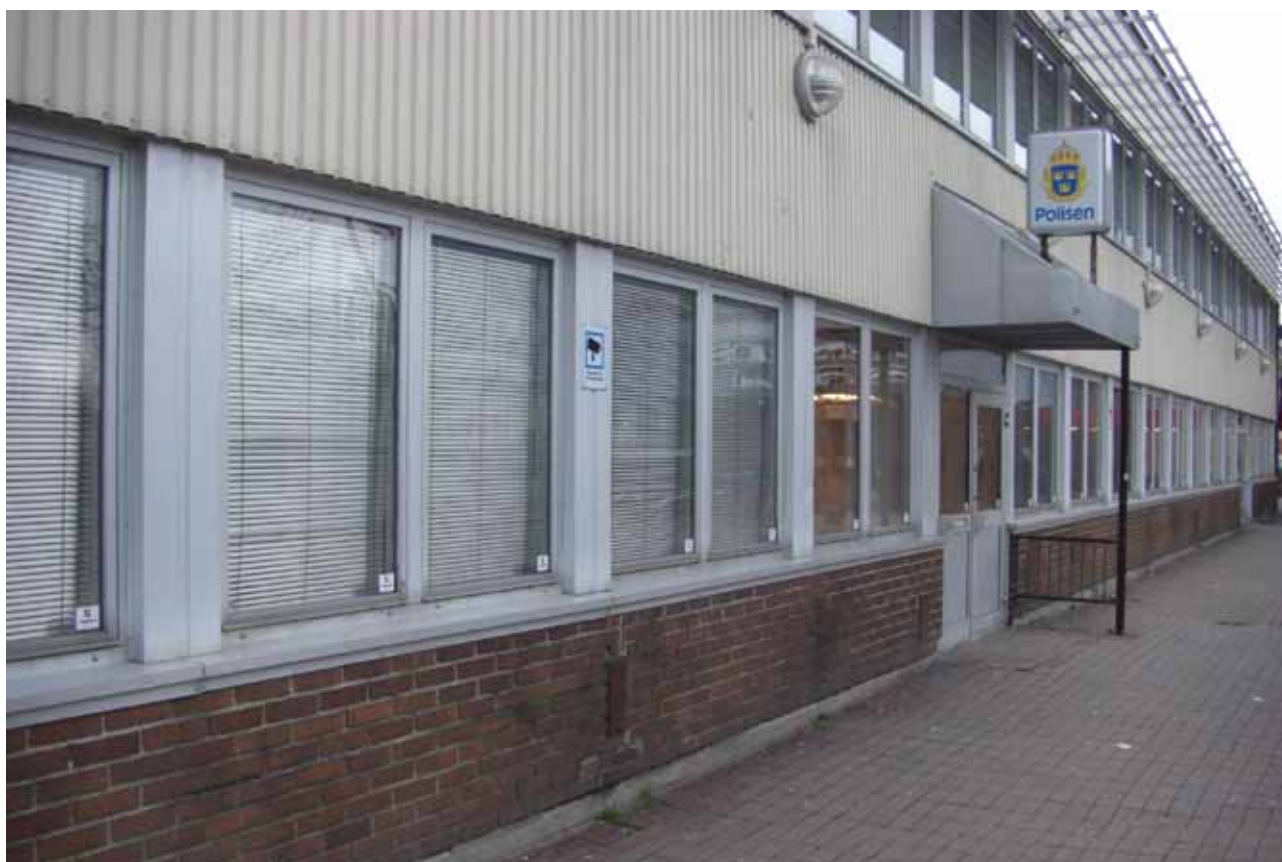
Object:	Police station, Rosengård, Malmö, Sweden 2009
System:	Hammerglass Insulate double pane
Performance:	Fastighetsskydd

<p>One of the largest property management companies in Rosengård, Malmö, Sweden, has installed the Hammerglass Add-On System fitted to existing windows.</p> <p>At the police station all windows were broken during a demonstration. All windows and doors were thereafter equipped with Hammerglass Insulate in the existing frames.</p> <p>A total of 25 windows on the ground floor.</p>

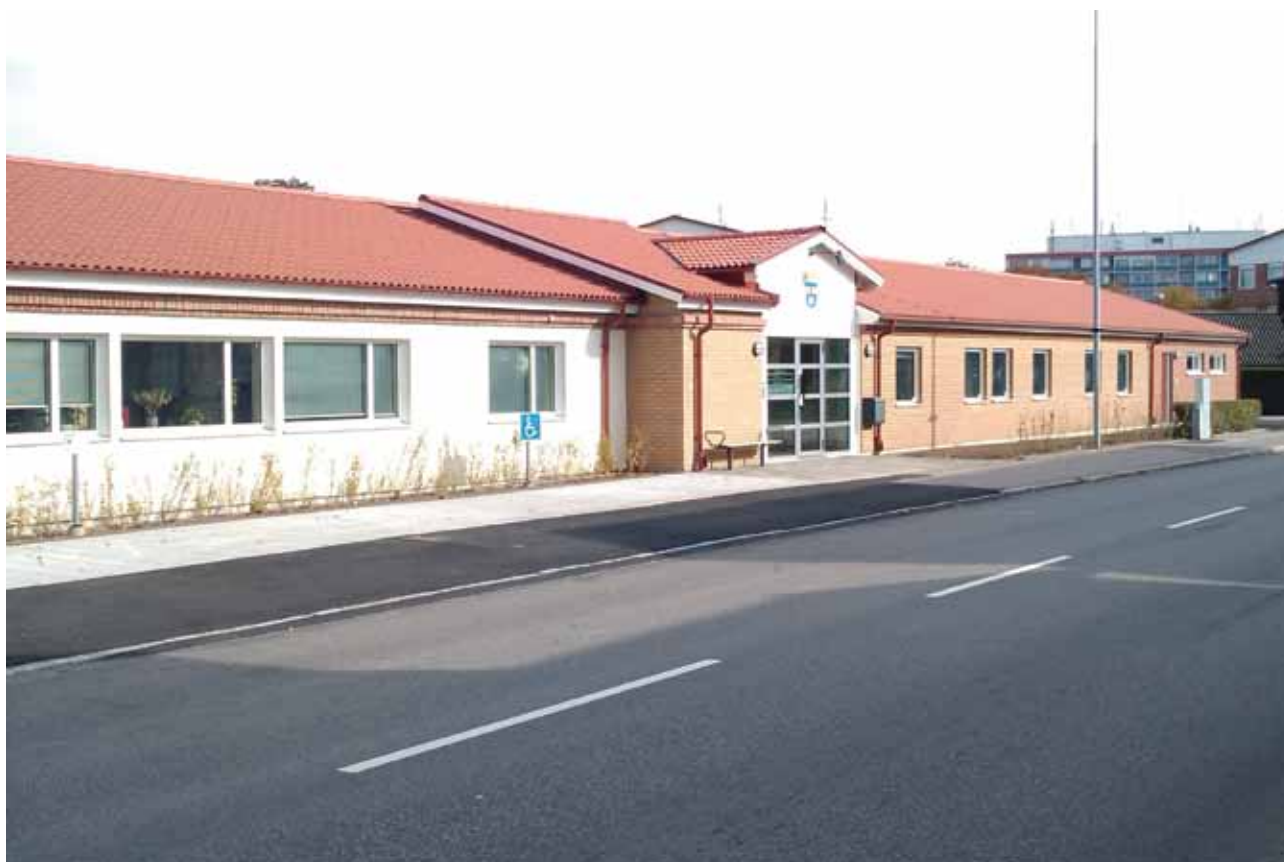
Object:	Police station, Klippan, Sweden 2009
System:	Hammerglass Add-On, Hammerglass Insulate
Performance:	Hammerglass AB
	<p>All the windows facing the street were replaced with Hammerglass Insulate as the police station was renovated.</p> <p>Hammerglass IR and EnergyBlinds sunscreens were installed in windows with need for efficient sun protection.</p>

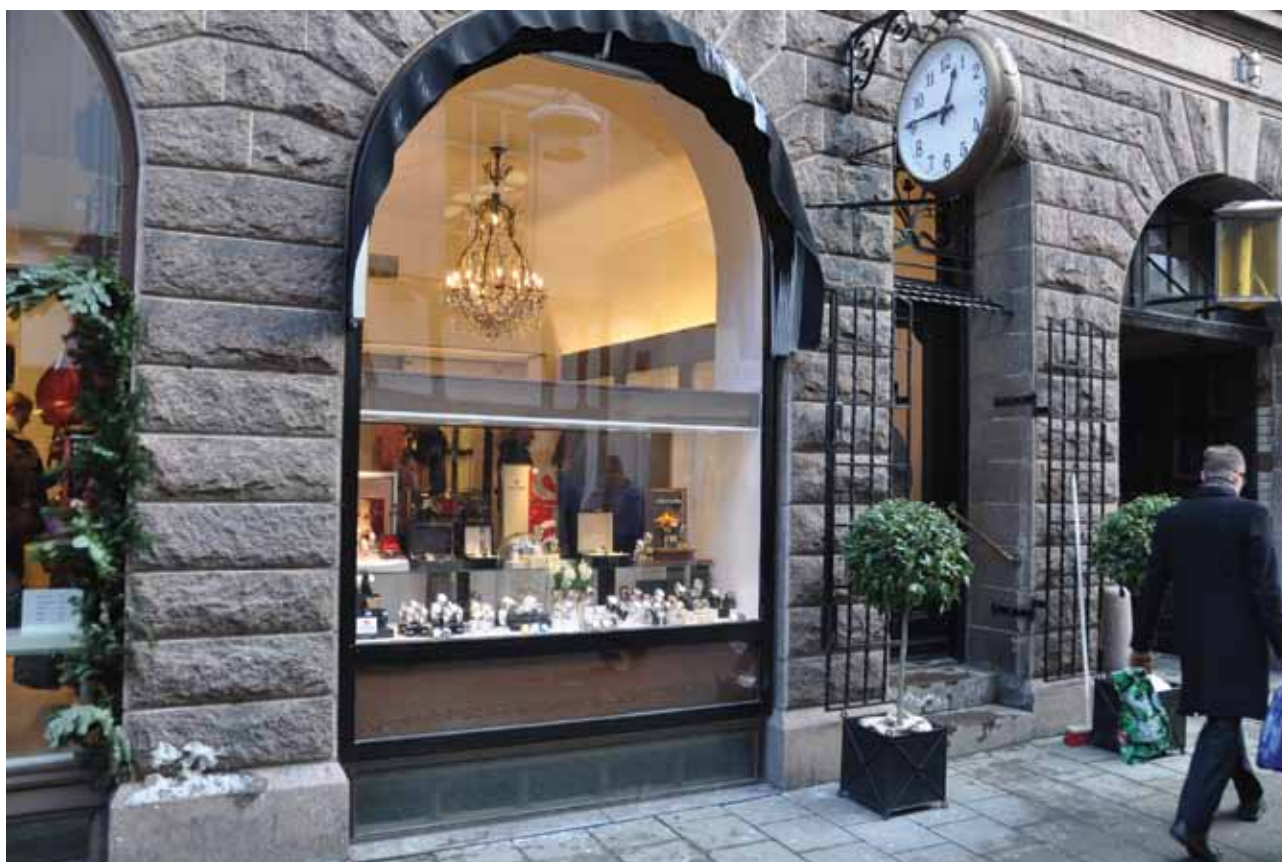
Object:	Carlssons Ur, Helsingborg, Sweden 2009
System:	Hammerglass Single 12 mm
Performance:	Gallerexperthen
	<p>Hammerglass Single 12 mm installed in existing wooden sashes in arched shop windows and entrance door. Security class P8B.</p> <p>Cold rolled steel profile in window bar (bottom of the window) prevent vehicles to drive through.</p> <p>The window glass is coated with a scratch-resistant SafeCoat film.</p>

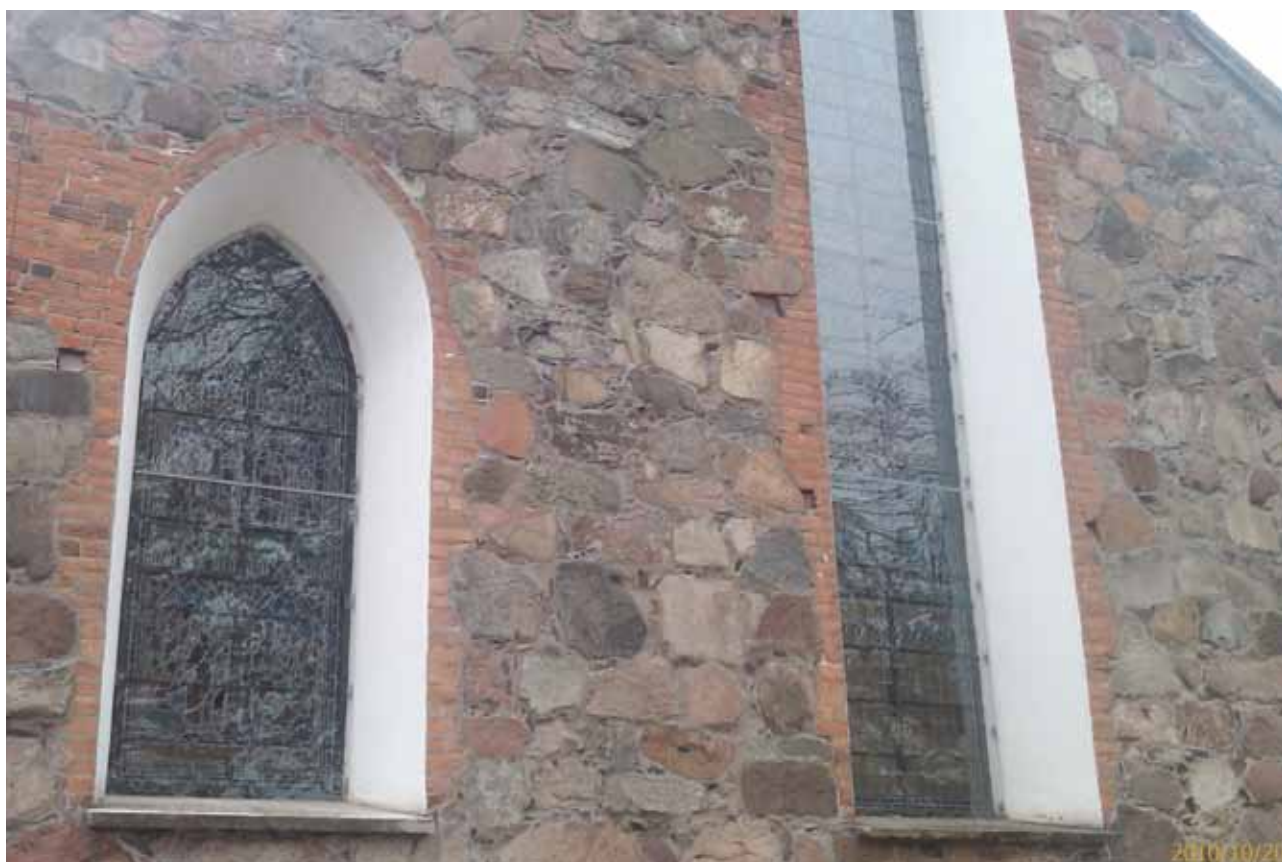
Object:	Church windows, Uppsala, Sweden 2009
System:	Hammerglass Single 12 mm Clear
Performance:	PEAB

<p>Hammerglass in front of all the leaded stained glass windows.</p> <p>The largest windows measures 2x10.5 metres. The Hammerglass panes were spliced with a tongue/groove system and mounted in the window niches with angled irons, at a distance of 80 mm from the church windows.</p> <p>Protects church windows without changing the visual effect of the stained glass windows.</p> <p>Approved by the Swedish Church Building Council.</p>

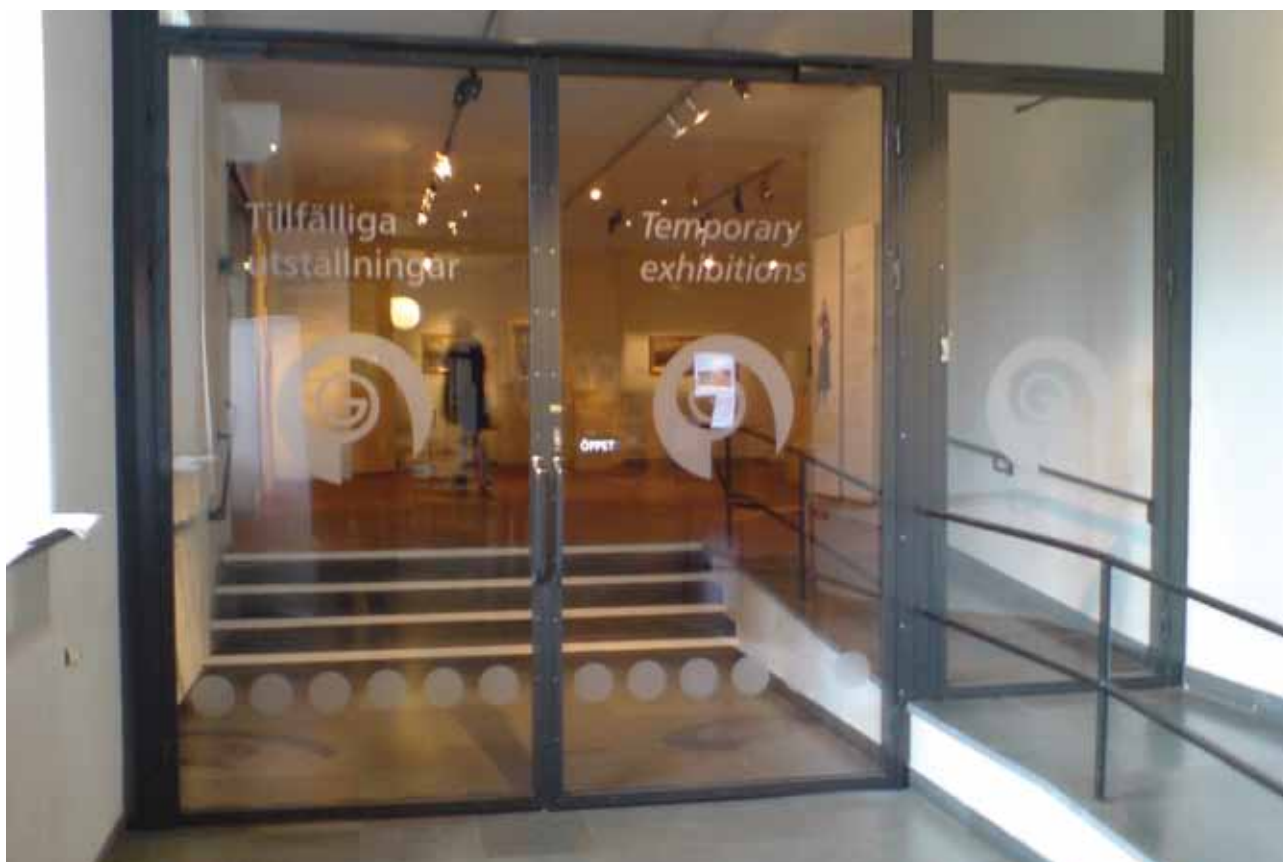
Object:	County Museum, Gävle, Sweden 2009
System:	Hammerglass Single 8 mm
Performance:	Låstjänst Alarm, Gävle
	<p>In the exhibition areas, Hammerglass Single 8 mm was installed on specially manufactured cold rolled steel profiles and window. Its low weight (10 kg/m² compared to approximately 75 kg/m² for laminated glass) provide a smooth and easy installation.</p> <p>Security class EN-356, P8B.</p>

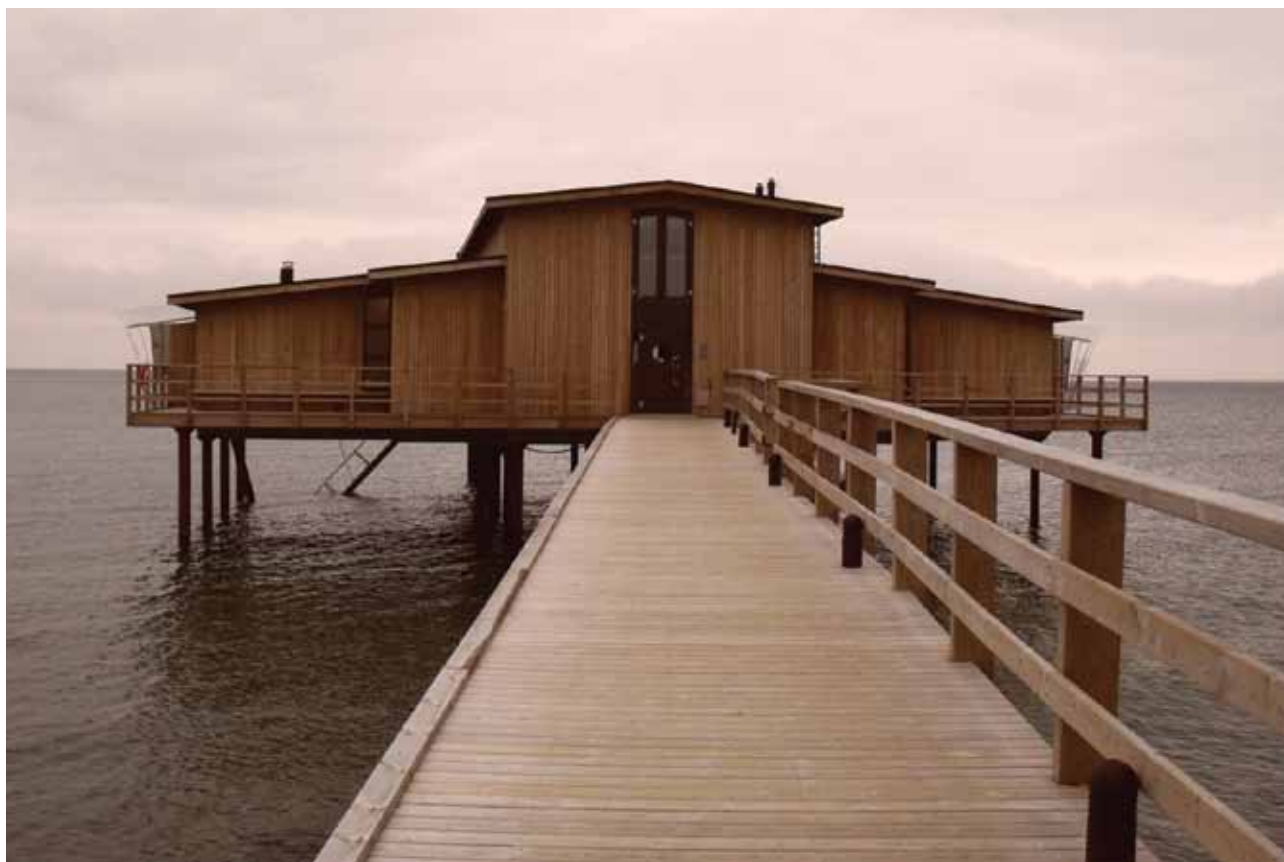
Object:	Outdoor Baths, Båstad, Sweden 2009
System:	Hammerglass Single 6 mm
Performance:	Hammerglass AB
	<p>Instead of grilles and barbed wire, Hammerglass Single was mounted in steel frames around the gates, to prevent outsiders from climbing them and intruding during night time.</p>

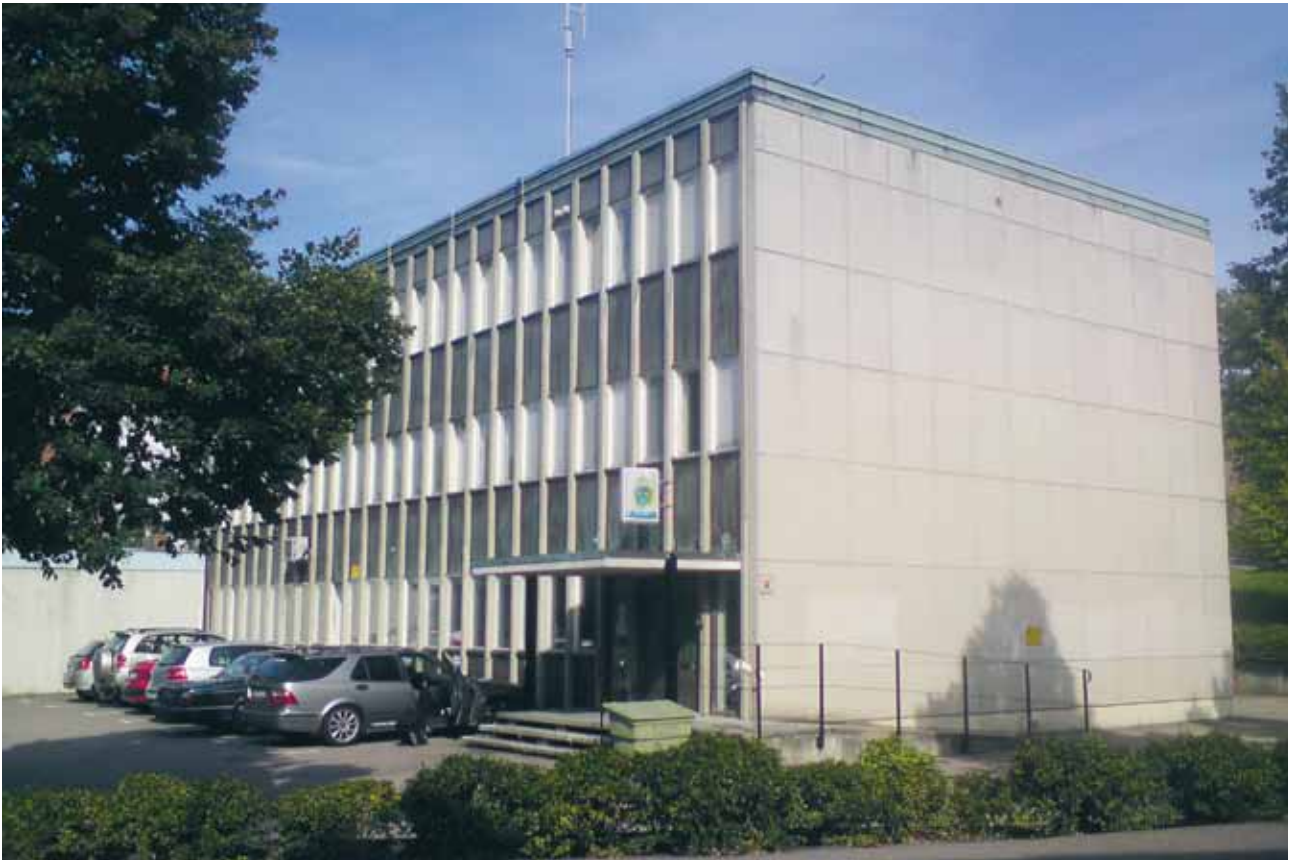
Object:	Police station, Laholm, Sweden 2008 and 2011
System:	Hammerglass Add-On System S
Performance:	Lås Team

<p>In 2008 a solar film Silver 20 was installed on the outside of the ground floor windows. On top of this solar film, Hammerglass Add-On System S were mounted.</p> <p>In 2011 the station was attacked with axes and stones but the Hammerglass resisted the attack and all windows were undamaged. Today the municipality has equipped the rest of the building with Hammerglass.</p> <p>Security class SS EN-356, P7B.</p>

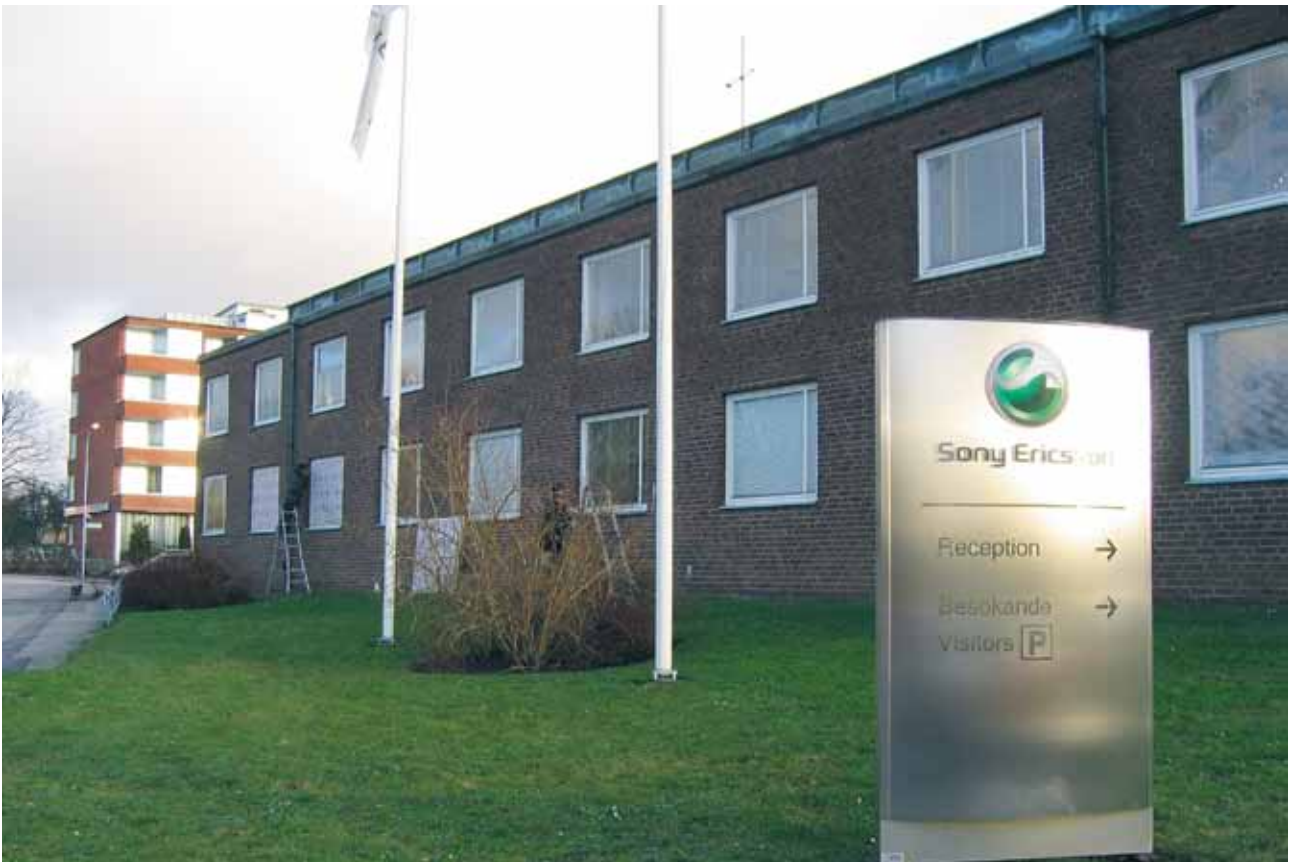
Object:	Sony Ericsson, Lund, Sweden 2006-2007
System:	Hammerglass Add-On System S, Hammerglass Insulate
Performance:	Hammerglass AB

<p>Property with repeated burglary problems and need for commercial protection. Sony Ericsson chose Hammerglass Add-On System S to avoid “sitting behind bars”.</p> <p>Hammerglass Add-On System S and Hammerglass Insulate were mounted in the ground floor windows and in windows accessible from the roof.</p> <p>Hammerglass Add-On System S is screwed into the frame of opening windows to secure against breakup of sashes.</p> <p>Total delivery of 250 units.</p>

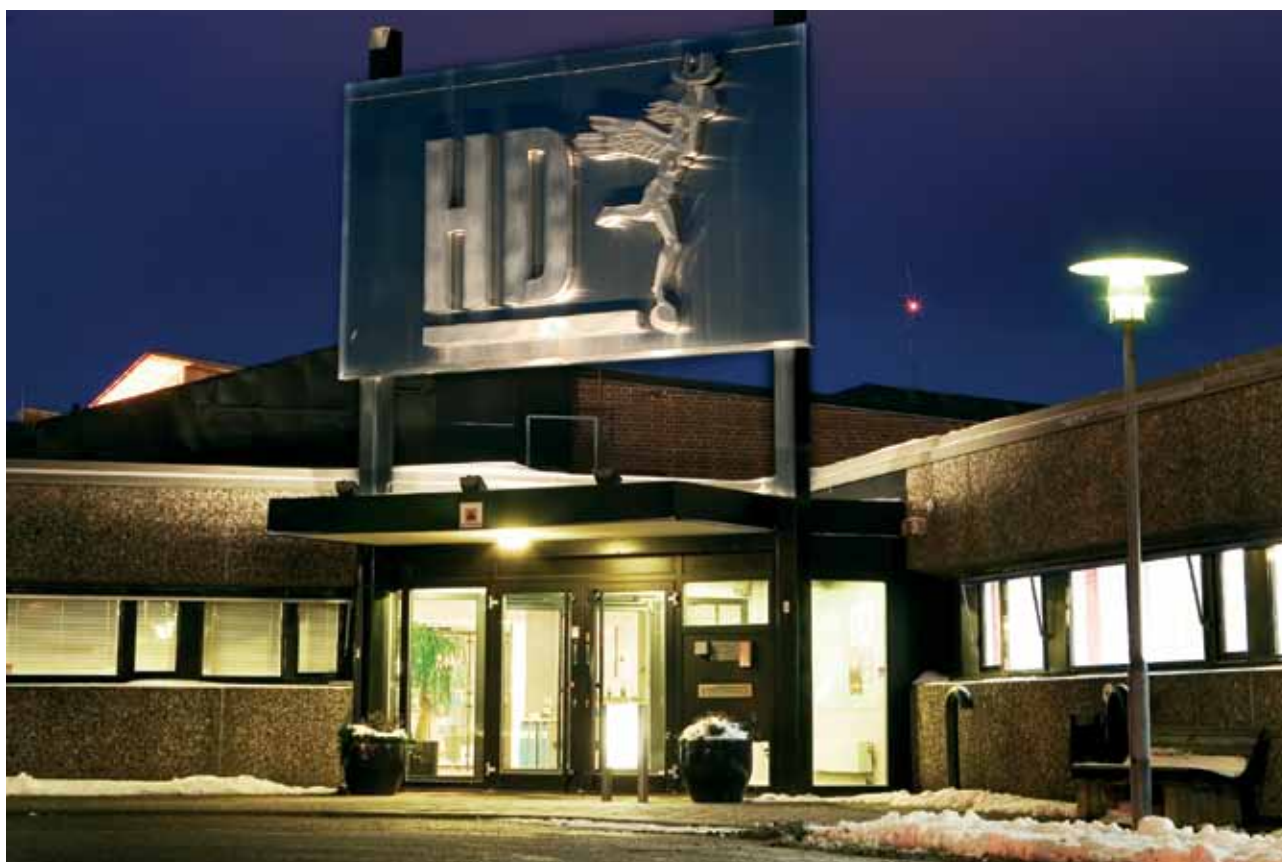
Object:	Helsingborgs Newspaper, Helsingborg, Sweden 2006
System:	Hammerglass Add-On System S
Performance:	Fastighetsskydd
	<p>Hammerglass Add-On System S with RAL-coloured profiles in all the windows on the ground floor, including entrances, and reinforcement even in skylights.</p> <p>At an earlier stage, a burglary protective film was applied. As this was not enough to prevent break-ins, Hammerglass Add-On System S was installed in all windows. The entrance sections were provided with Hammerglass Insulate.</p>

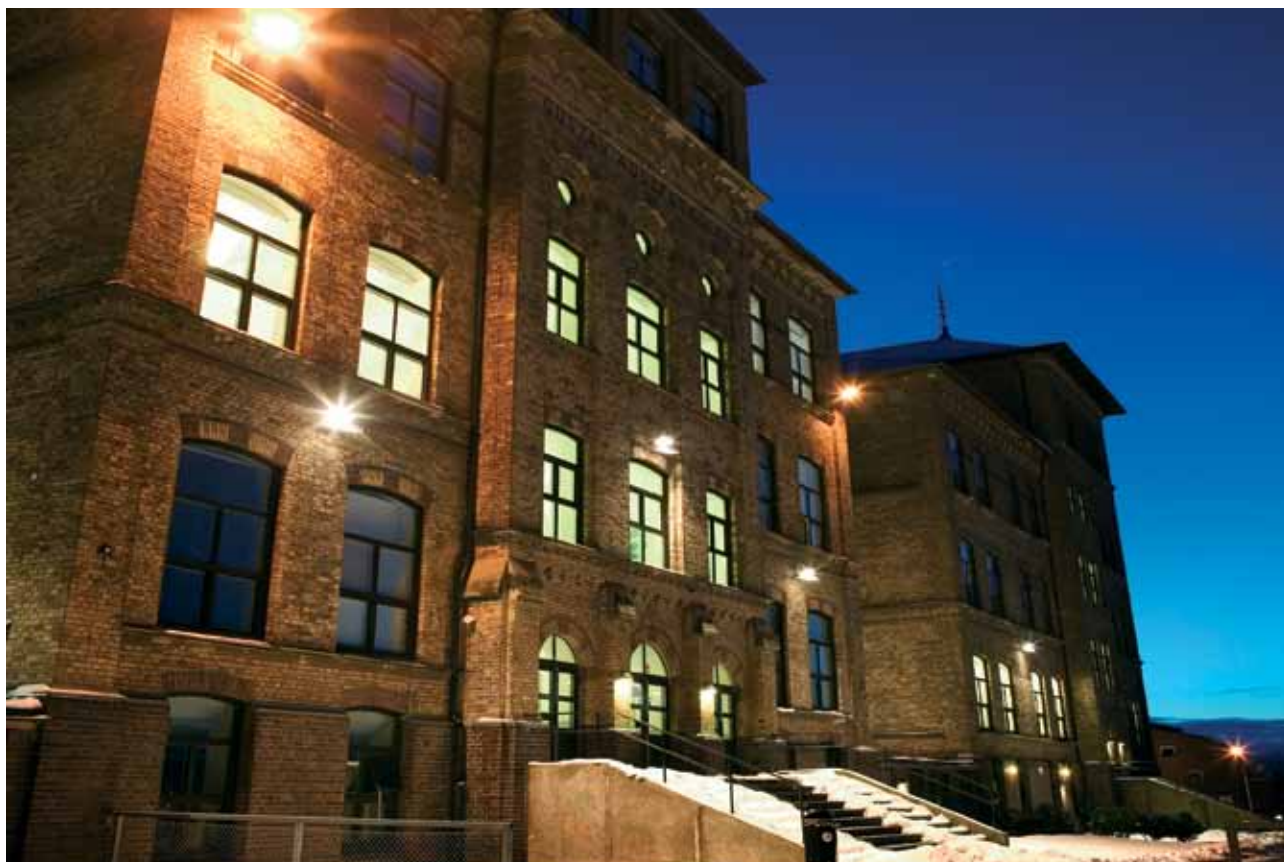
Object:	Gustav Adolf School, Helsingborg, Sweden 2006
System:	Hammerglass Insulate
Performance:	Fastighetsskydd
	<p>This school had major problems with vandalism.</p> <p>Hammerglass Insulate with arched top side was mounted in existing sashes on the windows of the ground floor and second floor.</p> <p>Delivery of Hammerglass Insulate in several stages as the school was under refurbishment.</p>

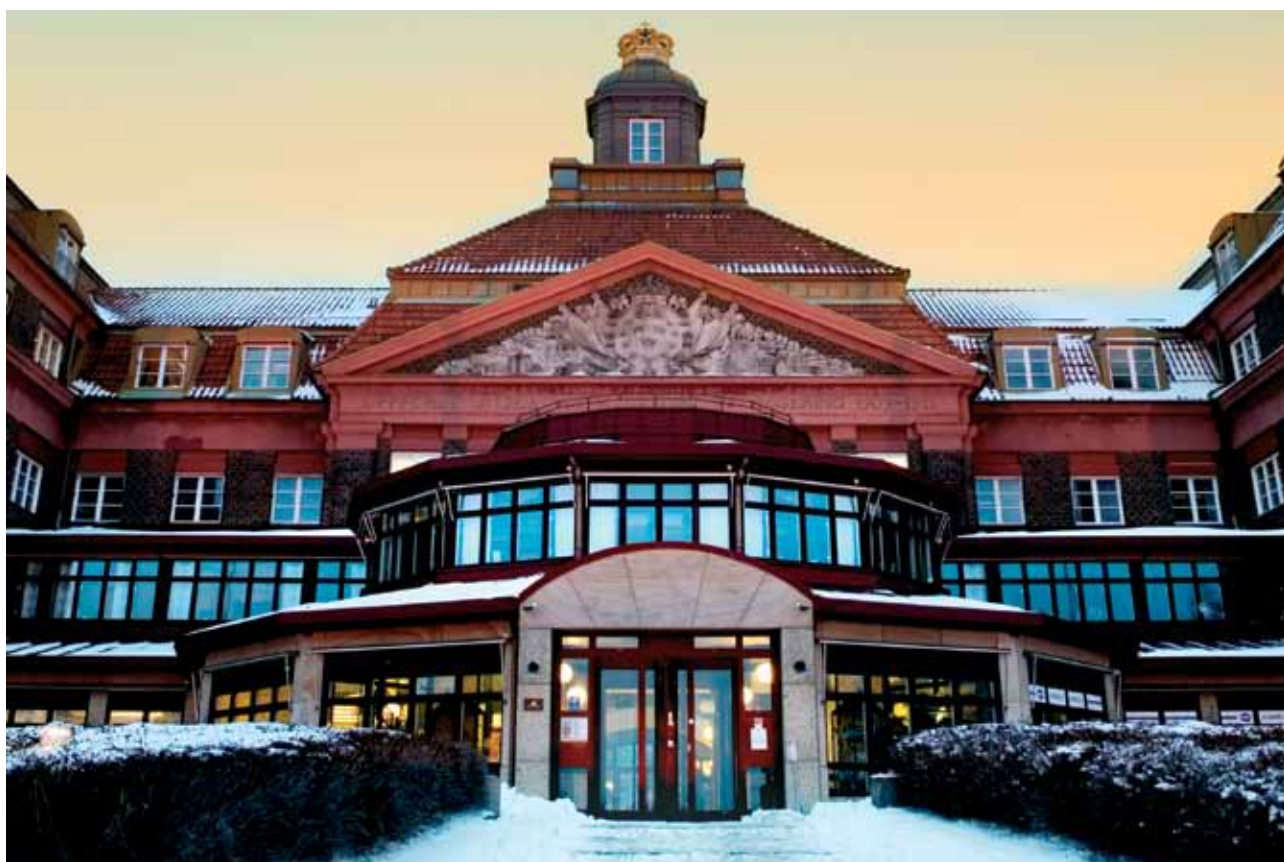
Object:	Kavalleristen, Helsingborg, Sweden 2000
System:	Hammerglass Single
Performance:	Metallfasader
	<p>Listed property with "smash-and-grab" theft problems. The entire ground floor equipped with Hammerglass Single in new aluminium outer profiles. Thereafter, the profile is reinforced by a window anchor for optimum strength.</p> <p>No alteration to the building's original appearance.</p>

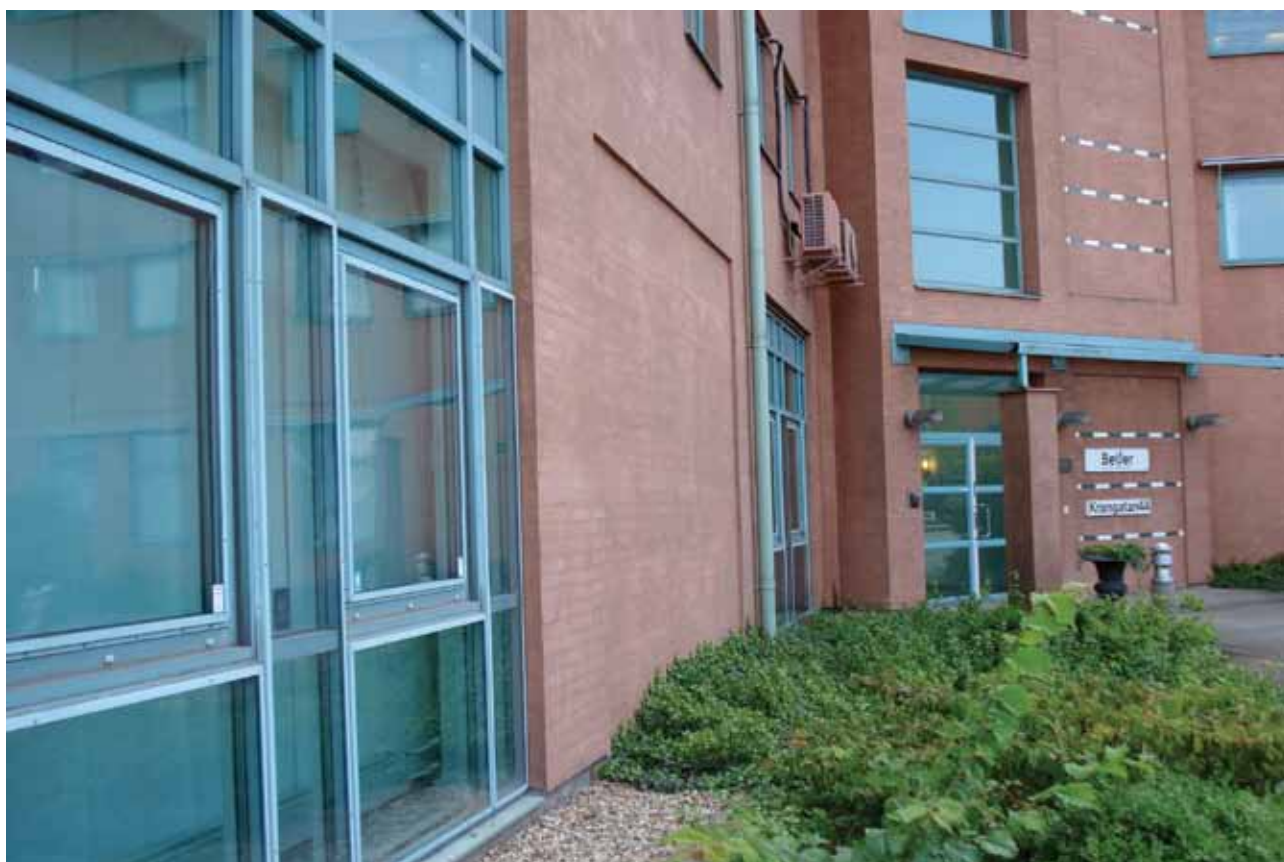
Object:	Beijer Electronics 1998
System:	Hammerglass Add-On System S
Performance:	Metallfasader
	<p>Property with repeated problems with break-ins, computer thefts and multiple glass restoration. Chose Hammerglass Add-On System S to avoid “sitting behind bars”.</p> <p>Hammerglass Add-On System S with RAL-coloured profiles has been fitted throughout the ground floor.</p> <p>Total delivery of 200 units.</p>

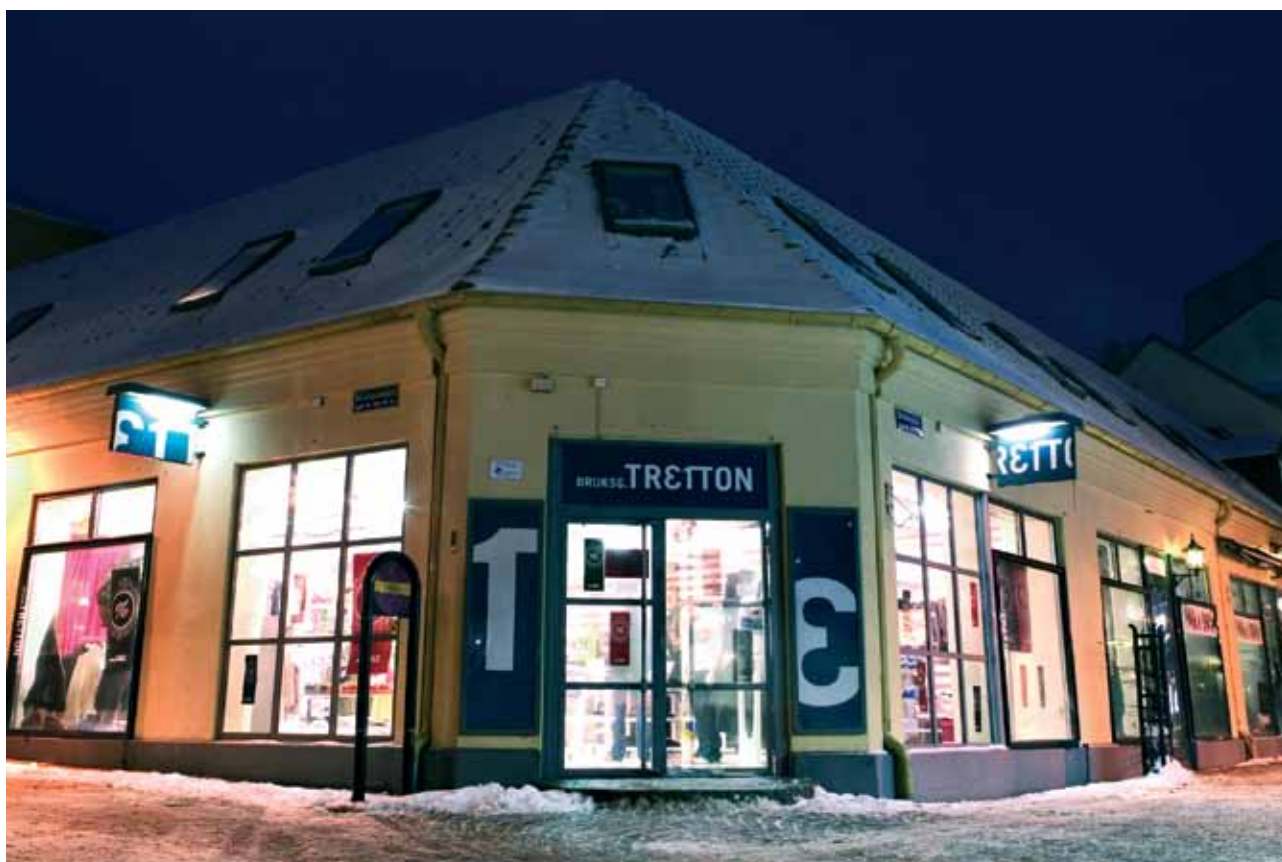
Object:	Bruksgatan No 13, Helsingborg, Sweden 1996
System:	Hammerglass Single
Performance:	Metallfasader
	<p>Hammerglass Single was installed in new steel profiles in the storefront and entrance party. The Hammerglass panes were glued into the frames and the glazing beads were fixed with screws.</p> <p>Forester Profile system.</p>
